# Baseline Watershed Assessment Tankerhoosen River Watershed

Friends of the Hockanum River  
Linear Park of Vernon, Inc.

May 28, 2008

Fuss & O'Neill, Inc.  
78 Interstate Drive  
West Springfield, MA 01089

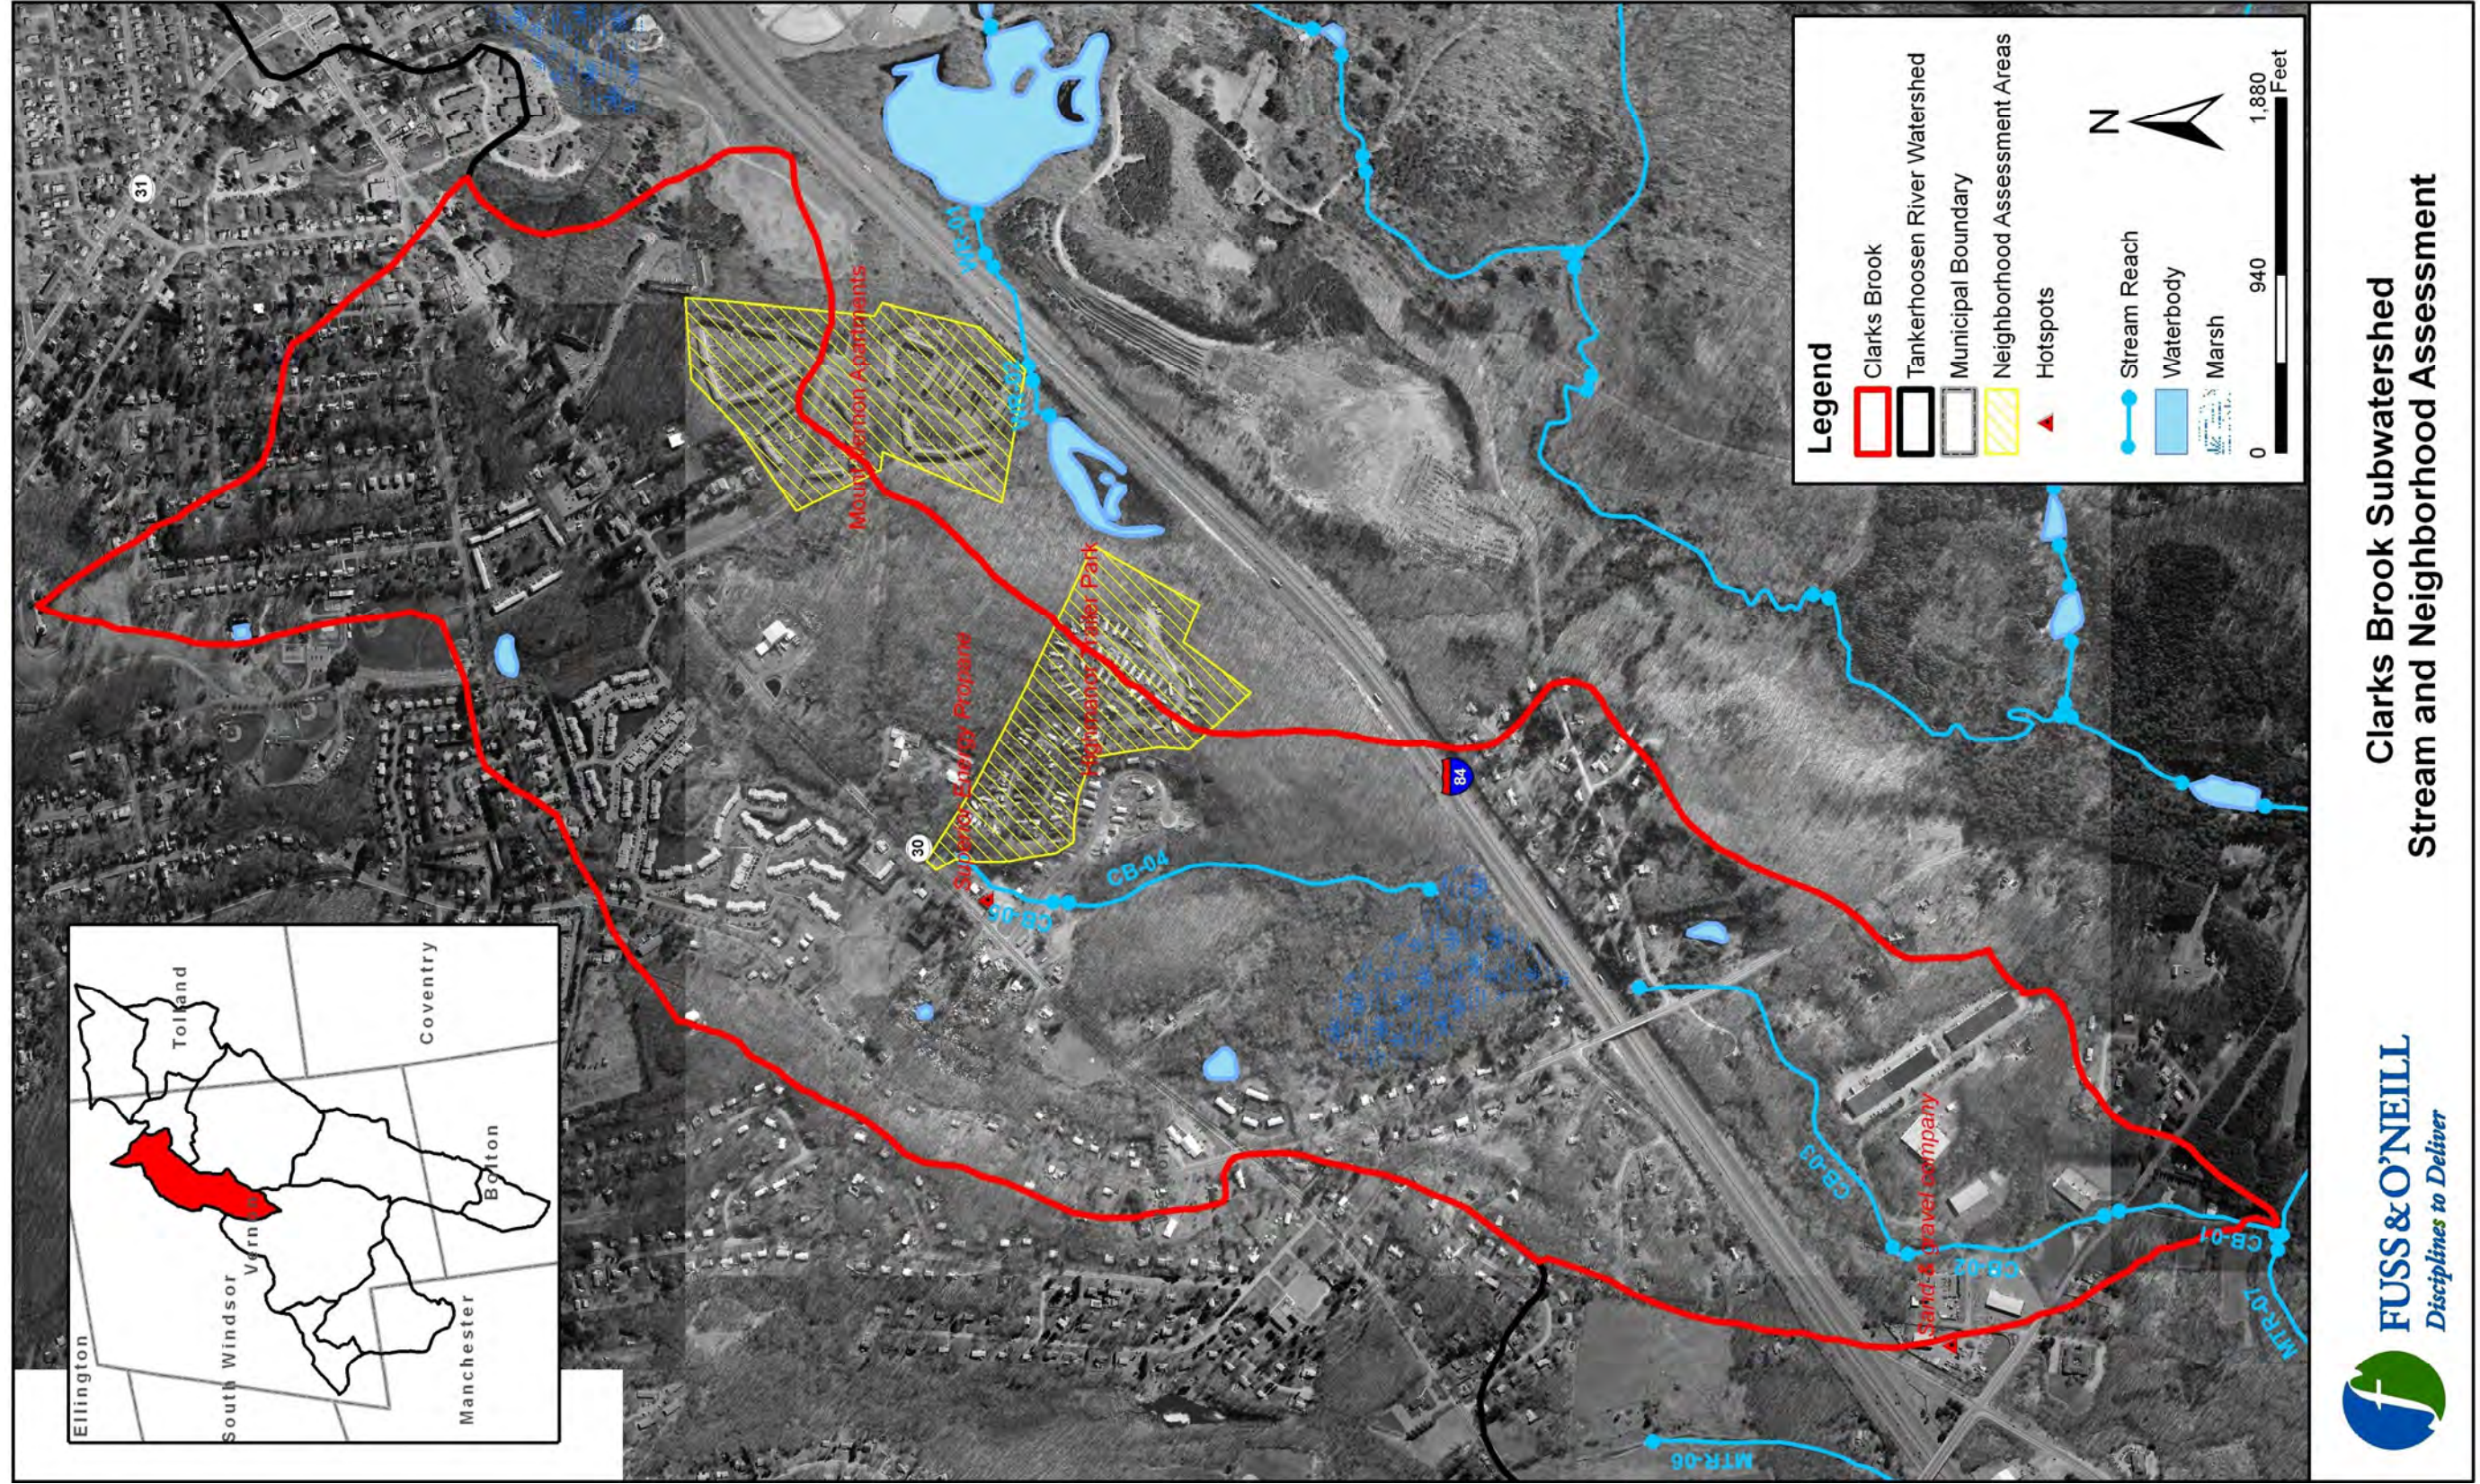
Figure 3. Clarks Brook Subwatershed Field Assessment Locations

- **RCH** – The overall stream conditions are optimal to suboptimal with the exception of bank vegetative protection which is rated as poor due to lack of stream buffer along portions of the left bank. The dominant bed substrate is cobble; there are no attached or floating plants in the stream; wildlife such as fish, frogs, and birds are present; and the stream is approximately 50 percent shaded. The reach has good accessibility.

- OT – The reach contains several outfall pipes, including several 4-inch plastic pipes which are believed to be connected to residential foundation drains or roof downspouts (no dry weather flows observed) and two 18-inch outfalls conveying roadway drainage (no dry weather flows observed). None of the observed outfall pipes appears to be contributing dry weather discharges or causing stream bank erosion.
- SC – Clarks Brook crosses under Bolton Road within a 5.5-foot circular concrete culvert. The upstream side of the culvert was partially blocked by brush and debris, and the concrete on the inside of the culvert is deteriorating. The sharp drop in elevation immediately downstream of the culvert creates a “perched” condition and a physical barrier to fish passage. This culvert is a potential candidate for fish barrier removal to address the perched outlet and cleaning/repair.

- ER – Some moderate, isolated bank erosion was observed on the left bank. This area is a potential candidate for bank stabilization.
- SC – An approximately 400-foot long circular culvert conveys Clarks Brook under a parking lot. The triple barrel metal culverts are 2 feet in diameter. The outlets of the culverts are perched slightly above elevation of the stream bottom. This culvert is a potential candidate for fish barrier removal to address the perched outlet.

- TR – Significant quantities of trash and debris (an estimated 1 pickup truck load) were observed including tires, automotive waste, appliances and a closed 55-gallon drum of unknown contents. The debris and waste materials should be removed and disposed in accordance with applicable local, state, and federal regulations.

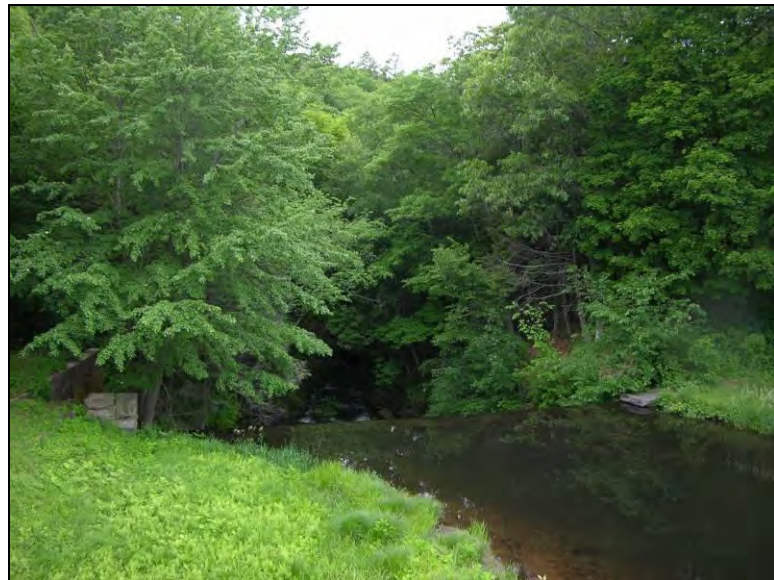
*The upstream side of Dobsonville Pond dam at the upstream limit of reach LTR-03. The photograph is taken near the confluence with reach TB-01.*

- SC – The dams that impound Dobsonville Pond and Talcotville Pond are potential barriers to fish passage. According to the CTDEP Inland Fisheries Division, there are currently no diadromous fish (herring, shad) passage plans for these dams (Murphy, personal communication, September 24, 2008). There has been an effort in recent years to provide American eel passage at inland dams when there is a need and opportunity. An assessment of the lower reaches of the Tankerhoosen River is recommended to evaluate the presence of American eel and other resident fish populations, as well as the potential benefit of providing fish passage for these dams. Based on the assessment findings, fish passage for the resident fish population in the lower Tankerhoosen River could be incorporated into future dam repair projects.

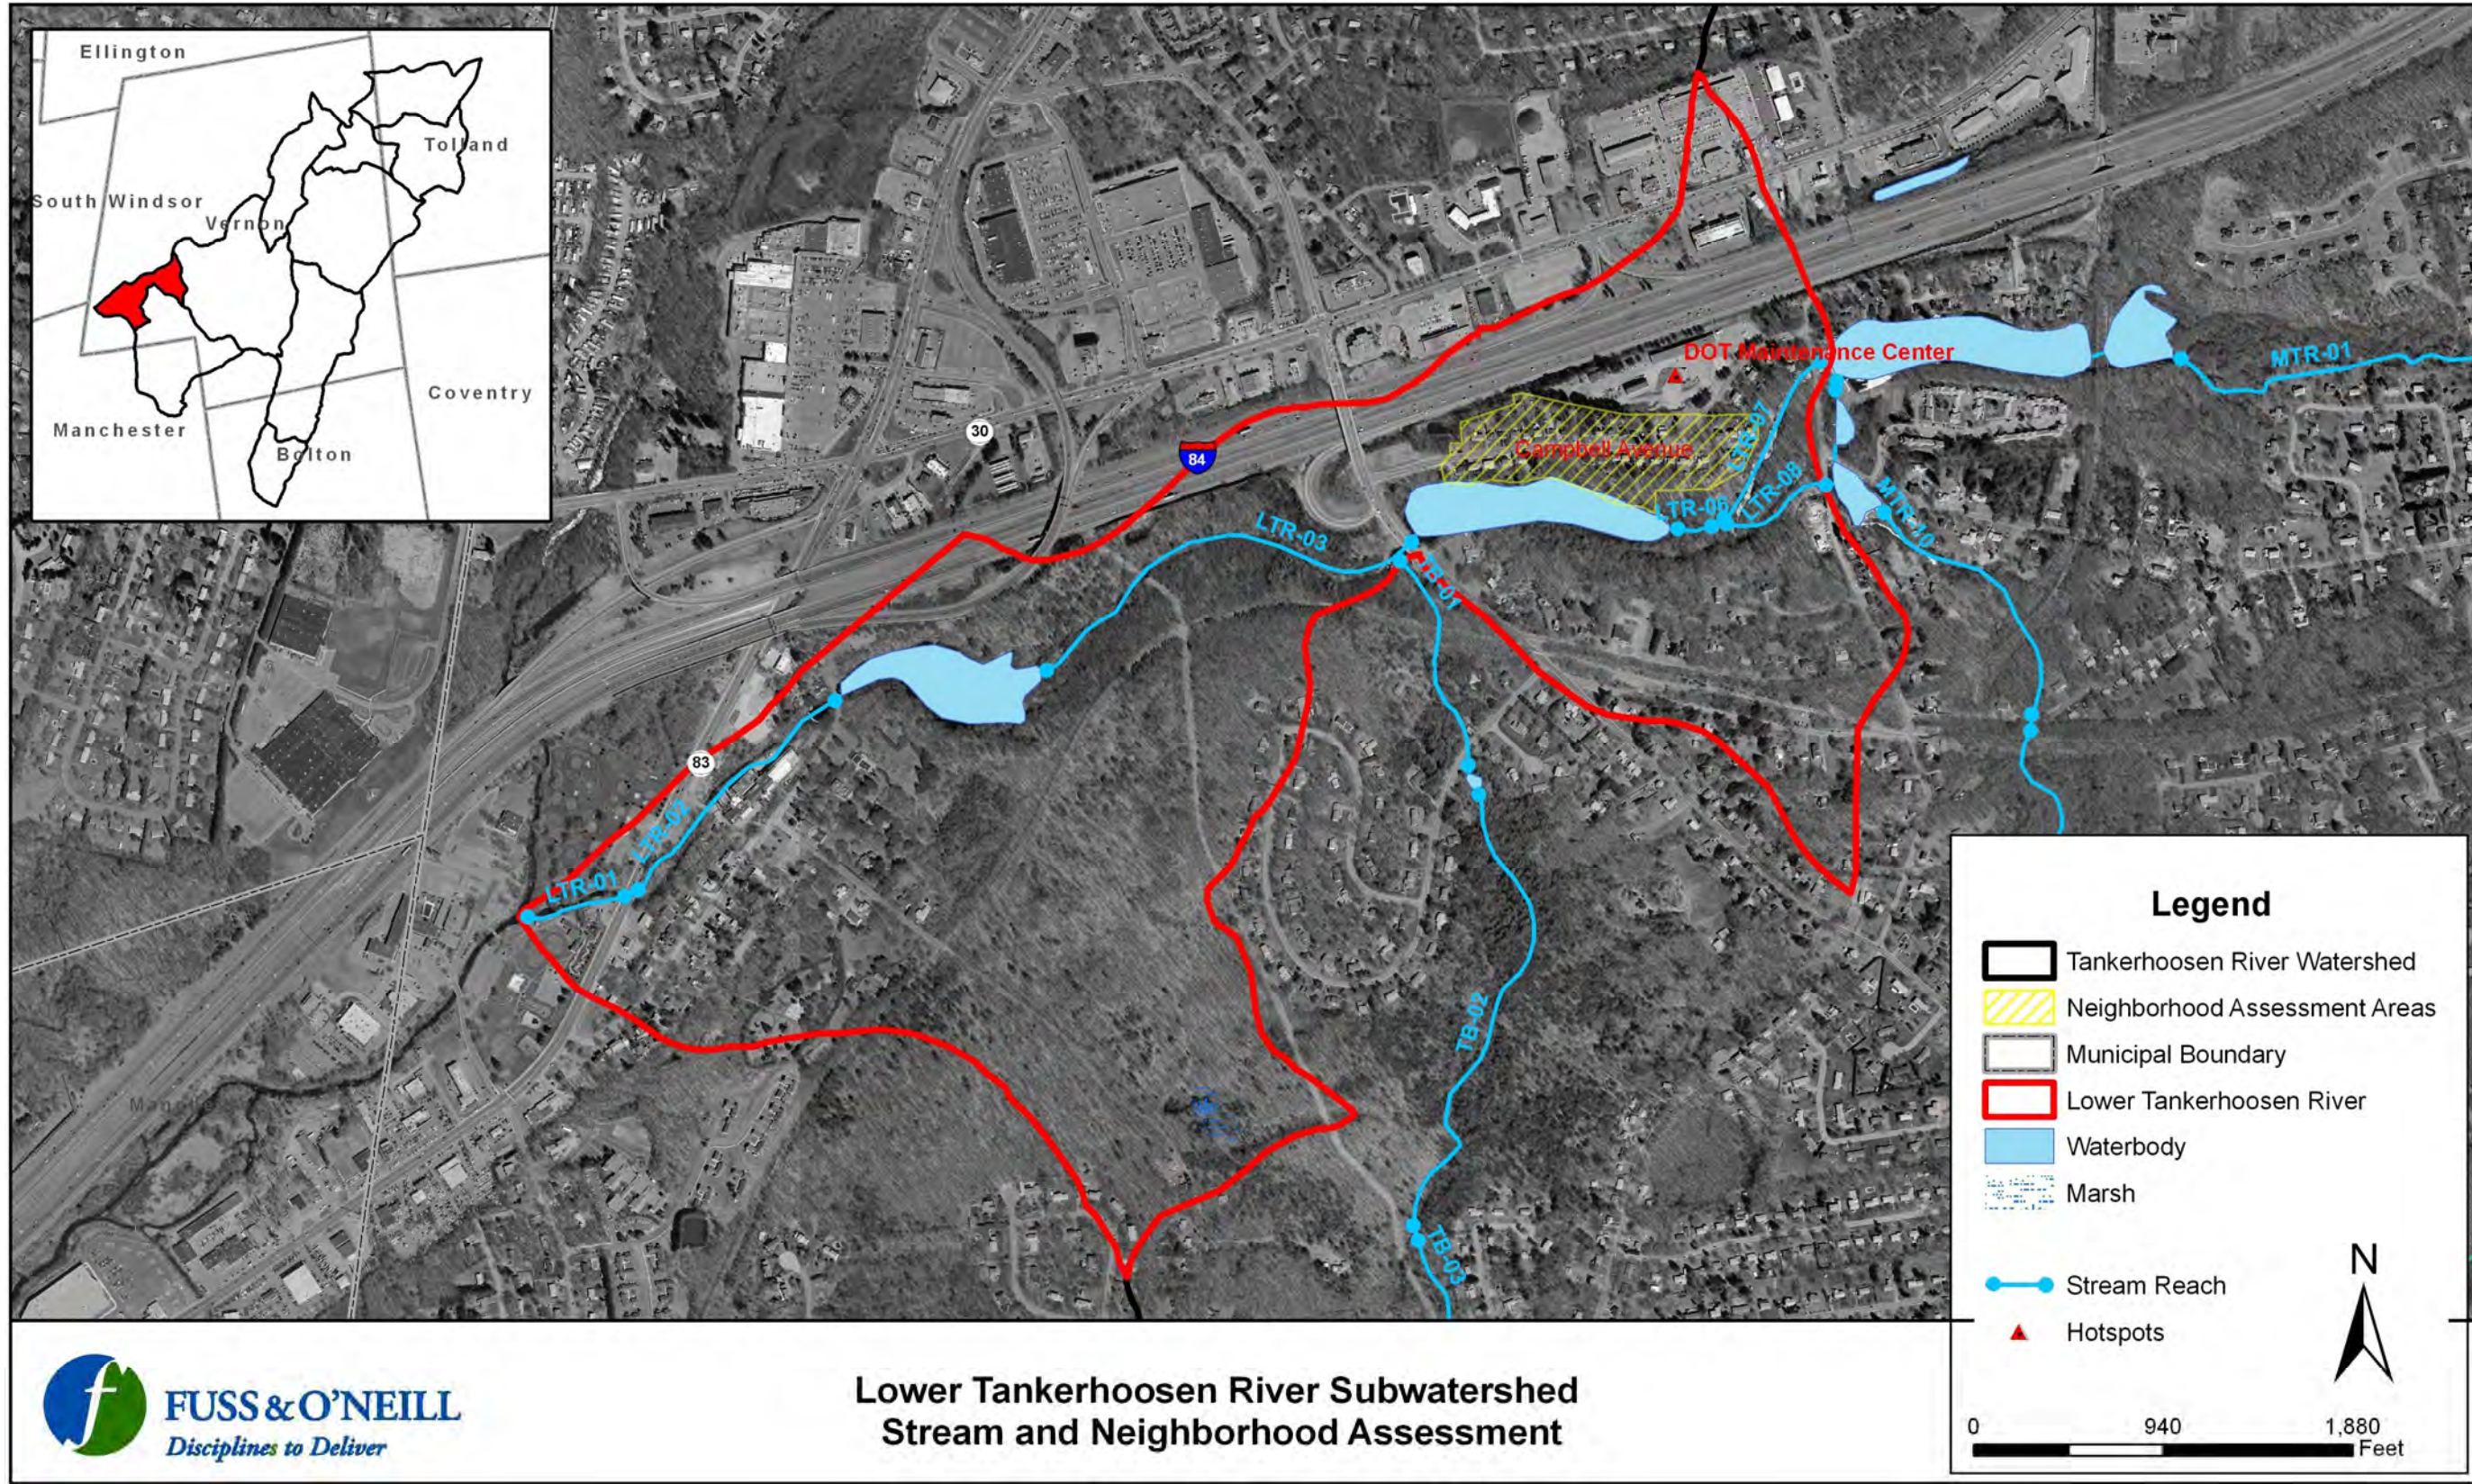
Figure 4. Lower Tankerhoosen River Subwatershed Field Assessment Locations

- RCH – The reach level assessment characterized this segment as generally suboptimal. The vegetated buffer width and floodplain vegetation is rated as optimal. The surrounding forested land provides good stream habitat. The beginning and end of the stream segment are altered by the manmade impoundments at both ends. The stream flows at 75 to 100% of the channel width and the substrate is dominated by cobble. The water is somewhat cloudy and has a naturally stained color. There are no plants in the stream and the surface is mostly shaded. The most significant issue observed along this reach is a stormwater detention basin associated with runoff from Interstate 84.

- OT – A stormwater outfall pipe conveys stormwater runoff from Interstate 84 to a detention basin located adjacent to the stream. The inside of the outfall pipe was observed to have an orange, rusty color, and an oily stain. A rusty, oily sludge was observed in the bottom of the detention basin. No standing water or discharge from the basin was observed at the time of the inspection. A discharge investigation is recommended to observe the basin function during wet weather and assess possible pollutant contribution to the stream. The basin and stormwater discharge is a potential stormwater retrofit candidate.

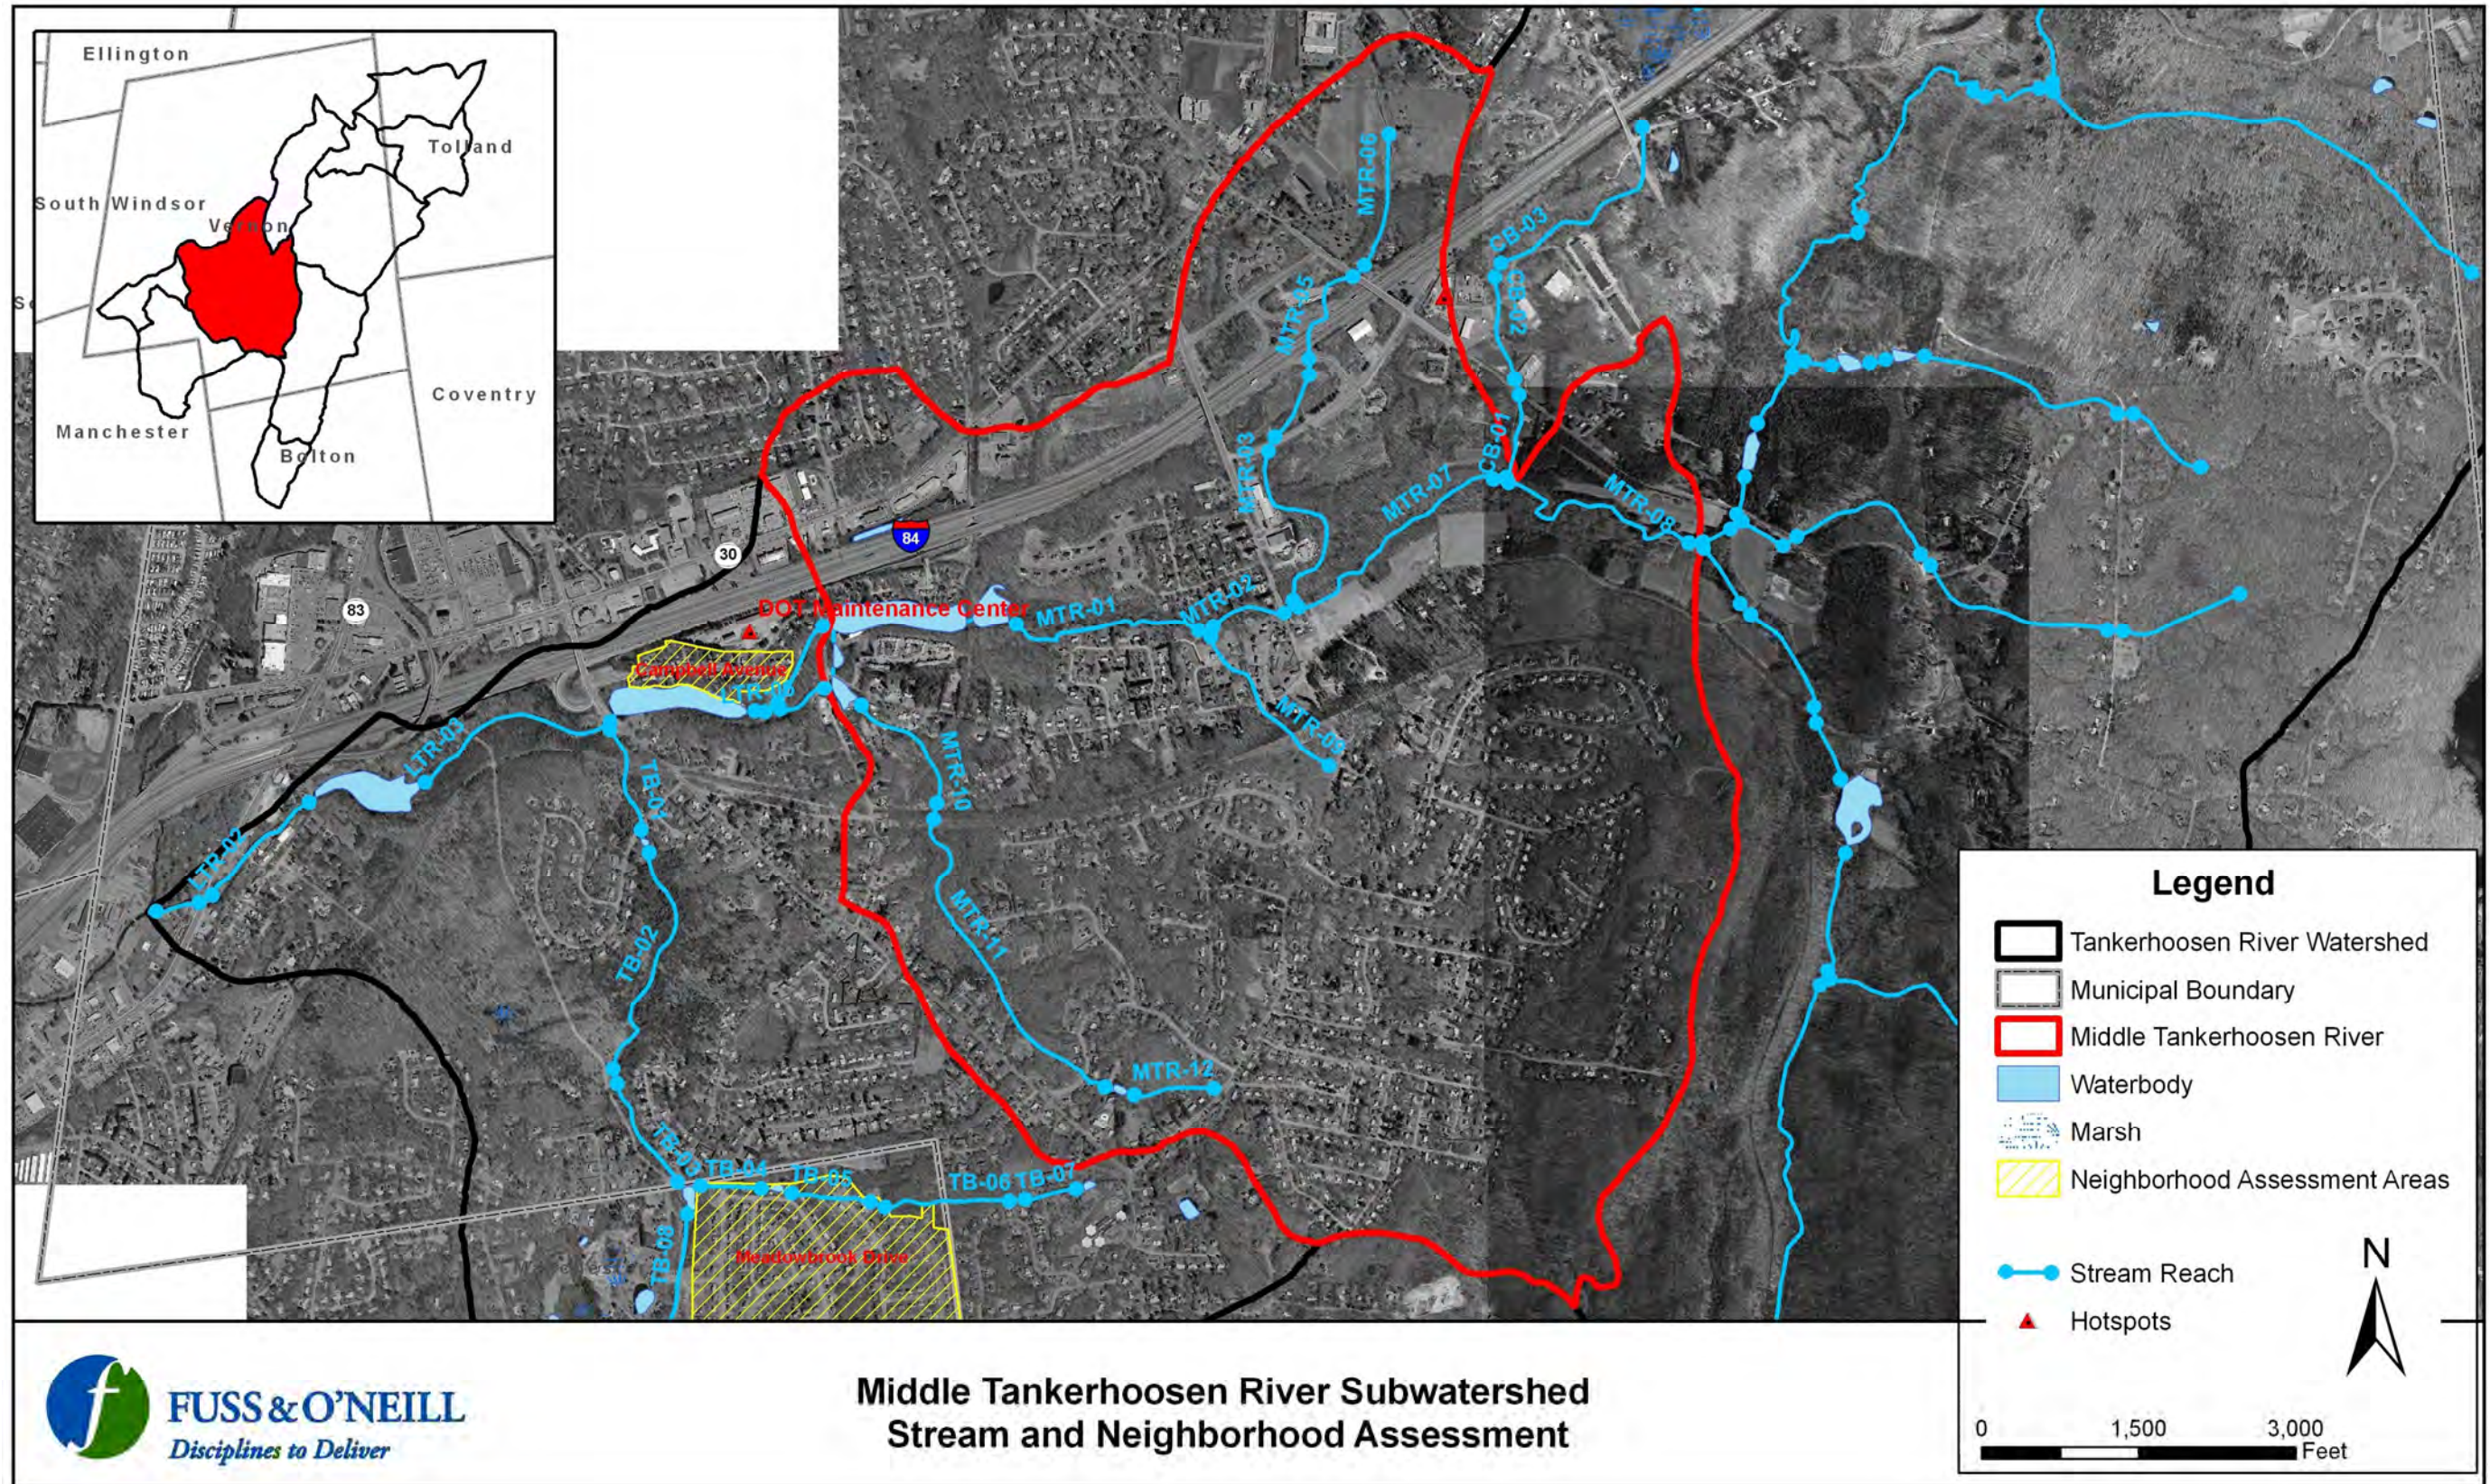
Figure 5. Middle Tankerhoosen River Subwatershed Field Assessment Locations

- RCH – The reach level assessment indicates suboptimal in-stream habitat, vegetative protection, bank erosion and floodplain connection. The overall buffer and floodplain conditions are generally marginal, with limited vegetative buffer width, floodplain

- OT – Four outfalls were observed along the left bank of the stream. Three of the outfalls are storm drainage pipes that convey stormwater runoff from the adjacent residential development. Sediment accumulation was observed at the outlets of several of the outfalls. An ABS outfall pipe was observed behind a residence. The pipe was submerged below the stream water surface at the time of the inspection. The source of this pipe and the nature of the potential discharge from the pipe should be investigated further.

- TR – Three instances of trash and/or debris were observed along this segment. TR-01 is a commercial-grade 55-gallon plastic drum located within the stream. The contents of the drum could not be determined. TR-02 consists of brush and debris stockpiled along the bank of the stream. The material was placed by the Town of Vernon following removal of a beaver dam, but never removed. TR-03 consists of approximately 16 plastic buckets that are submerged or partially submerged below the water surface of the stream. The contents of the buckets are unknown. Both areas should be the focus of stream cleanup efforts.

- IB – The left bank along much of the stream segment consists of residential lawns immediately adjacent to the stream, with little or no stream buffer. Stream bank erosion was observed in some areas along the left bank, including evidence of animal burrows in the stream bank below the exposed roots of the lawn.

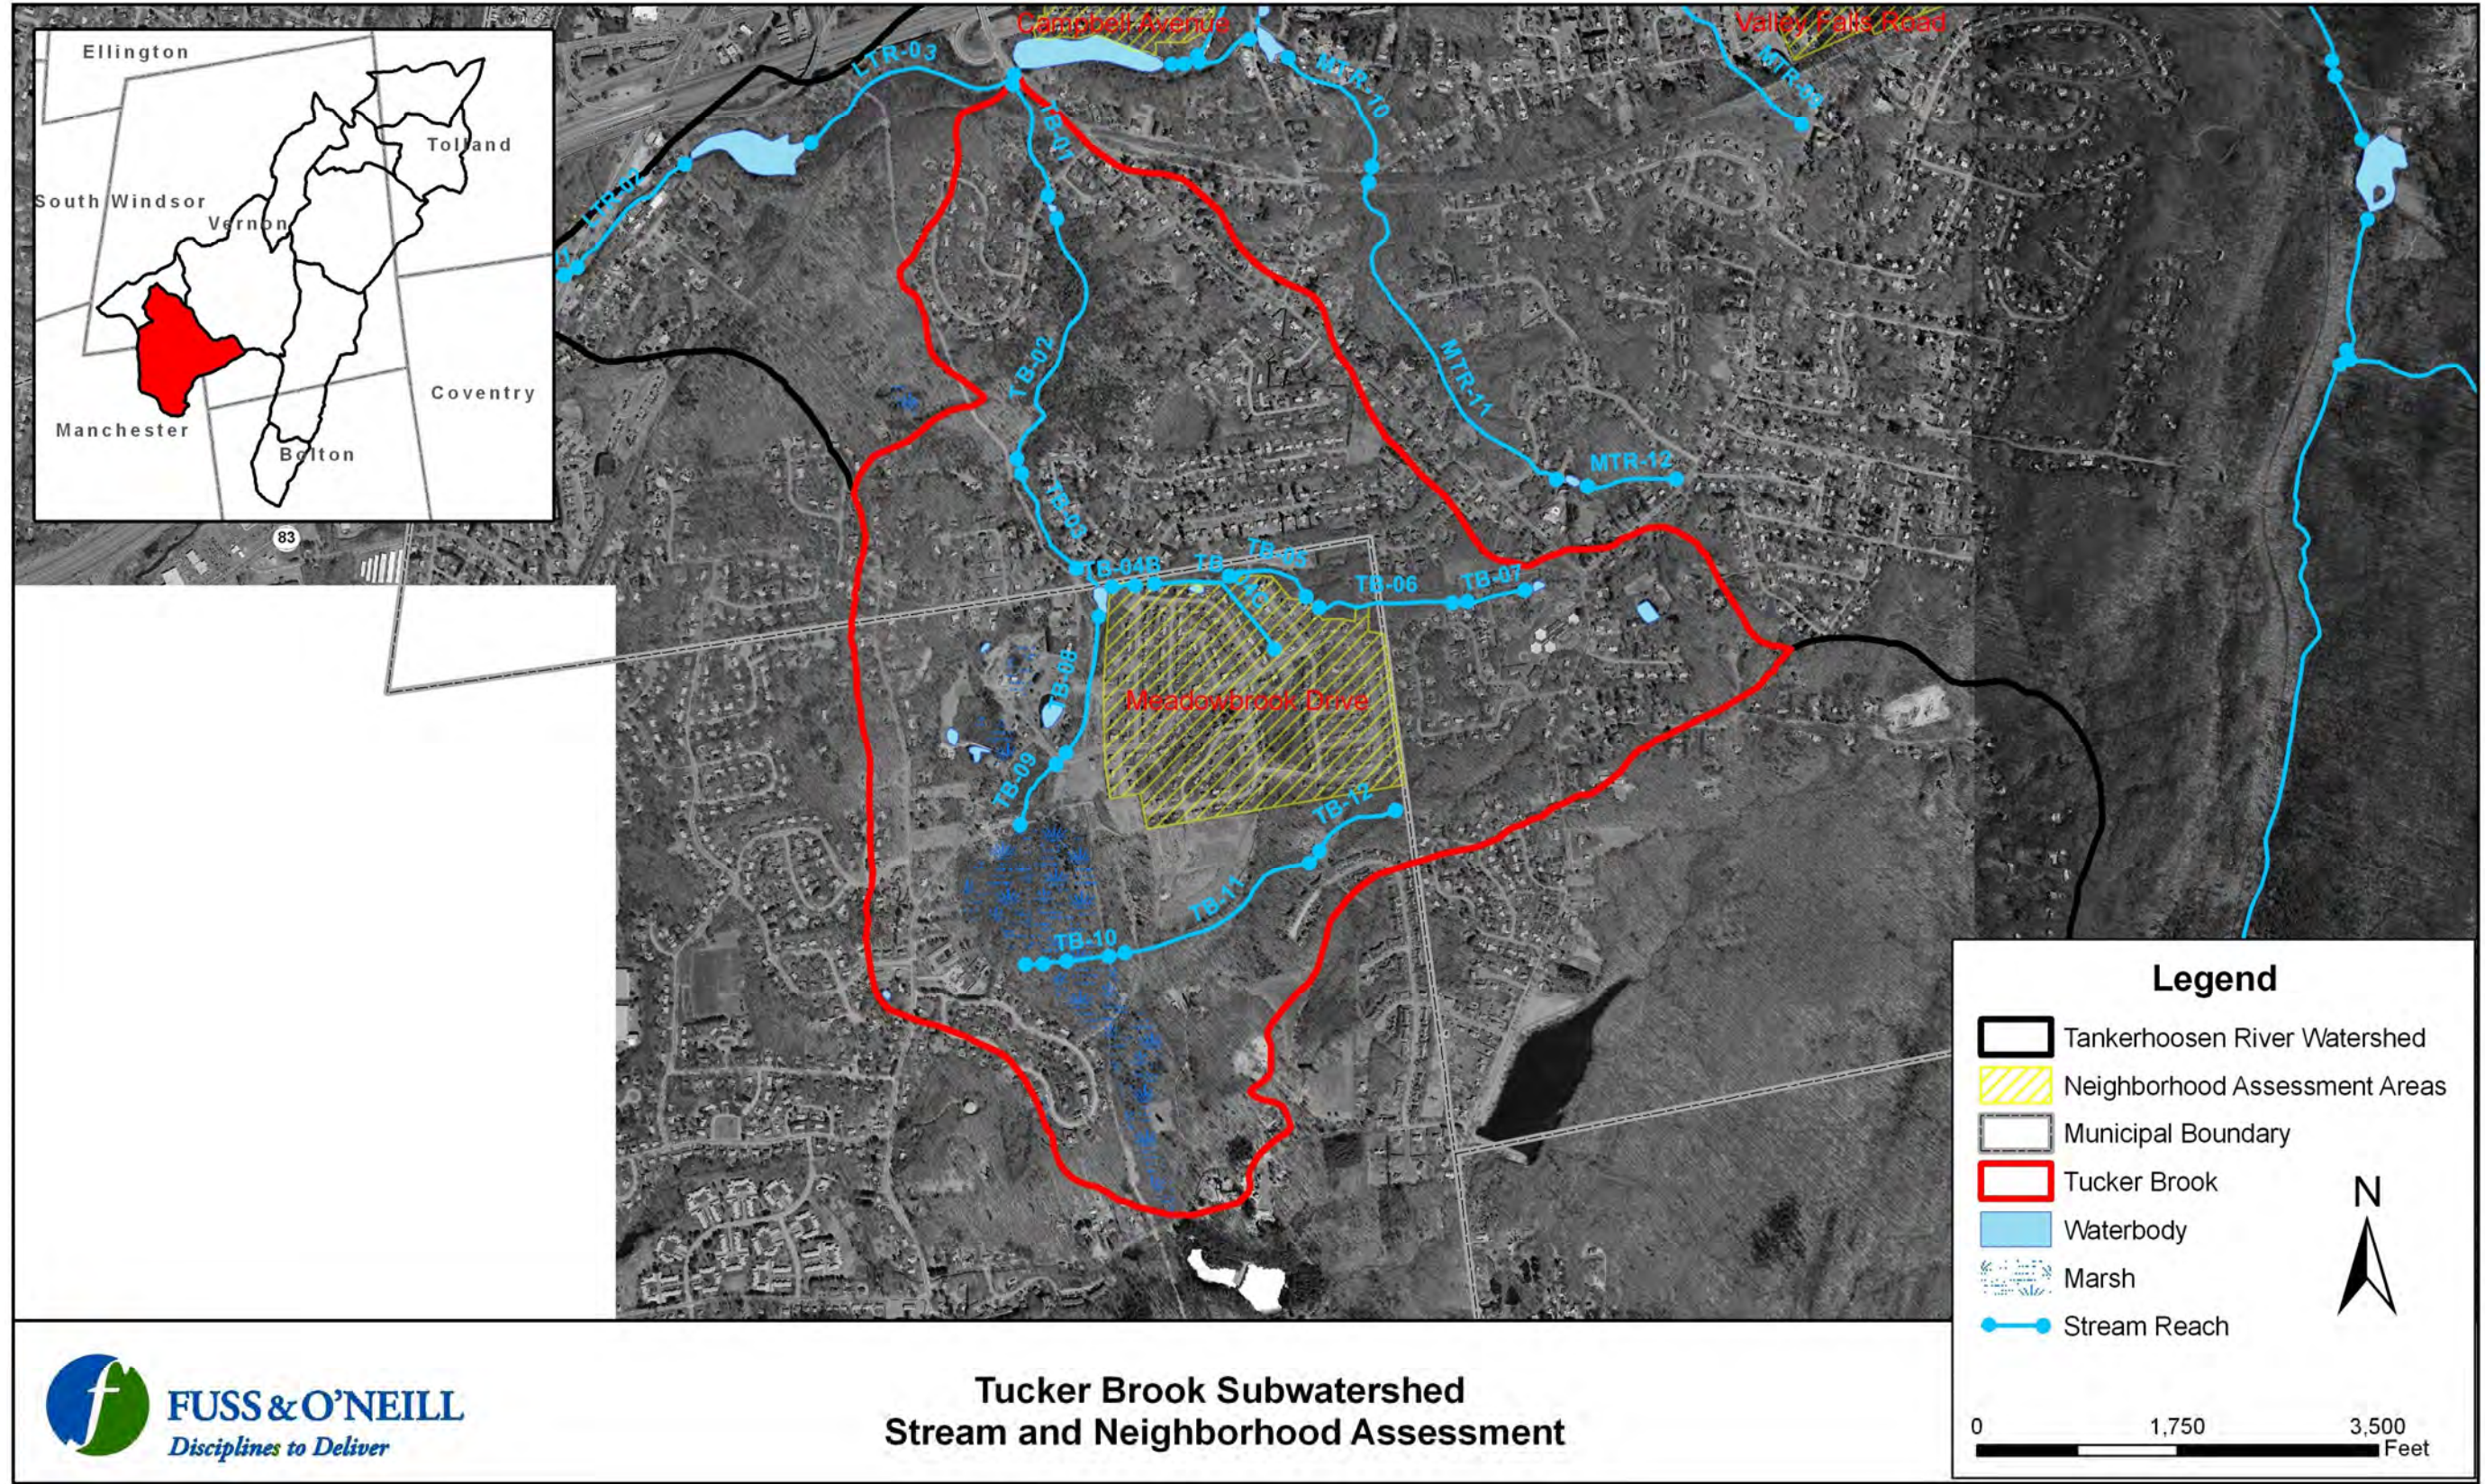
Figure 9. Tucker Brook Subwatershed Field Assessment Locations

- ER – Bank failure and scour is present on the right bank along an approximately 50-foot meandering portion of the stream. The bank is currently stabilized by tree roots and other hanging woody debris. The bank appears to be stable.

- IB – There is a bridge abutment on the right bank of Tucker Brook at the confluence with the lower Tankhoosen River. The Dobson Road overpass abutment extends approximately 40 feet upstream and is approximately 10 feet from the stream bank. The stream banks and riparian area along the downstream end of the reach at the confluence with the Tankerhoosen River lack a tree canopy; the stream is unshaded in this area. This area is a potential candidate for reforestation.

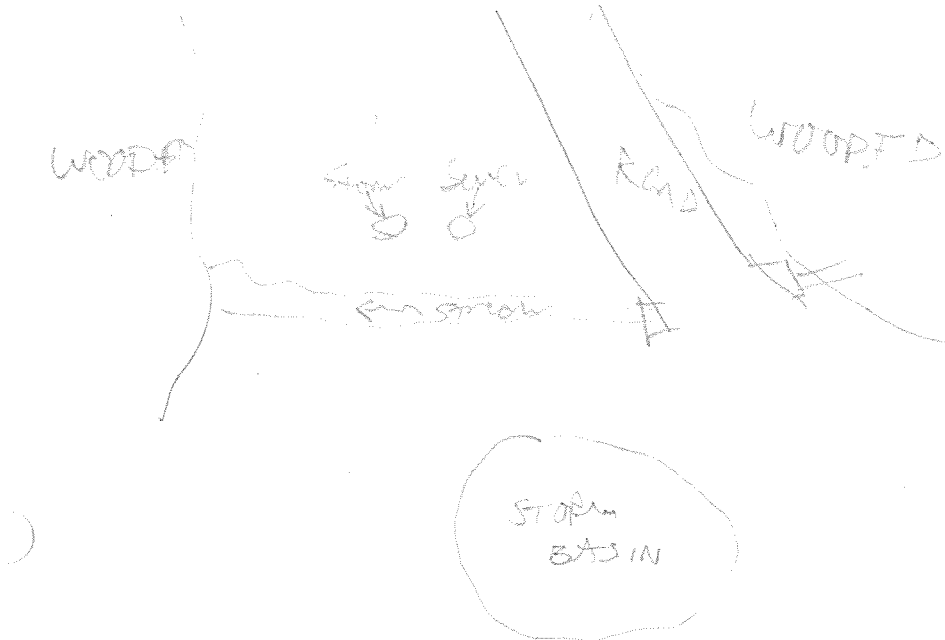
**NOTES:**  
No exposed pipe  
 REPORTED TO LOCAL AUTHORITIES  Yes  No

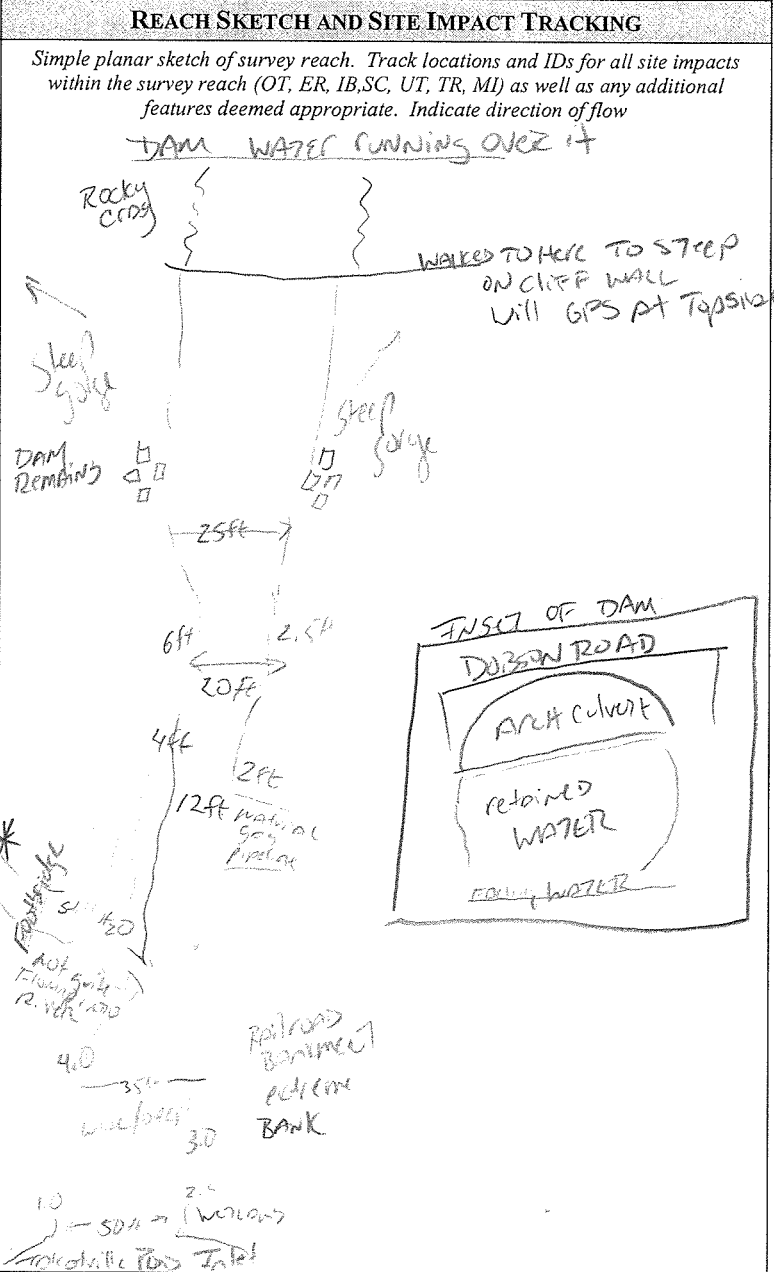
NOTES: (biggest problem you see in survey reach)  
 \* STORM WATER CATCH BASIN FOR I-84 HIGHWAY RUNOFF

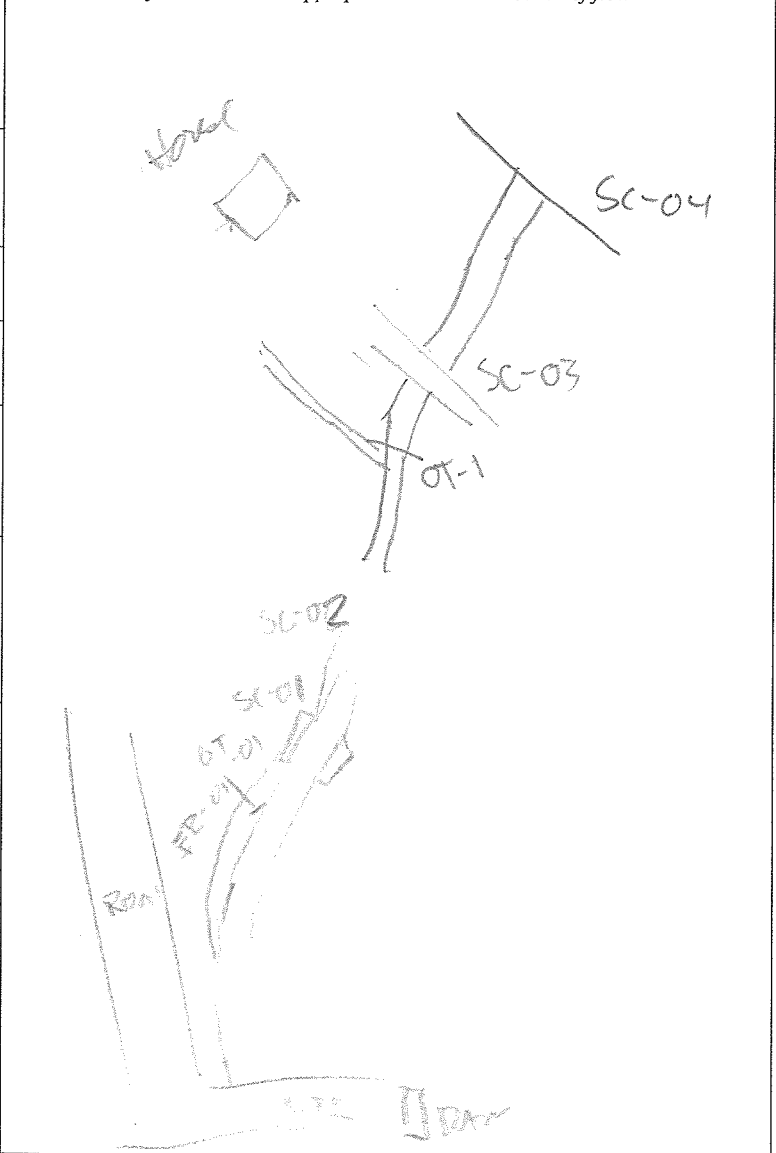
NOTES: (biggest problem you see in survey reach)  
Failing industrial-era infrastructure

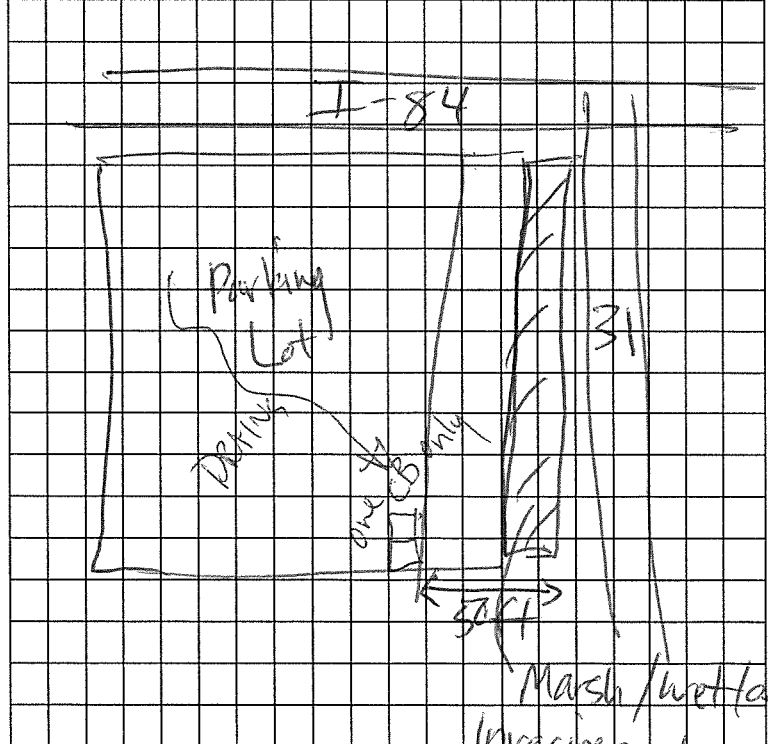
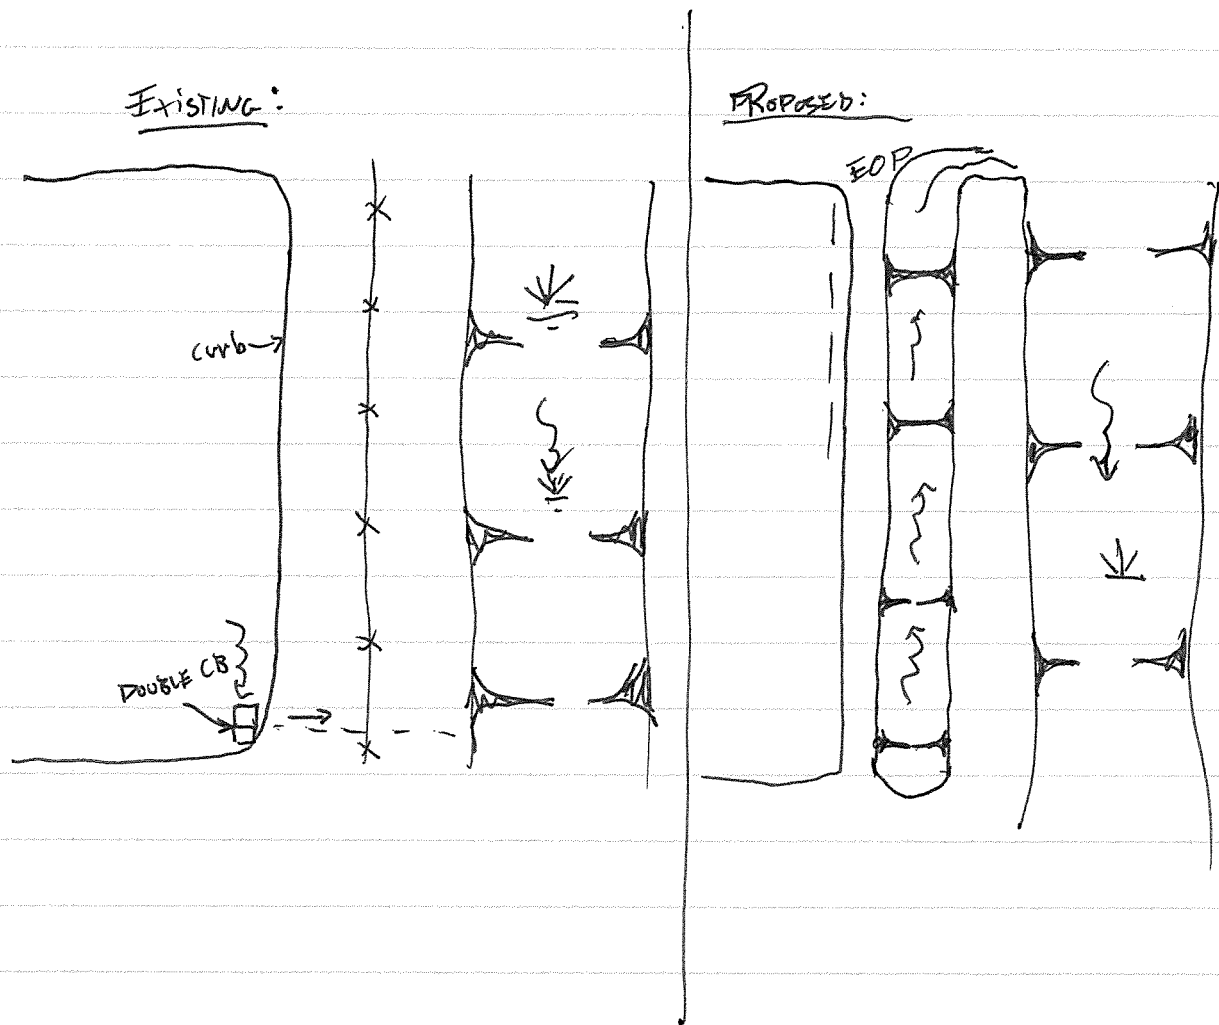
**Notes:**  
 SW runoff from parking lot directly enters wetland area & likely contains oil and sediments & salts. Retrofit possible with large buffer.

Discharge to wetland

Wide grass strip between curb & wetland could be used for Swale

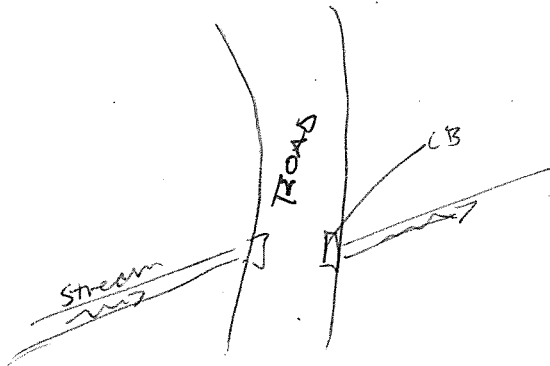
#1

#1:  
 Dry weather flow  
 severe erosion at outfall

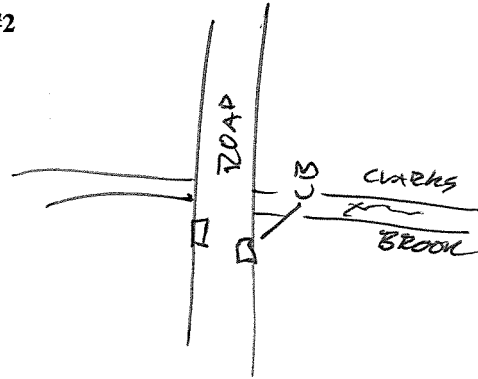
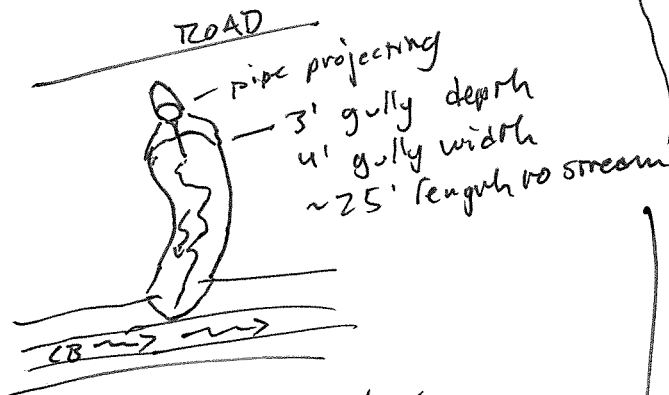
#2

Source is a wetland area adjacent to ind. bldg; no pipe in.

Water in CB @ higher level than stream surface & not draining

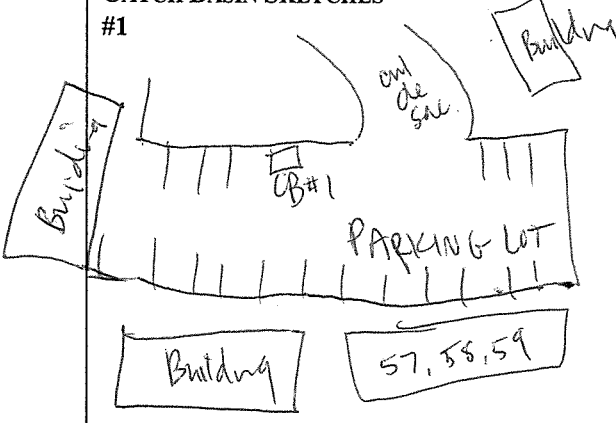
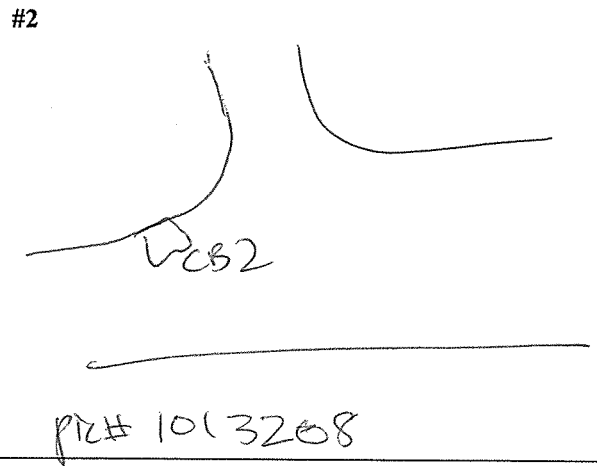
PIC # 3706/7 is small catch area draining behind Building [41 50 57.3] [72 26 19.0], leaf litter & debris in woods.
