**Summary Report
Condition Reassessment and
Post Tension Strand Evaluation
25 Sigourney Street
Hartford, Connecticut**

**DCS Project No. BI-2B-034A
Architects Project No. 206063**

13 October 2011

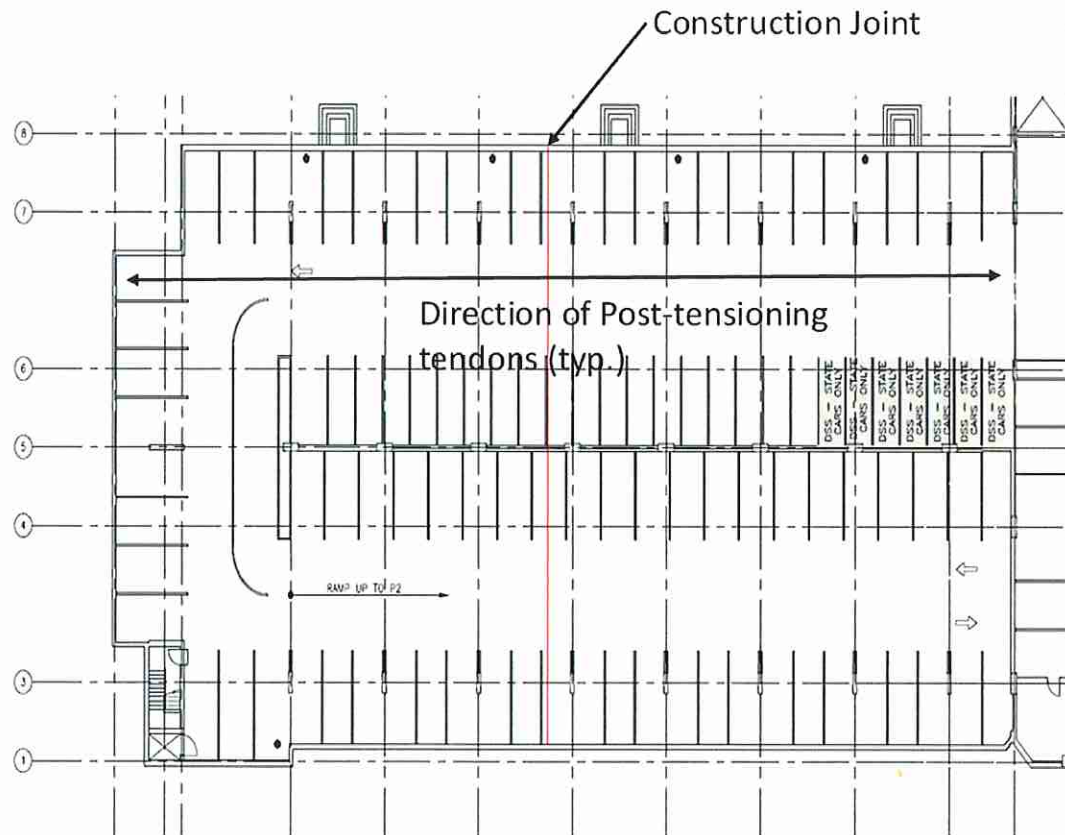
Figure 4. Typical layout of post-tensioning at 25 Sigourney St.

In the following sections the results of the post-tensioning system investigation are presented. Figure 4 shows the overall geometry of a typical parking level, with the direction of the post-tensioning tendons shown. The initial probe openings were completed on the slab surface on Levels 5 and 6 at locations where previous strand failures had occurred. Additional probe openings were made on Levels 4 and 2. At each probe area, openings were made on both the slab surface and soffit to examine the condition of the post-tensioning strands. Openings were also made at the construction joint shown in Figure 4. The probe openings indicated that significant

corrosion damage was present at both the high points and low points in the tendon trajectories.

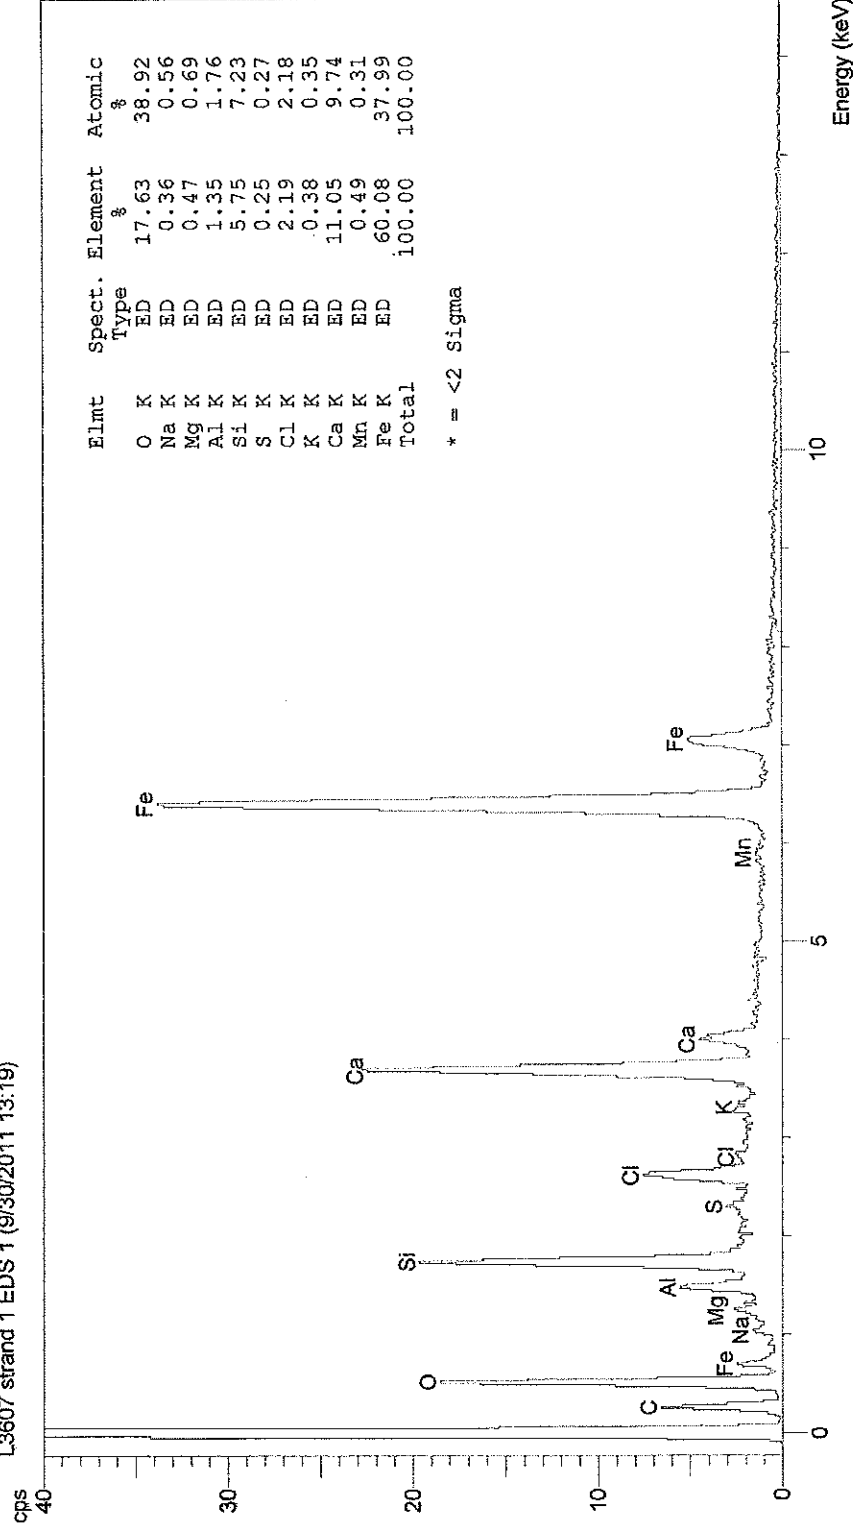
Strand 1, EDS 1.

The PE sheathing on Strand No.1 was generally intact but contained multiple locations of physical damage that had punctured the sheathing and visible iron oxide corrosion products mixed with emulsified grease. An example of one such location is shown in **Figures 1 and 2**. A second location of typical sheathing damage and exposed grease and corrosion product is shown in **Figure 3**.

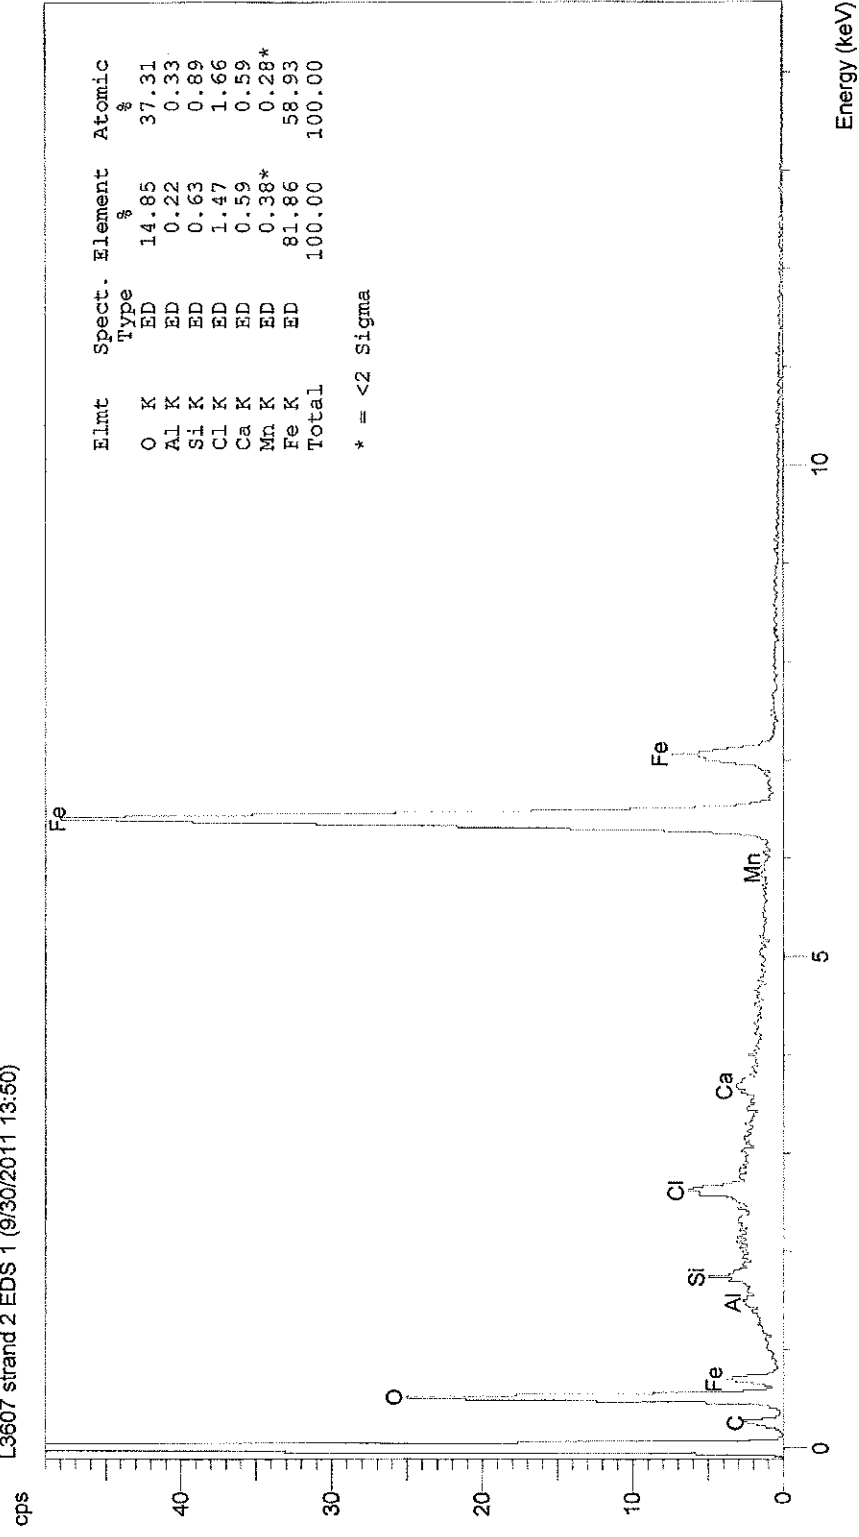
Strand 2, EDS 1.

The sheathing on Strand No.2 was far more severely damaged compared to Strand No.1. There was no visible grease which provided a less obstructed view of the severely corroded strand wire within the sheath. An example of the typical appearance of Strand No.2 is shown in **Figures 4 and 5**. A second location of typical damage and appearance of the corroded strand wires is shown in **Figure 6**.
