COMMUNITY
connectivity program

Beacon Falls

Burton Road

– Road Safety Audit

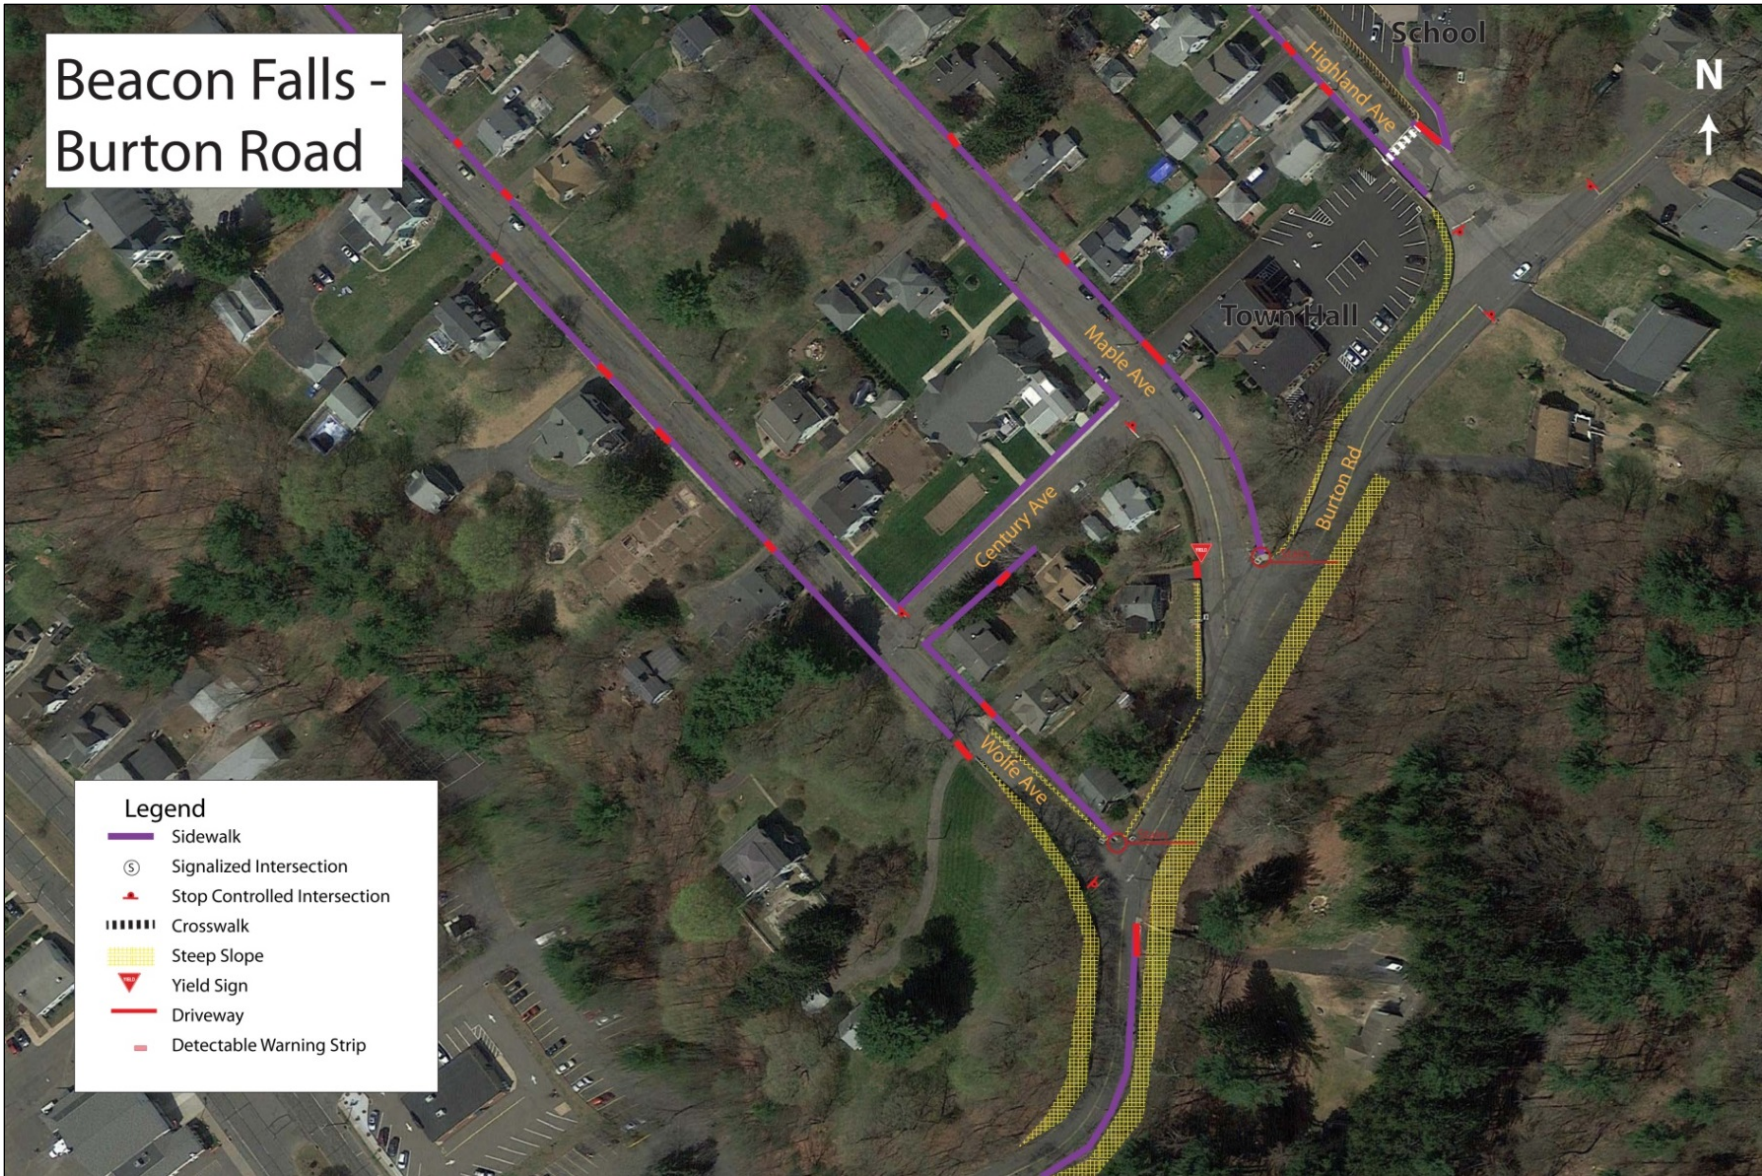
Figure 4. Burton Road Geometrics

Burton Road is a two lane, town owned road. It is a windy road cut into the side of a hill, with steep slopes on either side (Figure 4). Century Avenue, Wolfe Avenue and Maple Avenue are locally owned roads. There is sidewalk on the east side of Burton Road south of Wolfe Avenue, which continues to Main Street. Continuation of the sidewalk toward the Town Hall is challenging due to the narrow roadway width, retaining walls on the west side of the road and sharp drop offs on the east side. The east side also has a wetland area adjacent to the roadway. Maple Avenue has a sidewalk on the north side that terminates at Burton Road with stairs due to the grade. Century Avenue has a sidewalk along the entire west side and along half of the east side. Wolfe Avenue has a sidewalk along the north side that ends at Burton Road with stairs due to the grade. On the south side the sidewalk ends 100 feet east of Century Road. The intersection of Highland Avenue and Burton Road is three-way stop controlled. Maple Avenue meets Burton road at a skewed angle and controlled by a Yield sign for Burton Road, Wolfe Avenue is stop controlled at Burton Road. There are no signalized intersections within the RSA area, and there are no striped crosswalks in the RSA area.
