CANTON ROAD SAFETY AUDIT

DOWD AND MAPLE AVENUE (ROUTE 565) AND BRIDGE STREET (ROUTE 179)

JANUARY 2023

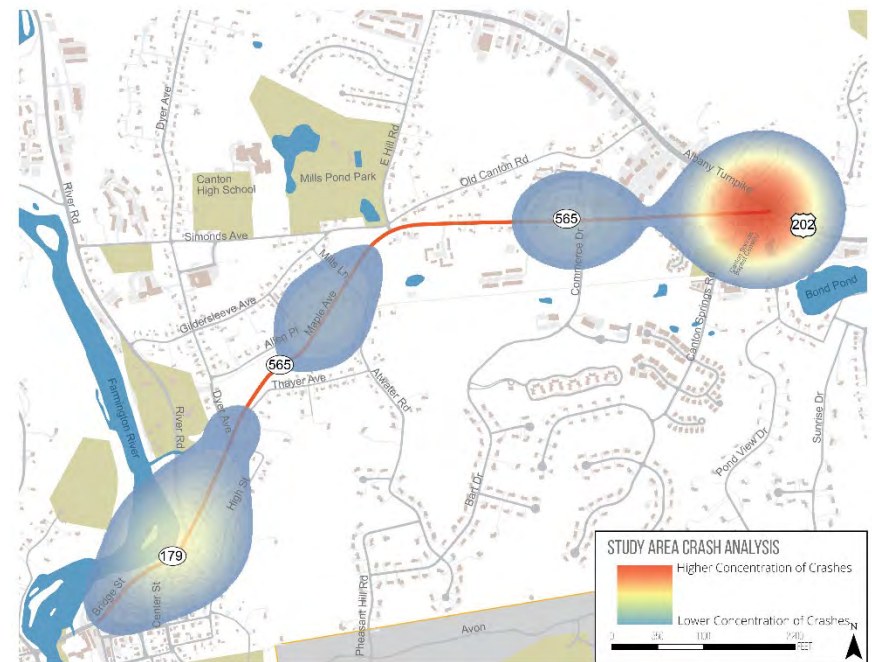
Exhibit 10: Study Area Crash Heatmap

Crashes: Based on data retrieved from the Connecticut Crash Data Repository (CTCDR) for the five-year period between January 2017 through December 2021, there were a total of 206 crashes in the Canton RSA study area. Crashes were concentrated in the vicinities of the Route 565 (Dowd and Maple Avenue) / Route 44 (US 202) intersection in the commercial area, the intersection of Route 179 (Bridge Street) between River Road and North Street, the Farmington River trail crossing of Route 565 (Dowd and Maple Avenue), and the stop-controlled intersection of Route 565 (Dowd and Maple Avenue), and Commerce Drive.

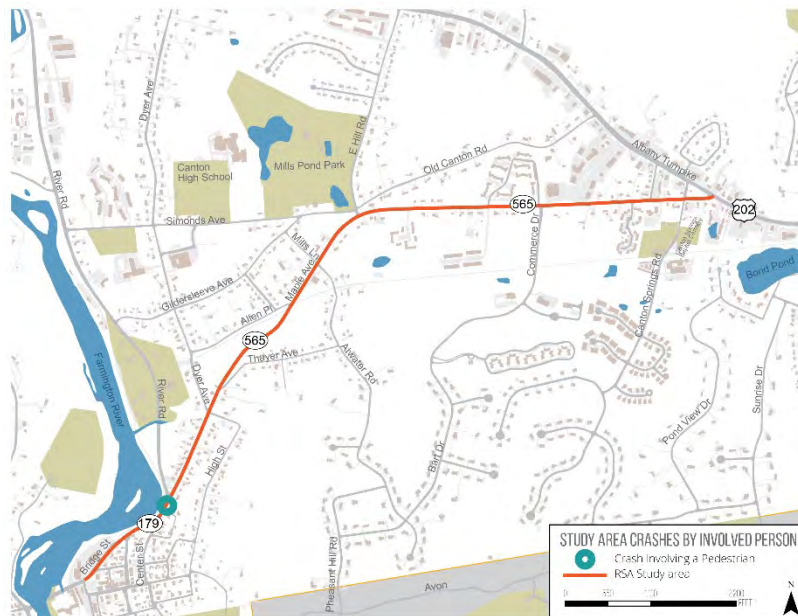
Exhibit 15: Crashes by Involved Person

Crashes by Involved Person: There was one crash involving a pedestrian in the study area, which occurred on Route 179 (Bridge Street) near the River Road intersection. There were no crashes involving bicyclists in the study area. Exhibit 15 shows the location of the pedestrian crash.

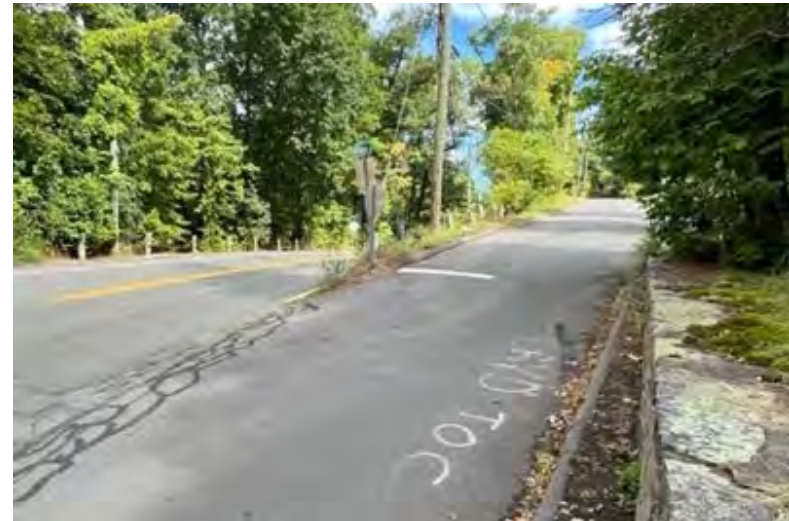
Exhibit 23: Thayer Avenue, headed northeast.

- Participants discussed the potential to turn Thayer Avenue into a one-way street uphill, that would outlet at the intersection of Atwater Road. Exhibit 23 shows the narrow right of way for Thayer Avenue.

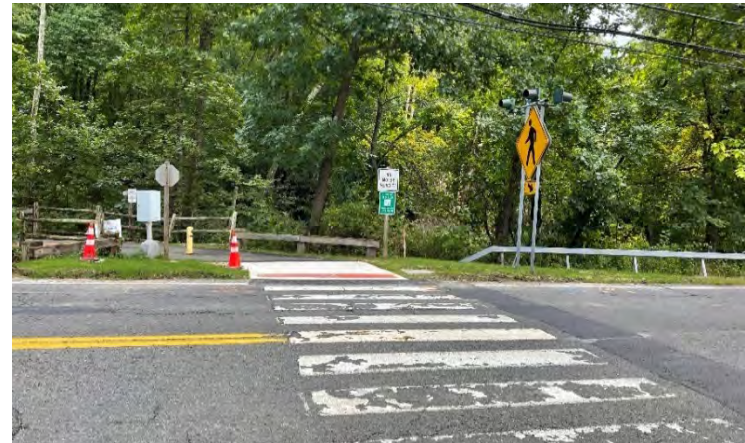
Exhibit 24: View of the Farmington River Trail crossing looking east across Route 565

- Participants raised the potential of a median island to facilitate trail crossings and to act as a further traffic calming measure.
