COMMUNITY
connectivity program

Fairfield

Post Road (CT Route 130) – Road Safety Audit

June 22, 2016

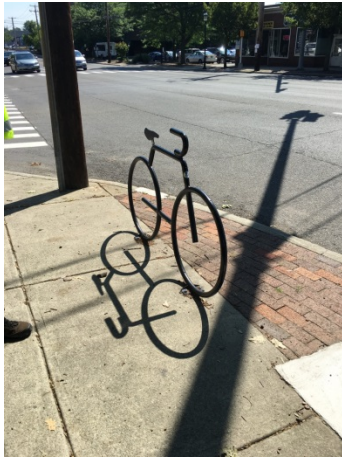
Figure 5. Bike rack

A number of best practices have already been applied to this area of Fairfield. A bike rack was installed on Post Road to service the local businesses (Figure 5). Along Post Road, pedestrian crosswalks have been upgraded with fresh paint, new push buttons and detectable warning strips (Figure 6 and Figure 7).
