COMMUNITY
connectivity program

Greenwich

Downtown

Road Safety Audit

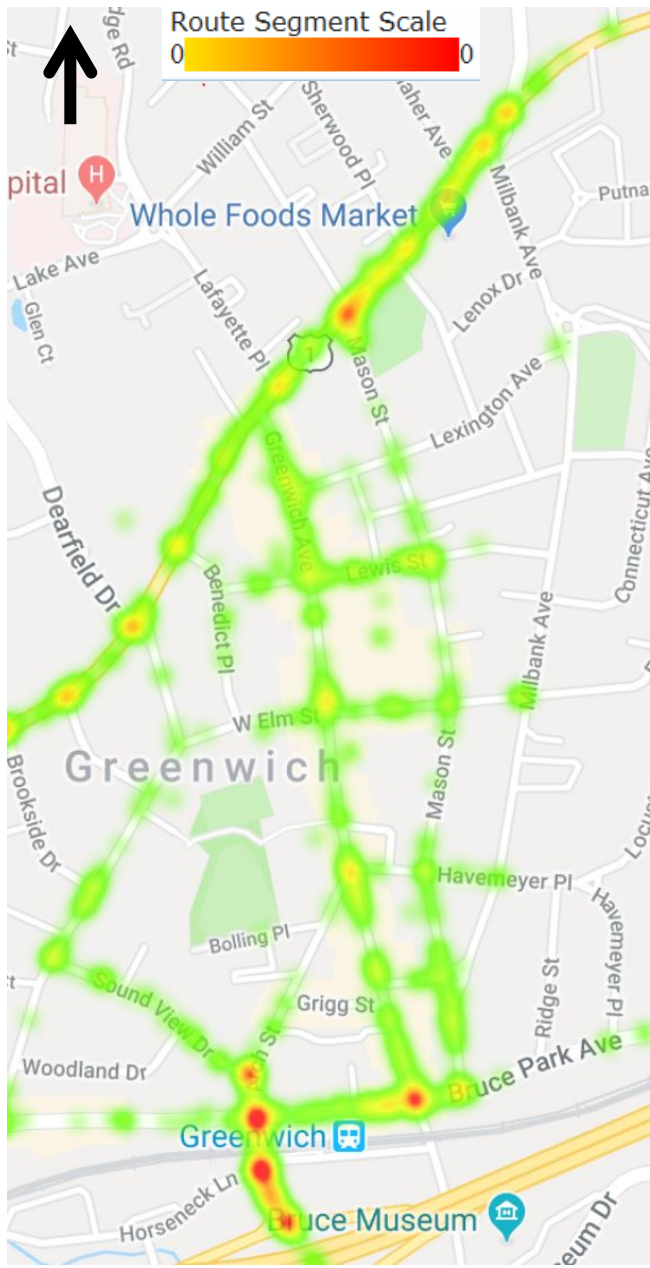
Figure 3 Crashes in 2015-2017 Heat Map (Connecticut Crash Data Repository)

Table 1 and Table 2 provide additional information on the type of collision and the severity of the crash. Figure 3 and Figure 4 graphically display crashes that occurred in this area during 2015-2017. Crashes are dispersed throughout the RSA area but do cluster more significantly on Route 1, Greenwich Avenue, and Railroad Avenue.
