COMMUNITY
connectivity program

Manchester

Downtown – Road Safety Audit

August 3, 2016

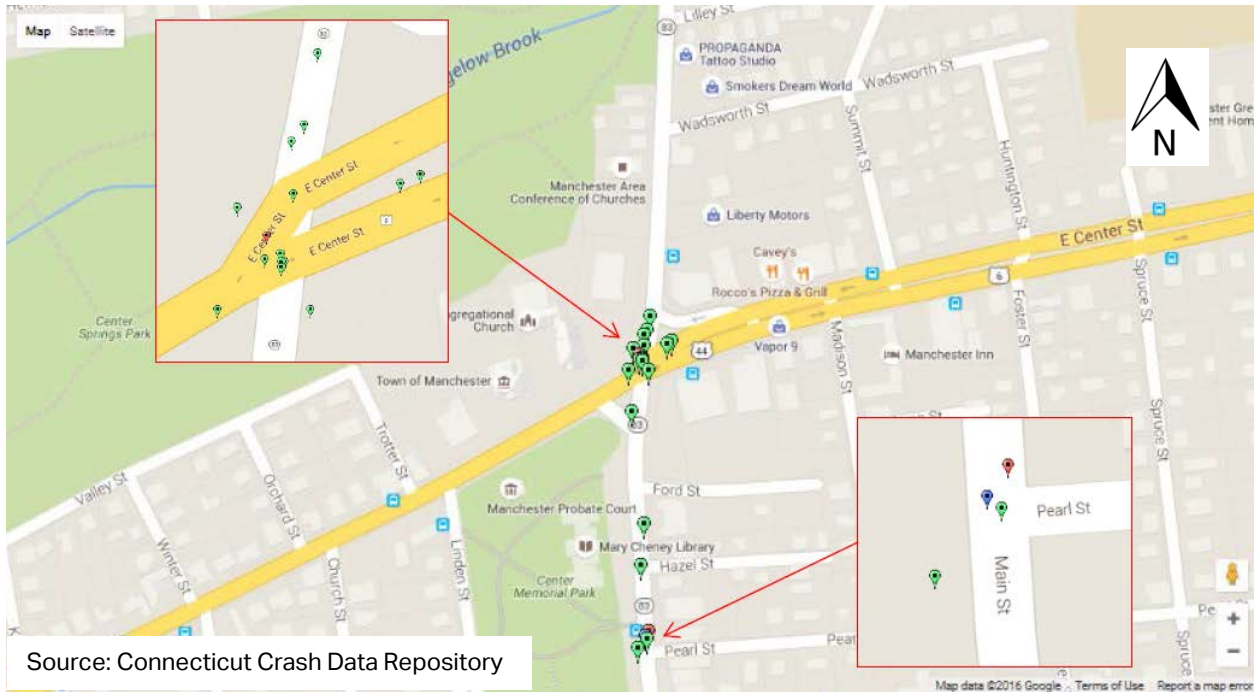
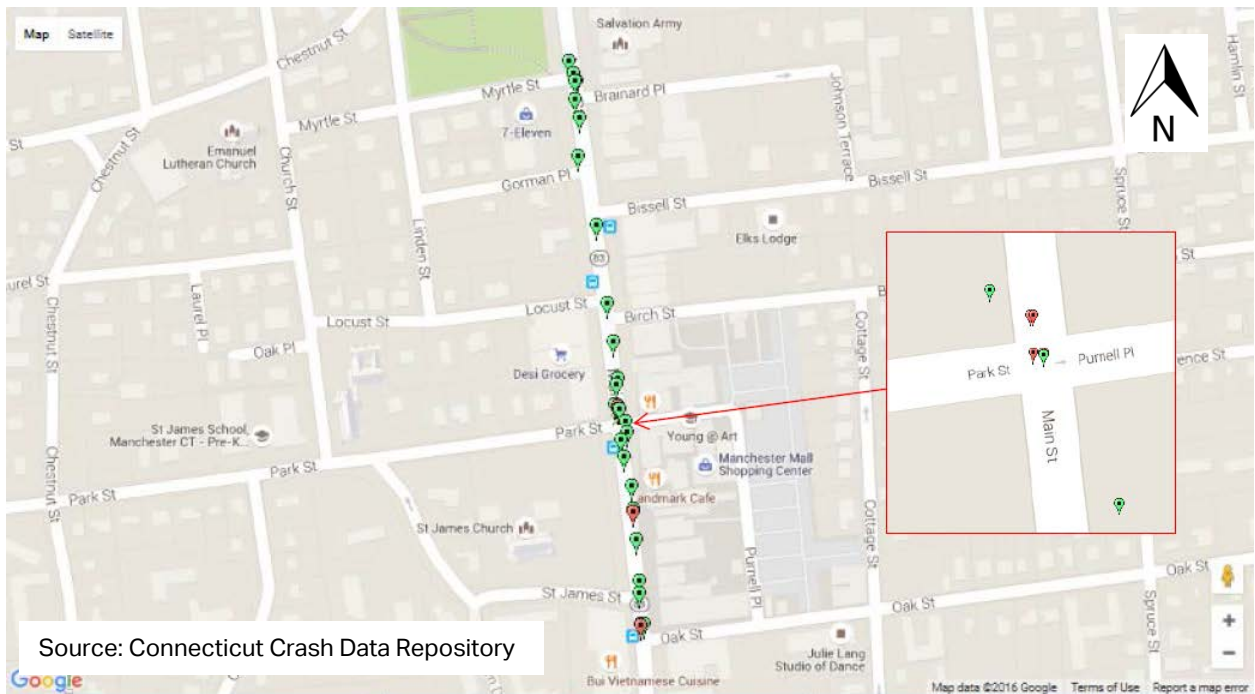
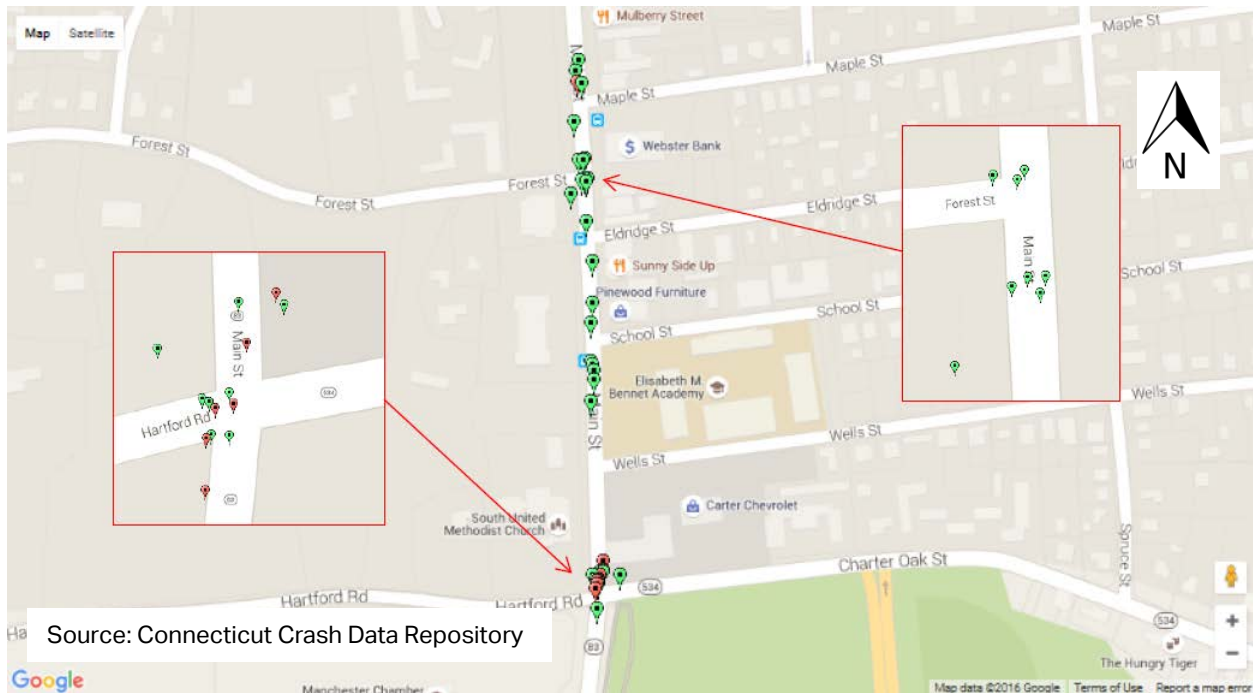
Figure 3 through Figure 5 display the crashes that occurred along the corridor during 2015. The majority of crashes are concentrated at the intersections. The largest cluster of crashes occurred at the signalized intersections of Center/East Center Street and Hartford Street/Charter Oak Street. A relatively high proportion of the accidents that occurred at the intersection with Hartford Street/Charter Oak Street resulted in injuries, suggesting higher

speeds at this location, possibly due to the less urban feel of Main Street south of this location and the presence of the interstate highway ramps.
