COMMUNITY
connectivity program

Waterford

Route 156 and Logger Hill Road – Road Safety Audit

April 6 - 2016

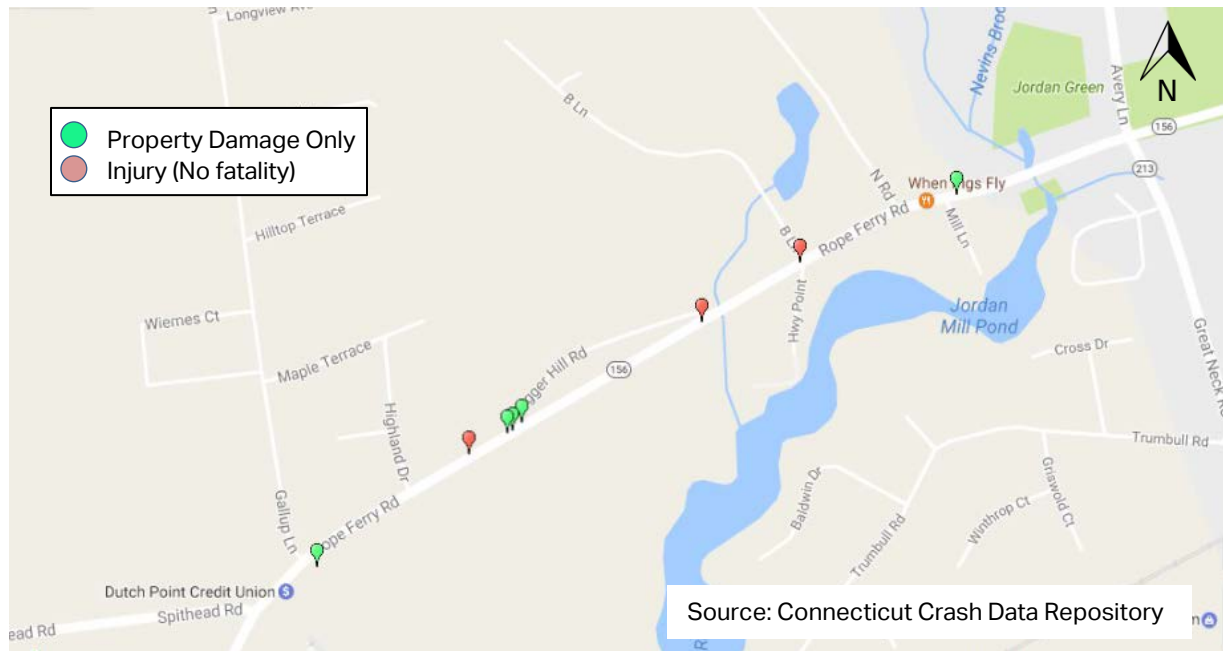
Figure 3. Crashes that Occurred in 2015 (Connecticut Crash Data Repository)

Between 2012 and 2014 there were 9 crashes in the RSA Area. The majority of crashes (78%) reported in this area resulted in property damage only; however 22% of crashes did result in an injury (Table 1 and Table 2). No crashes involved bicyclists or pedestrians. The majority (67%) of crash types reported were rear-end collisions. Figure 3 displays crashes that occurred in this area during 2015. The crash history for year 2015 shows that they are dispersed throughout the corridor, but there is a concentration at the western Logger Hill Road / Rope Ferry Road Intersection, indicating a need for further evaluation of this location.

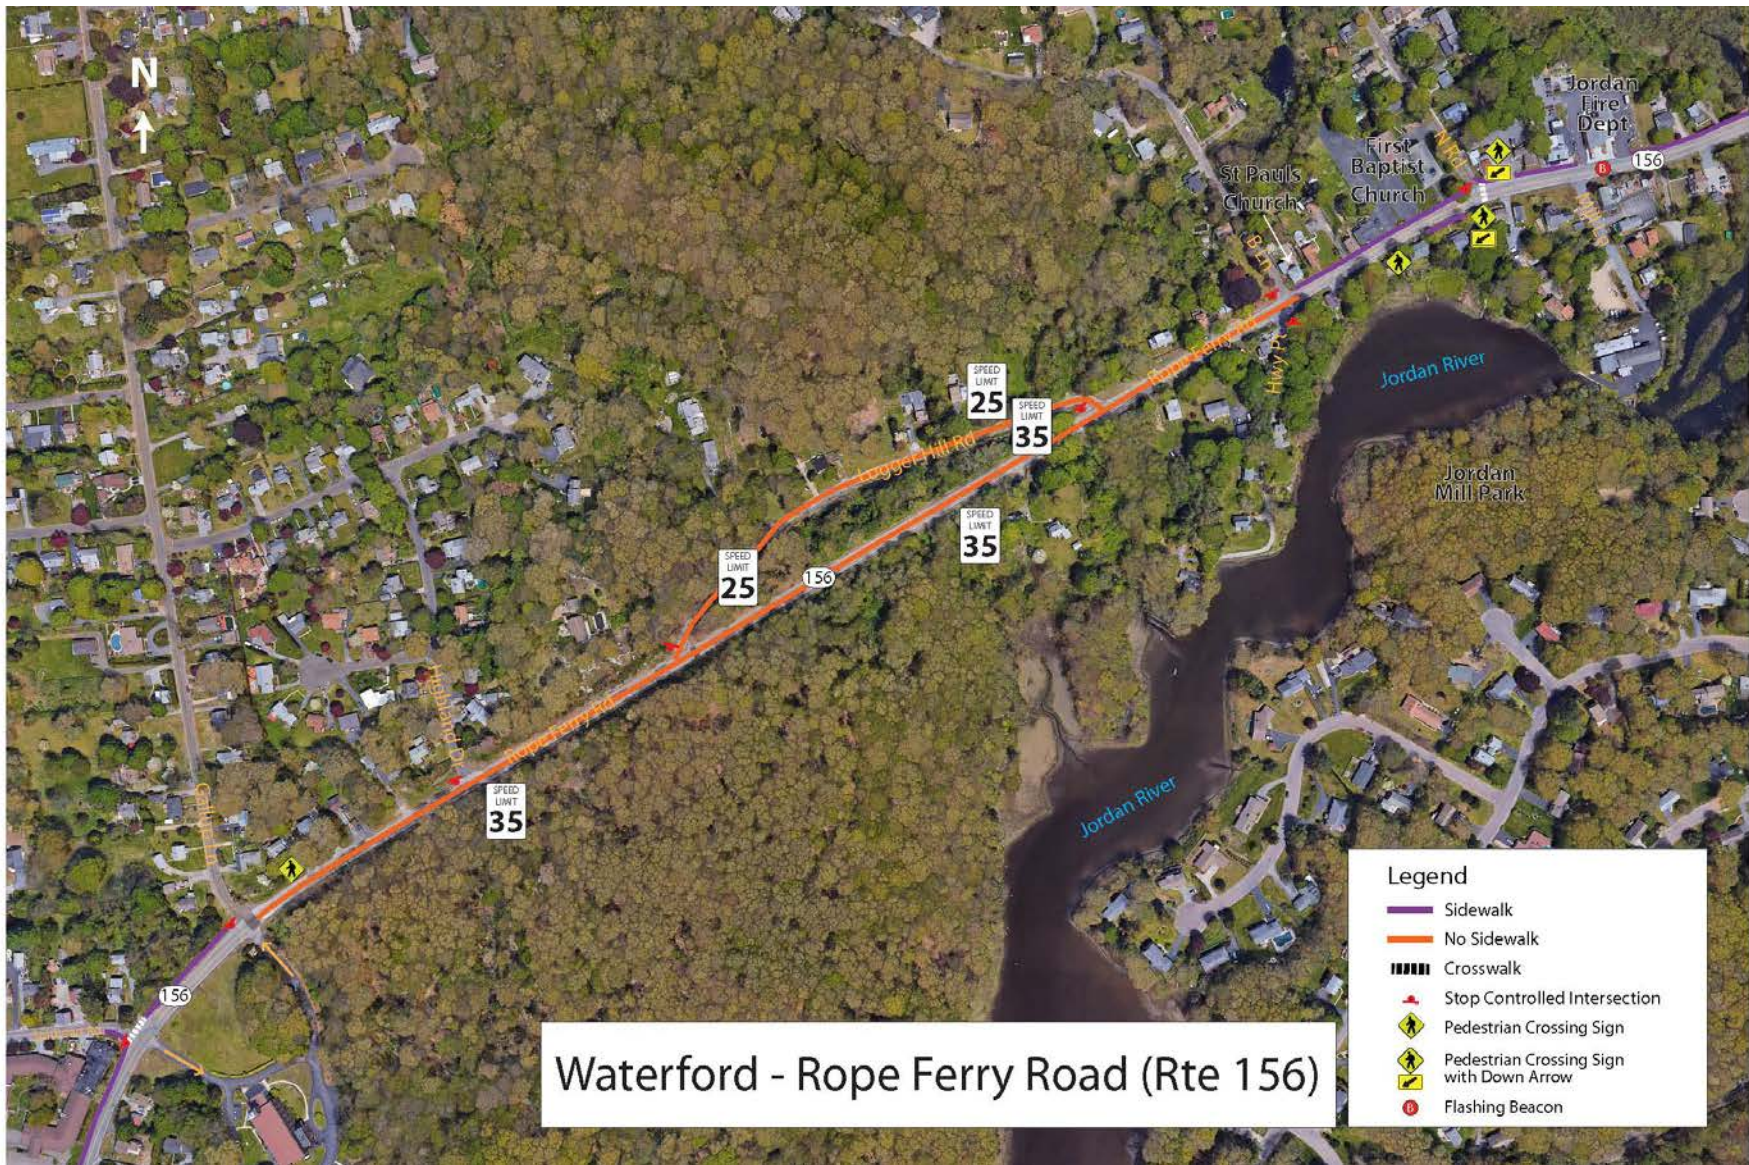
Figure 4. Rope Ferry Road Geometrics

Rope Ferry Road/Route 156 is a two lane, state-owned roadway with a speed limit of 35 mph, and a 7% down grade heading east. Logger Hill Road is a two lane, local road with a speed limit of 25 mph and no sidewalks. There is a sidewalk along the north side of Rope Ferry Road, east of B Lane, but between B Lane and Gallup Lane there is no sidewalk. The sidewalk begins again west of Gallup Lane on the north side of Rope Ferry Road. There is one crosswalk in the study area across Rope Ferry Road at the North Road intersection. None of the cross streets in the study area have crosswalks, and there are no signalized intersections in the study area. The nearest signal is approximately 1,200 feet to the east of North Road at the intersection of Rope Ferry Road and Avery Lane. The geometry of the corridor is shown in Figure 4 and described in Table 3.
