# West Hartford

Albany Avenue (U.S. Route 44) & North Main Street

(Route 218) Bishops Corner – Road Safety Audit

March - 2016

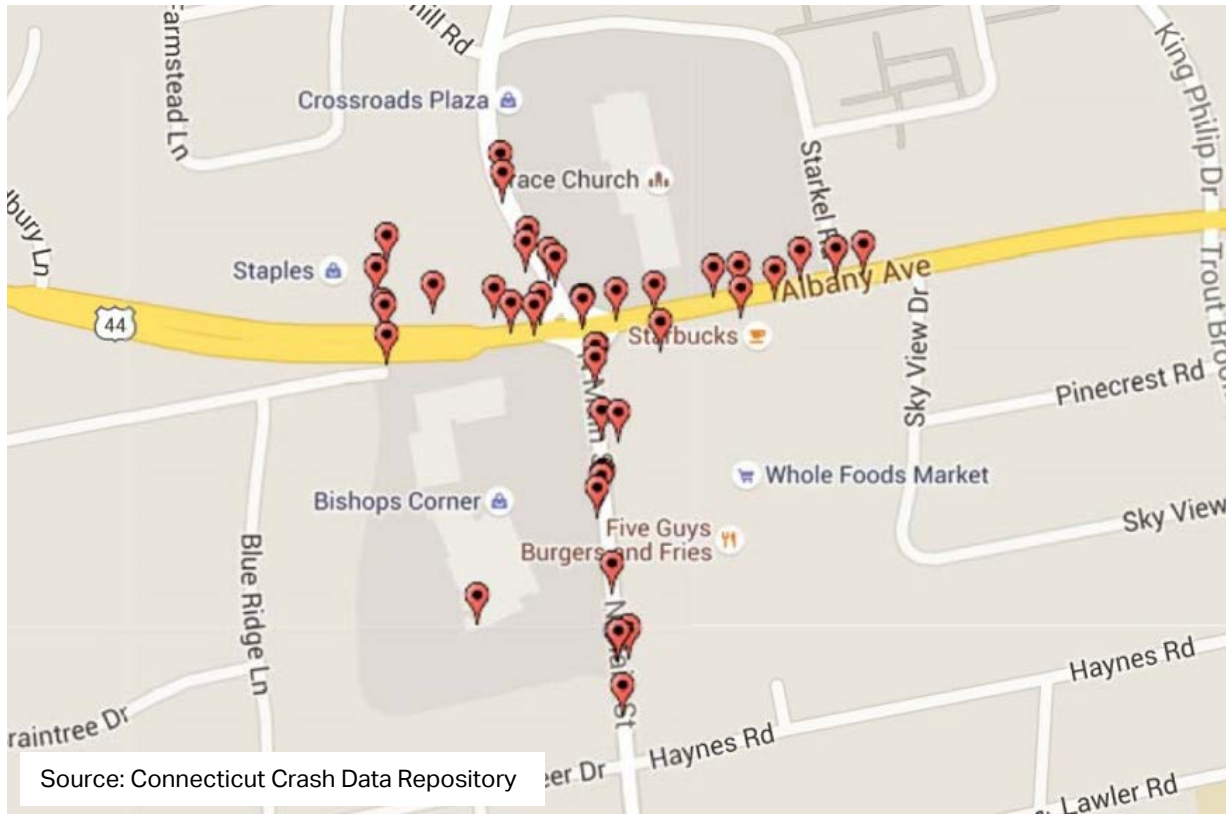
**Figure 4. Crashes that Occurred in 2015 (Connecticut Crash Data Repository)**

As noted previously, traffic volumes are significant at this location. Crash history shows that the most frequent are rear-end crashes on the approaches to the intersection (Figure 4). This is indicative of congestion coupled with access management issues (many driveways). The peak crash rate is in the afternoon which can be attributed to commuting, shopping, and school activities.

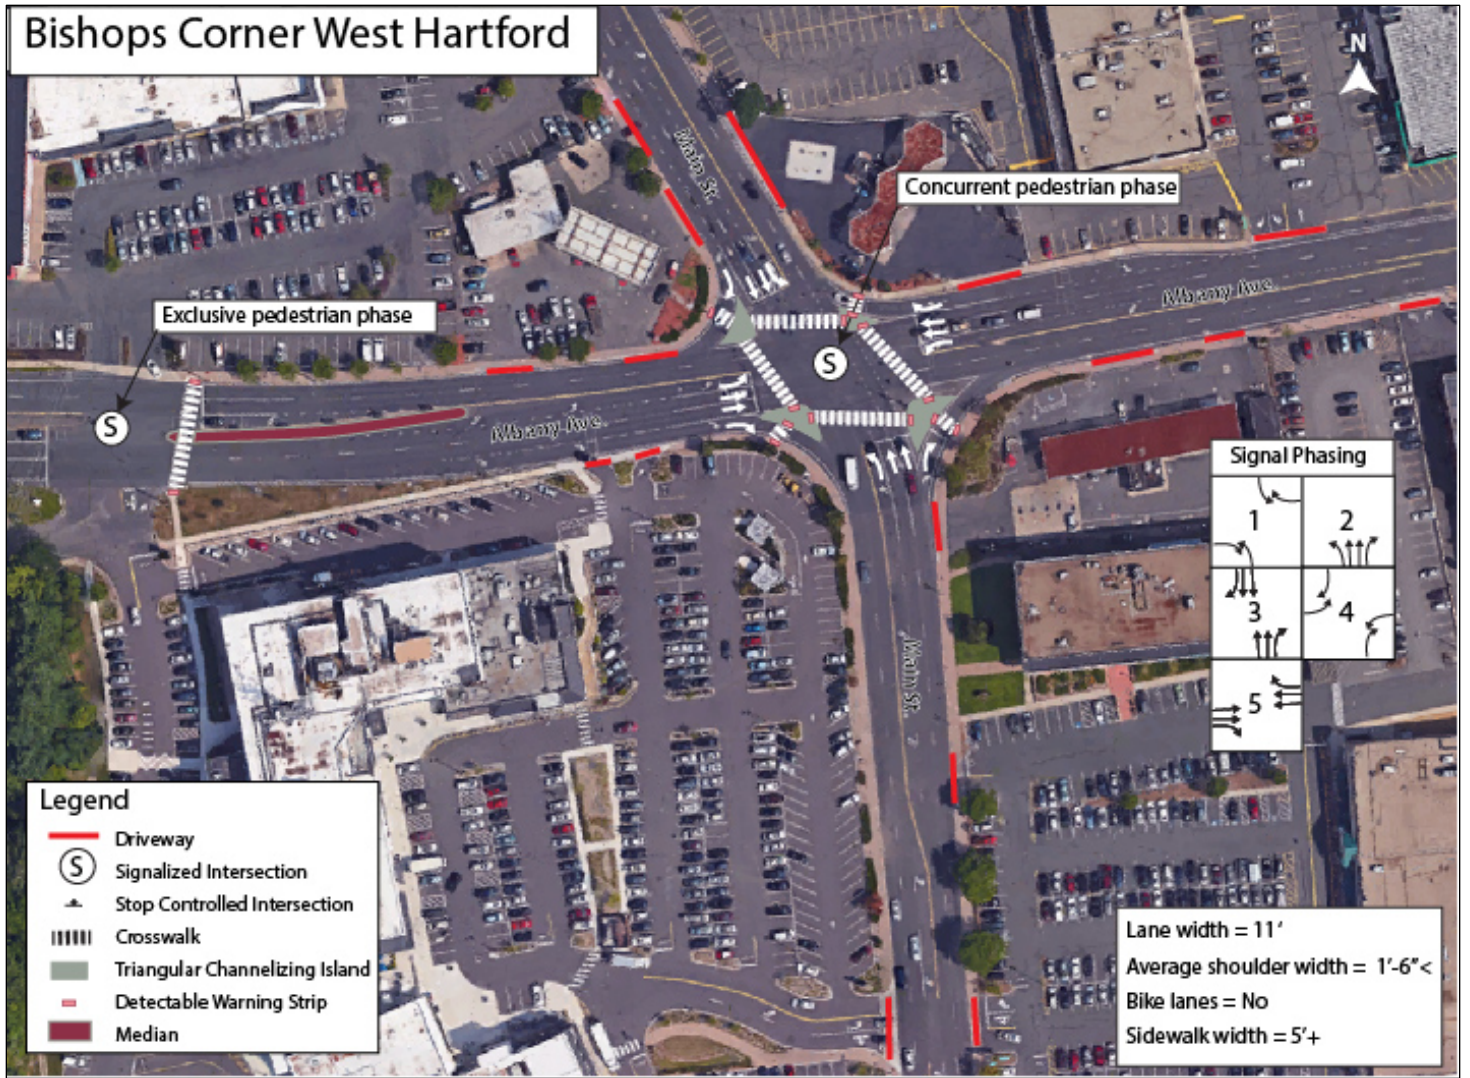
Figure 5. Bishops Corner Road Geometrics

The large number of wide driveways near the intersection permit traffic to turn onto and off of the roadway with few restrictions. The additional maneuvers create difficulties for drivers to negotiate a clear path through the intersection while simultaneously watching the signals, striping, and adjacent pedestrian movements. Vehicles stopping to turn at these driveways can block and impede the flow of traffic, cause abrupt lane changes, and add to the general operational difficulty of the intersection (Figure 5).

5. There are numerous driveways and the town could work with the owners to reduce width, limit turning movements and consolidate access as the owners approach the town for other permits/requests.

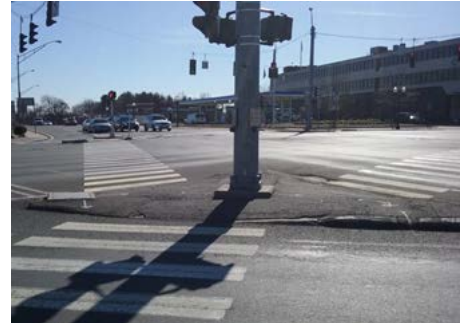
Figure 13. Triangular Channelizing Island

1. There is a conflict between right turning vehicles and pedestrians crossing to the triangular channelizing islands. Pedestrians cross the right turn lane without a pedestrian signal, although they are in a marked crosswalk and the turning vehicles are controlled by the signal operation (Figure 12 and Figure 13). The vehicle has the legal right-of-way when the signal is green or green arrow, but the pedestrian has the legal right-of-way if the vehicle signal is red. Neither drivers nor pedestrians are always fully aware of the rules, and pedestrians often don't look up to see the vehicle signal. Furthermore, at the two corners lacking an auxiliary signal, visibility is even

more difficult, since the signal controlling the right turn is not obvious. Multiple alternatives were discussed, including elimination of the right-turn green arrow, reverting to the exclusive pedestrian phase, and adding auxiliary heads where they are missing. In addition, various methods for controlling the triangular channelizing island crossings with a pedestrian signal were discussed, with the most obvious solution being the use of an exclusive pedestrian phase.
