COMMUNITY
connectivity program

Westport

Hillspoint Road, Compo Road and Compo Beach Road
Road Safety Audit
August 23, 2016

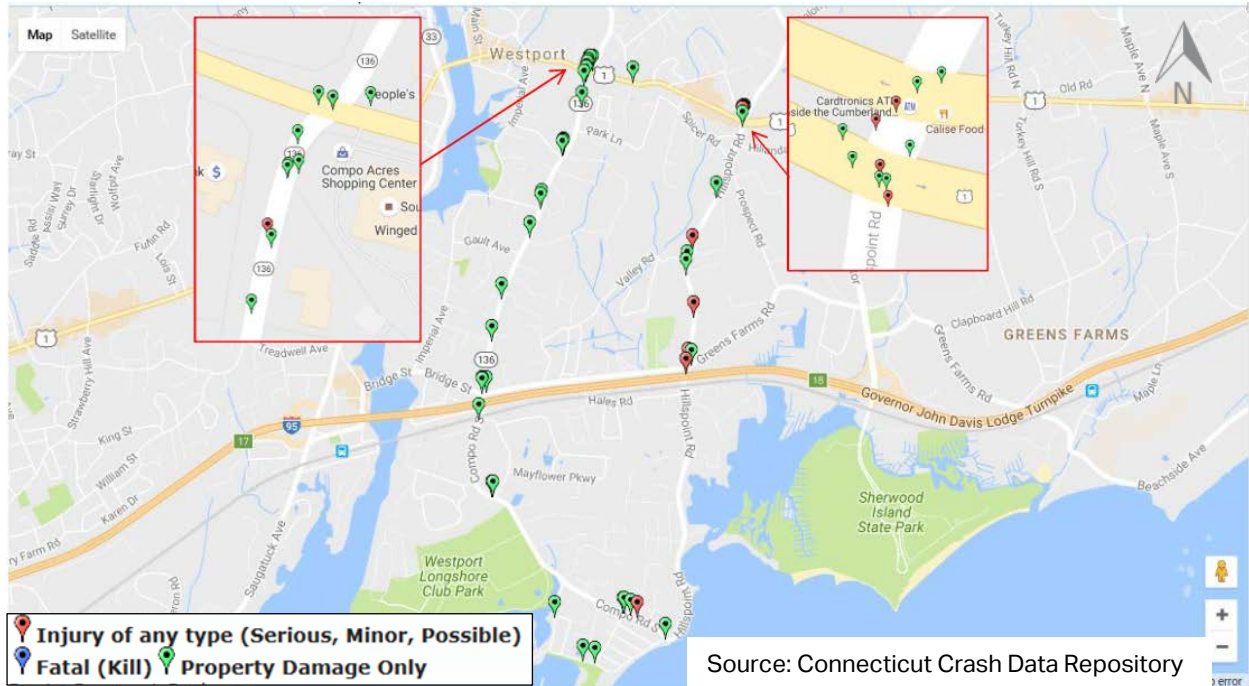
Figure 3. Crashes that Occurred in 2015 (Connecticut Crash Data Repository)

Figure 3 displays crashes that occurred in this area during 2015. Crashes are distributed evenly along Compo Road South and Hillspoint Road to the north of I-95. Clusters of crashes are seen at the high-volume intersections of Compo Road South and Route 1, and Hillspoint Road and Route 1.

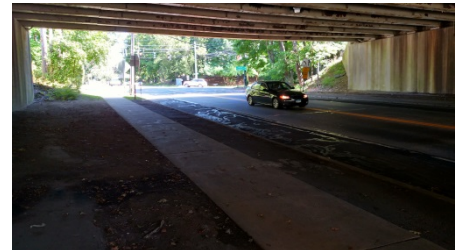
- At Valley Road the sidewalk transitions from the west side to the east side of Hillspoint Road. There is no crosswalk connecting the two sides.
- Under the I-95 bridge on Compo Road South there are wide shoulders and sidewalks with a snow shelf (buffer strip). It is dark under the bridge even during the daytime and it lacks sufficient lighting to provide a safe and inviting environment for pedestrians. (Figure 5).

Figure 5. Under the I-95 Bridge

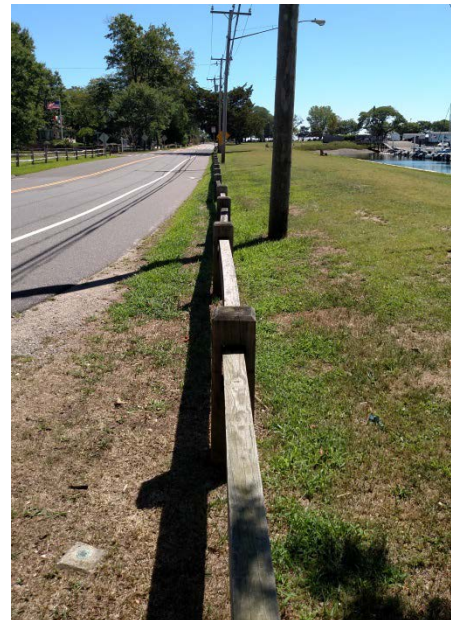
- There is no sidewalk from Owenoke Park to Soundview Drive. The shoulder is wide but pedestrians tend to walk behind the wooden guard rail for Compo Beach & Yacht Club (Figure 12).

Figure 12. Wide Shoulder on Compo Beach Road and Wooden Fence Pedestrians Walk Behind

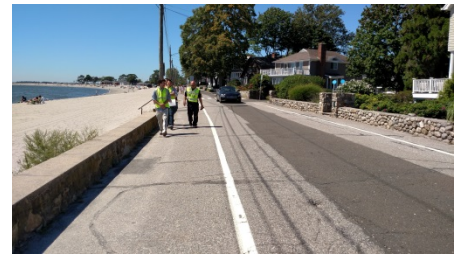
- Soundview Drive has no sidewalks but has wide shoulders (Figure 14). It is a one-way road and vehicles tend to go the speed limit. There are several mid-block crosswalks which provide access from the side streets to the beach. The neighborhood association has put up planters by the crosswalks that act as traffic calming (Figure 15). There is a substantial amount of pedestrian activity along this corridor.

Figure 14. Wide Shoulders on Soundview Drive

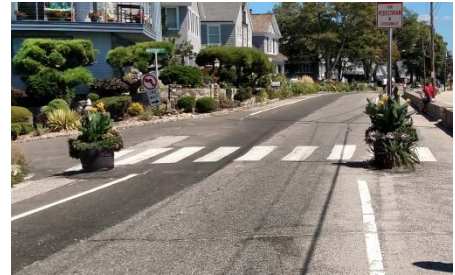
Figure 15. Planters Provide Traffic Calming at Crosswalks
