CONNECTICUT
DEPARTMENT
OF
TRANSPORTATION

CONDITION INSPECTION
FOR THE
DARIEN STATION

**CONN. DEPT OF TRANSPORTATION
STATION INSPECTION**

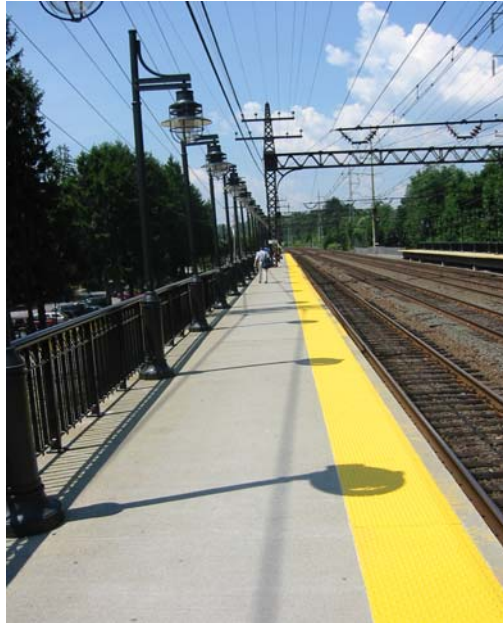
Description: _____
General view of the
east platform

Reference: _____
Looking south

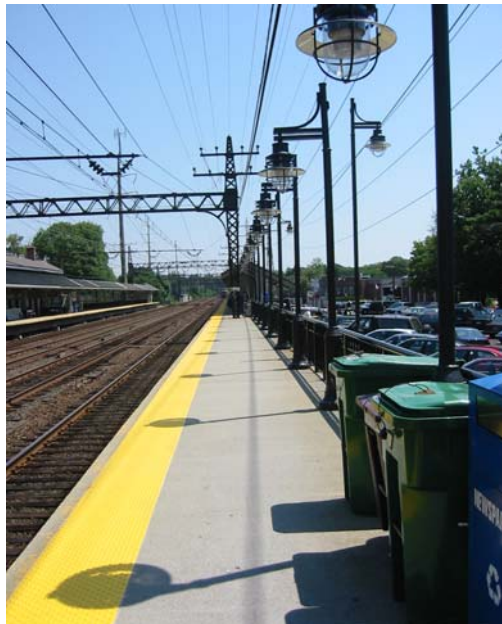
PHOTO NO. 2

Location: _____
Middle of Span X of
the east platform

Description: _____
General view of the
east platform

Reference: _____
Looking north

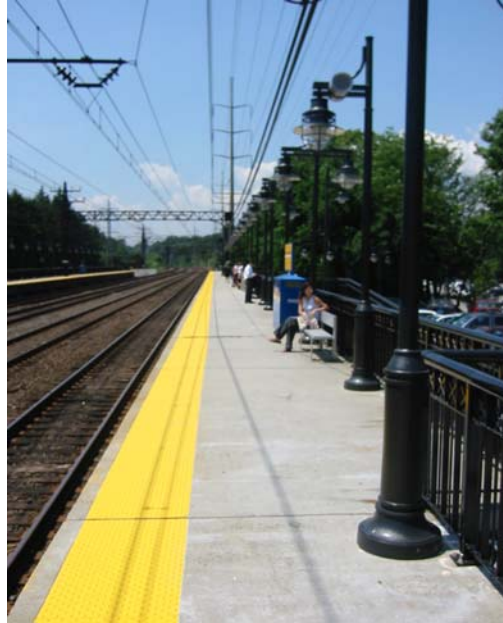
Description: _____
General view of the
west platform

Reference: _____
Looking south

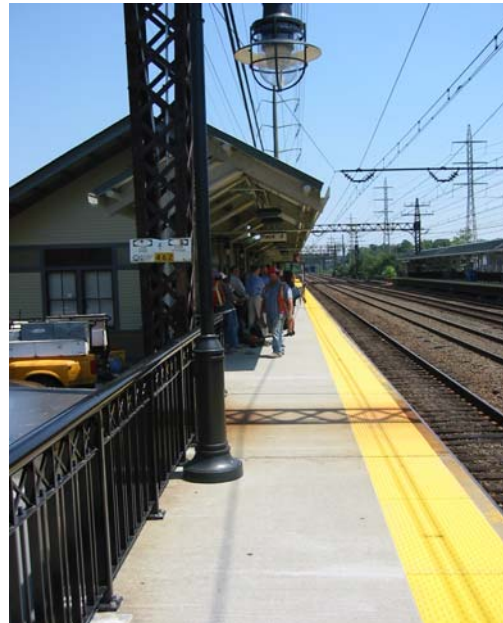
PHOTO NO. 4

Location: _____
Middle of Span XIII of
the west platform

Description: _____
General view of the
west platform

Reference: _____
Looking north

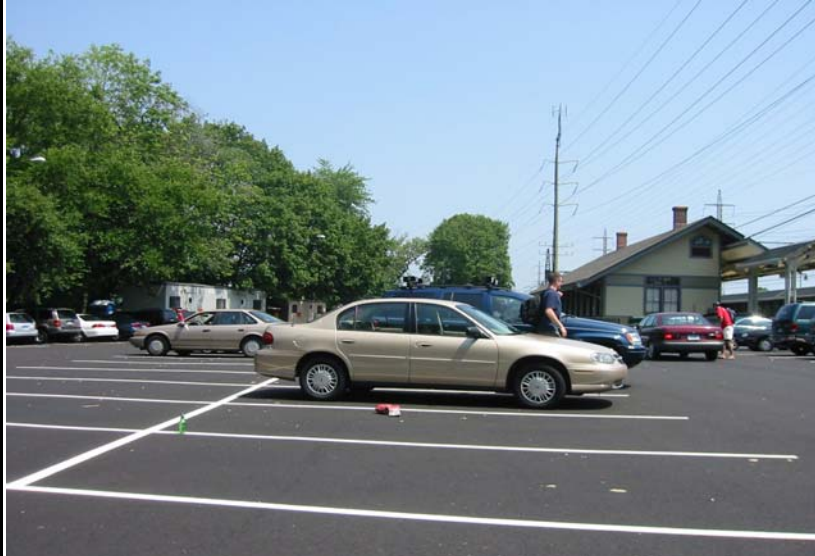
Description: _____
General view of Quad I

Reference: _____
Looking north

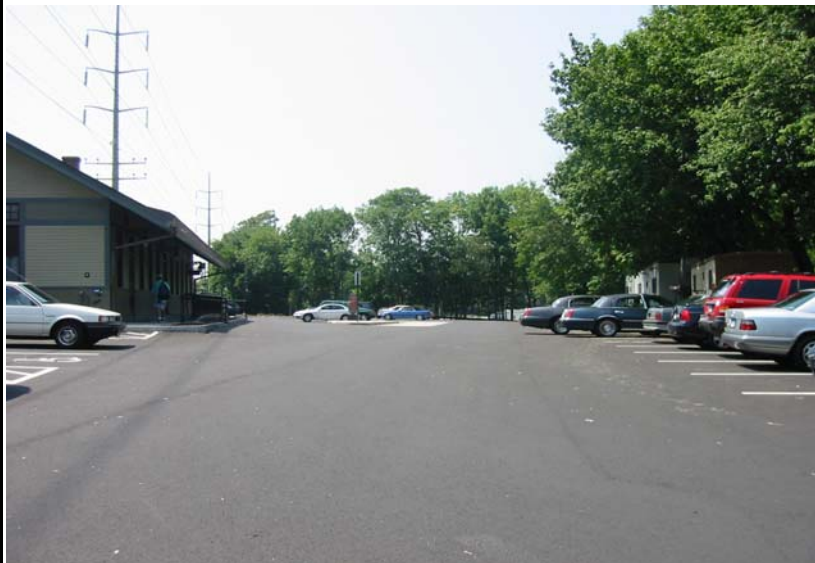
PHOTO NO. 6

Location: _____
North side of Quad I

Description: _____
General view of Quad I

Reference: _____
Looking south

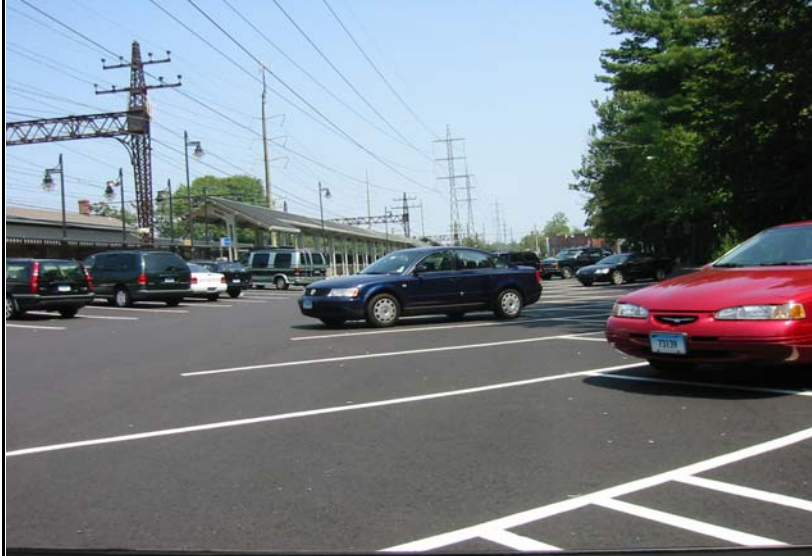
Description: _____
General view of Quad II

Reference: _____
Looking north

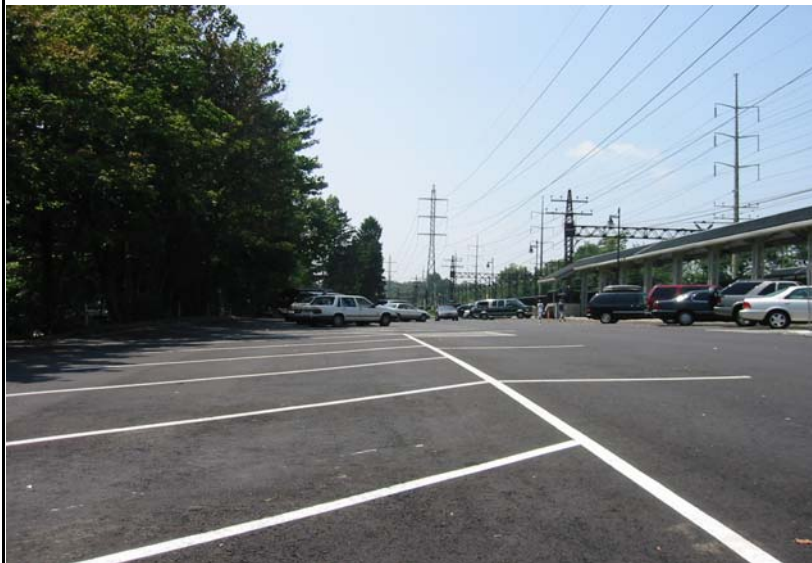
PHOTO NO. 8

Location: _____
North side of Quad II

Description: _____
General view of Quad II

Reference: _____
Looking south

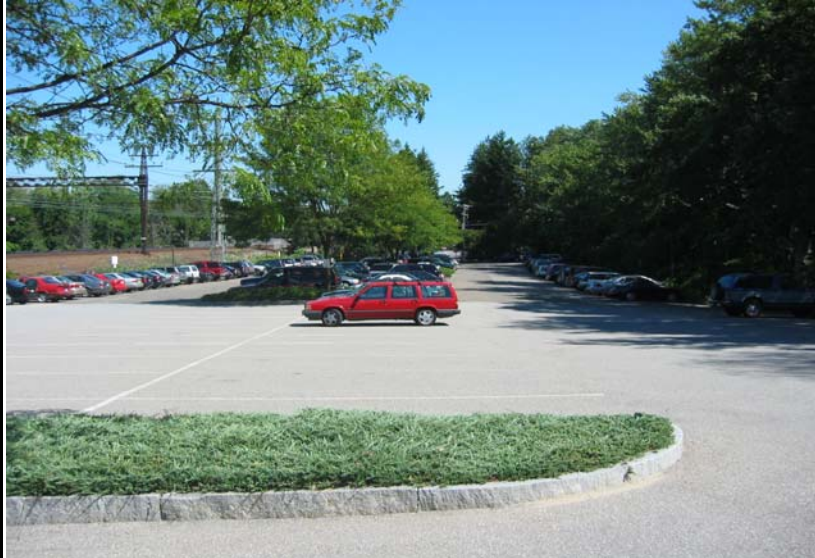
Description: _____
General view of Quad III

Reference: _____
Looking north

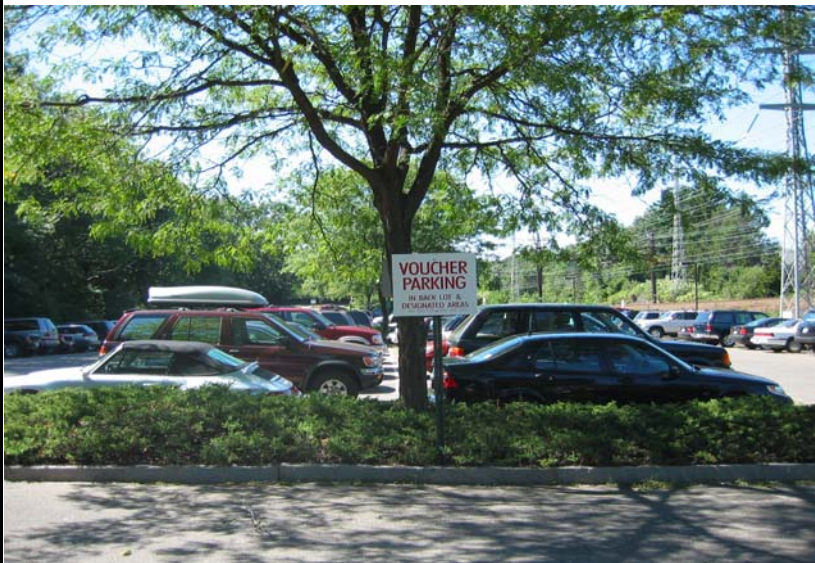
PHOTO NO. 10

Location: _____
North side of Quad III

Description: _____
General view of Quad III

Reference: _____
Looking south

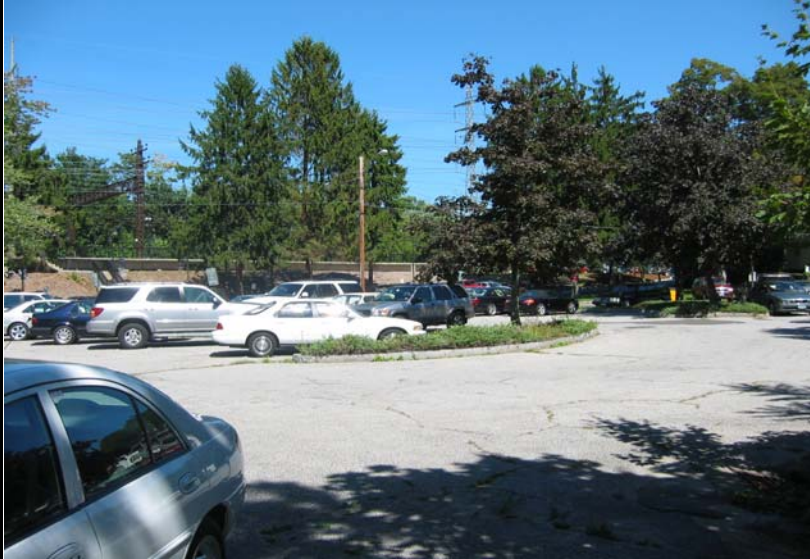
Description: _____
General view of Quad IV

Reference: _____
Looking northwest

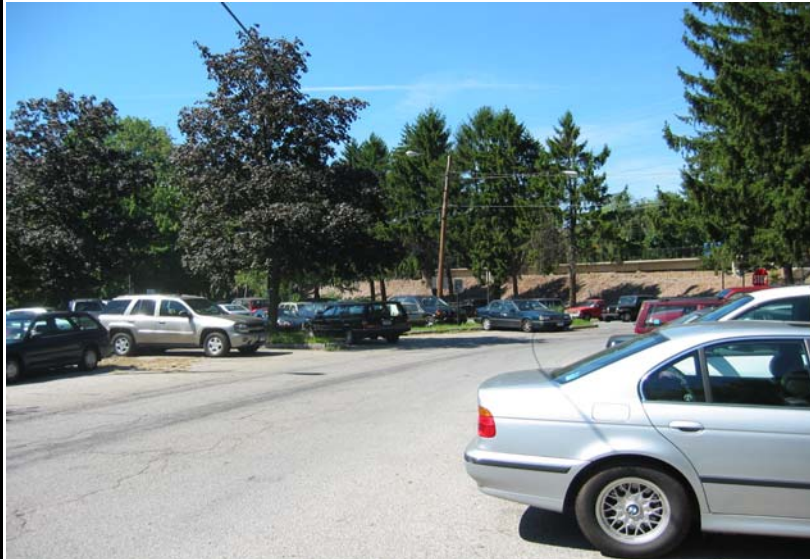
PHOTO NO. 12

Location: _____
Northeast corner of
Quad IV

Description: _____
General view of Quad IV

Reference: _____
Looking southwest

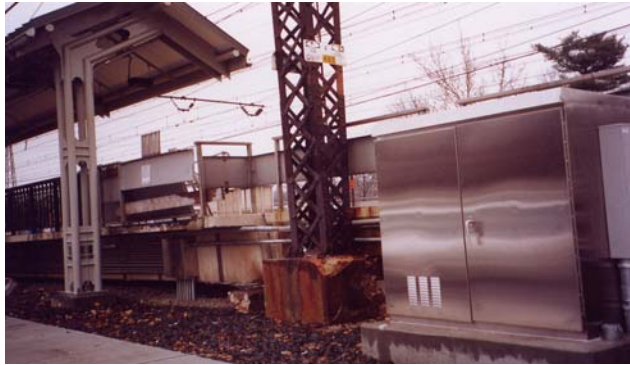
Description: _____
new electrical
service cabinet for
the building and
the southbound
platform.

Reference: _____
Platform Service
Section

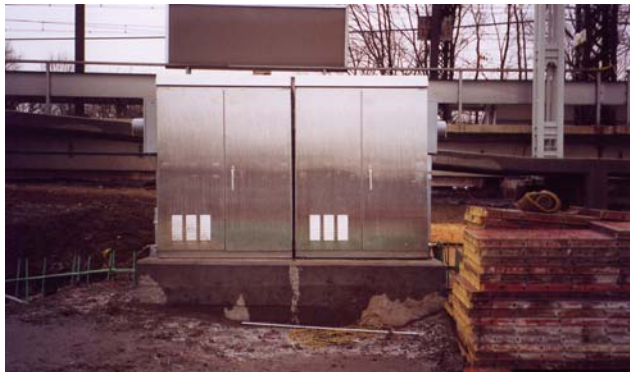
PHOTO NO. 18

Location: _____
adjacent to
northbound
platform

Description: _____
new electrical
service cabinet
for the
northbound
platform

Reference: _____
Platform Service
Section
