Individual Station Report

Stratford

Station Condition Inspection

Connecticut Department of Transportation

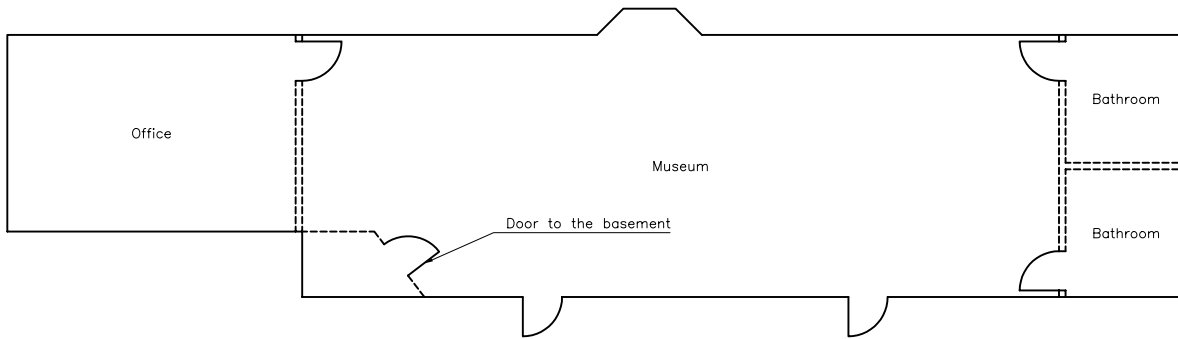
Urbitran Associates, Inc.
Connecticut Dept. of Transportation
Stratford Station North Station House Plan
Date: 12/06/01

1. There is an 1/8" crack at the underside of the beam along the entire length.
2. The underside of the beam is deteriorated.
3. The base timber panel is missing and damaged in various areas.
4. Two windows are cracked on the north exterior face of the building..

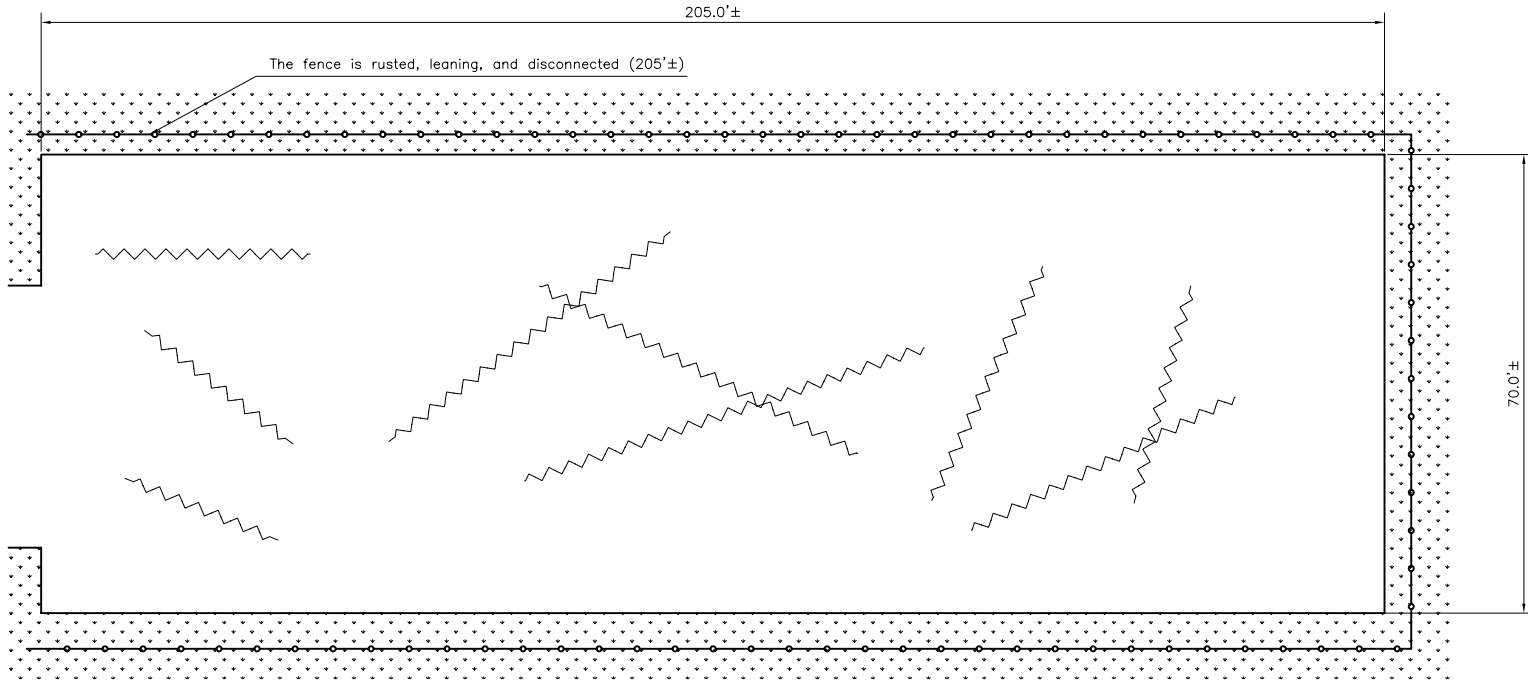
Urbitran Associates, Inc.
Connecticut Dept. of Transportation
Stratford Station Quadrant III Plan
Date: 8/23/02

- NOTES:
1. The asphalt surface is cracked 5000'±.
 2. The concrete sidewalk is cracked with an uneven walking surface (160'x5').
