CONNECTICUT  
DEPARTMENT  
OF  
TRANSPORTATION

CONDITION INSPECTION  
FOR THE  
WILTON STATION

**CONN. DEPT OF TRANSPORTATION  
STATION INSPECTION**

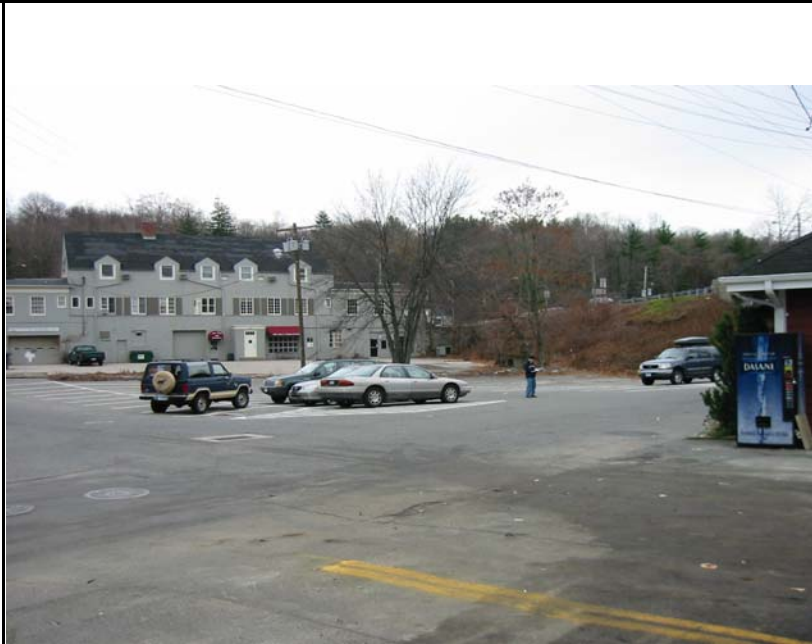
PHOTO NO. 2

Location: \_\_\_\_\_  
Northwest corner of  
Quad I

Description: \_\_\_\_\_  
General view of Quad I

Reference: \_\_\_\_\_  
Looking Southwest

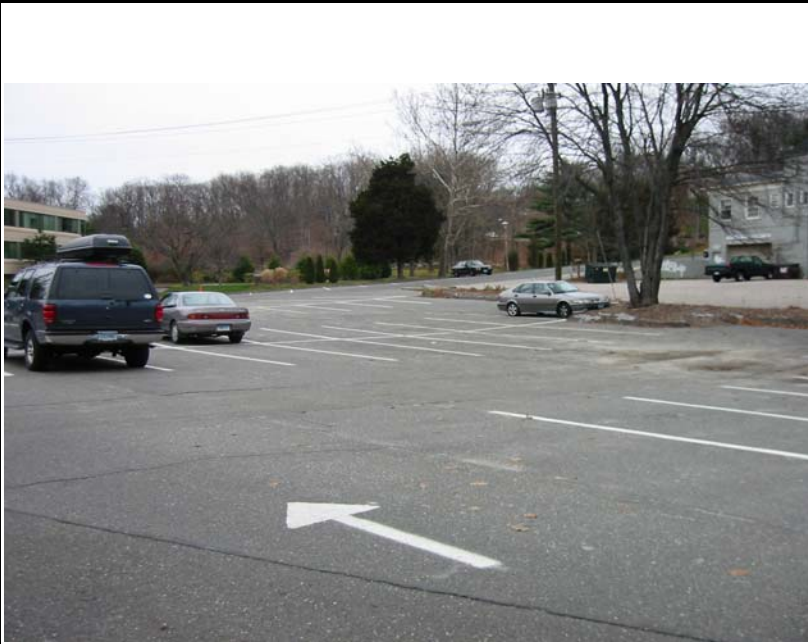
PHOTO NO. 4

Location: \_\_\_\_\_  
Northwest corner of  
Quad I

Description: \_\_\_\_\_  
General view of Quad II

Reference: \_\_\_\_\_  
Looking North

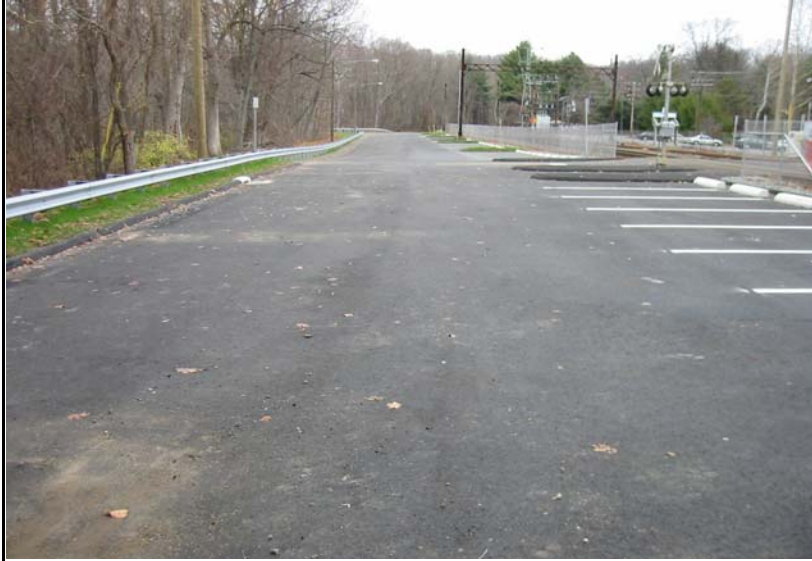
PHOTO NO. 6

Location: \_\_\_\_\_  
North end of Quad III

Description: \_\_\_\_\_  
General view of Quad III

Reference: \_\_\_\_\_  
Looking South

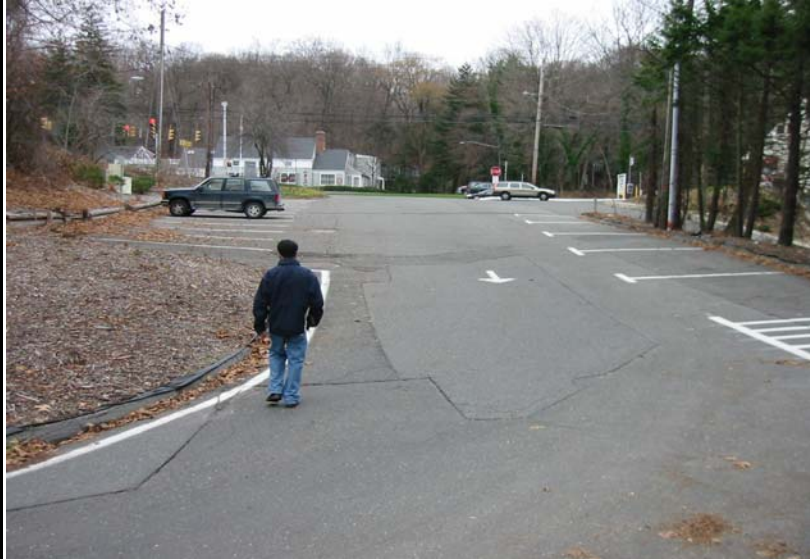
PHOTO NO. 8

Location: \_\_\_\_\_  
East end of Quad V

Description: \_\_\_\_\_  
General view of Quad V

Reference: \_\_\_\_\_  
Looking West

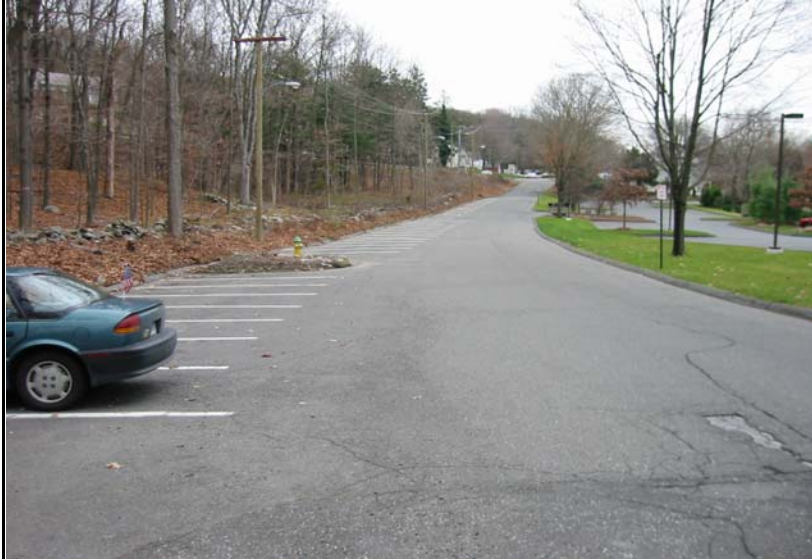
PHOTO NO. 10

Location: \_\_\_\_\_  
South end of Quad VI

Description: \_\_\_\_\_  
General view of  
Quad VI

Reference: \_\_\_\_\_  
Looking North

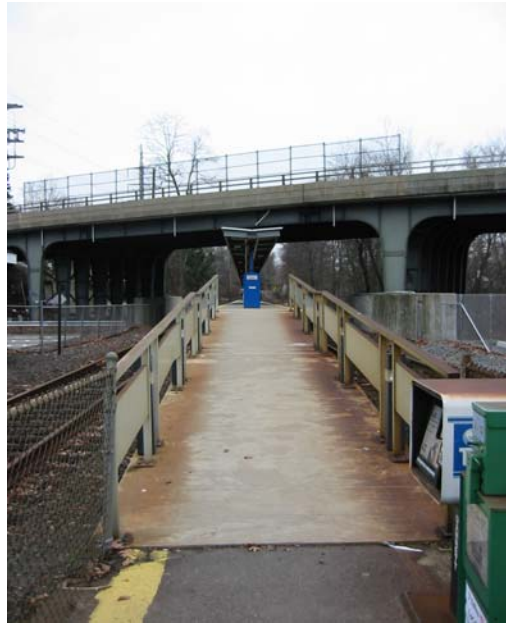
PHOTO NO. 14

Location: \_\_\_\_\_  
Middle of Span VII

Description: \_\_\_\_\_  
General view of the  
platform

Reference: \_\_\_\_\_  
Looking North

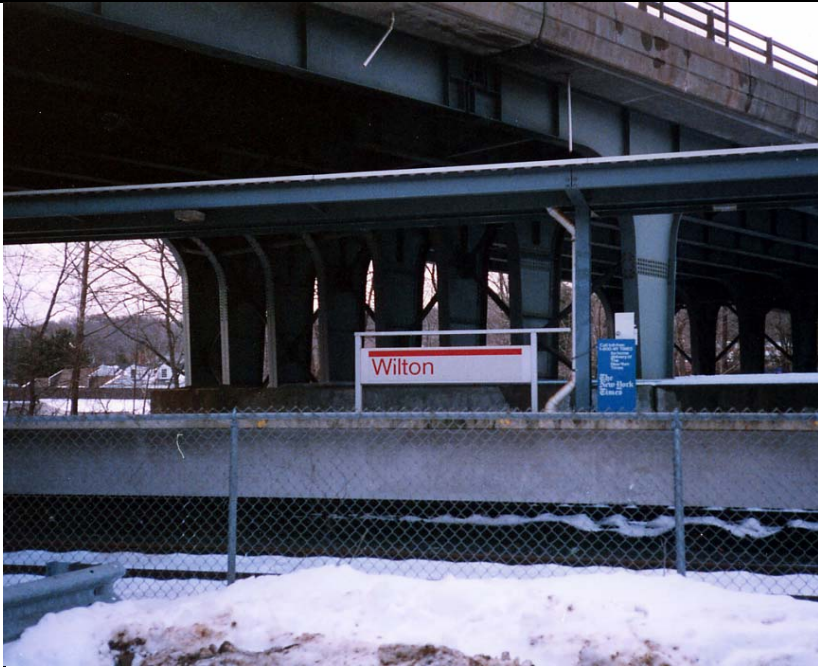
PHOTO NO. 44

On the platform there is a V shape metal rain canopy with gutters and downspouts. Downspouts are in good condition but the gutters need recaulking at the seams.

Location: \_\_\_\_\_  
WILTON  
STATION \_\_\_\_\_

Description: \_\_\_\_\_  
Metallic rain  
canopy over  
platform V  
shaped with  
plastic  
downspouts

Reference: \_\_\_\_\_  
Mechanical  
\_\_\_\_\_
