# REHABILITATION STUDY REPORT

State Project No. 063-703  
Bridge No. 03614 in Hartford, CT  
I-91 TR 828, 15-161 over Drainage

State of Connecticut  
Department of Transportation  
Newington, Connecticut

*Submitted:* February, 2016

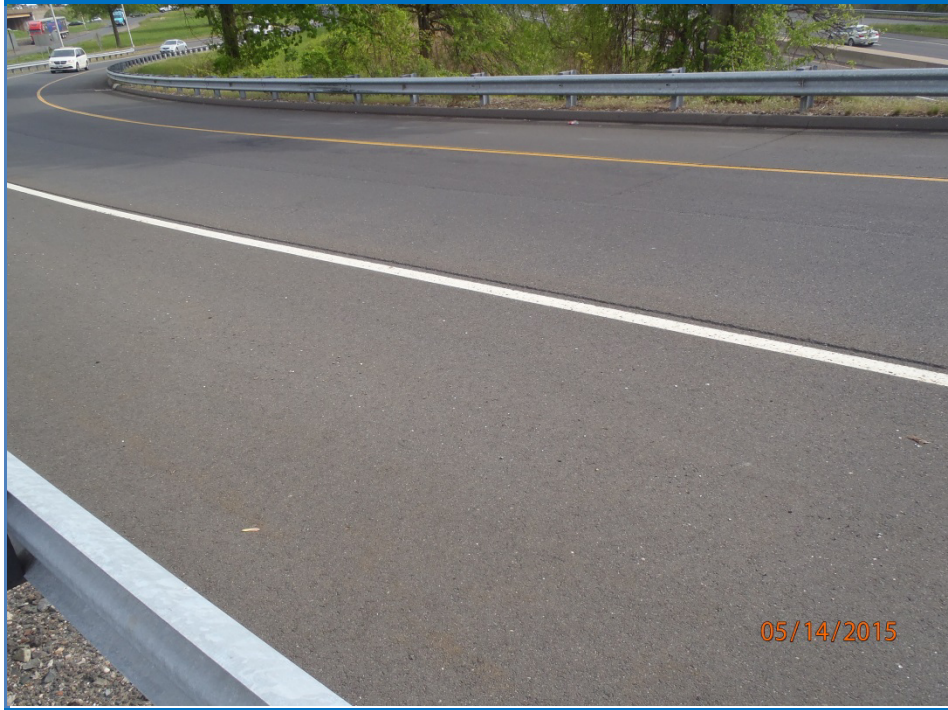
**3: TR 15-191, Looking northerly up off-ramp**

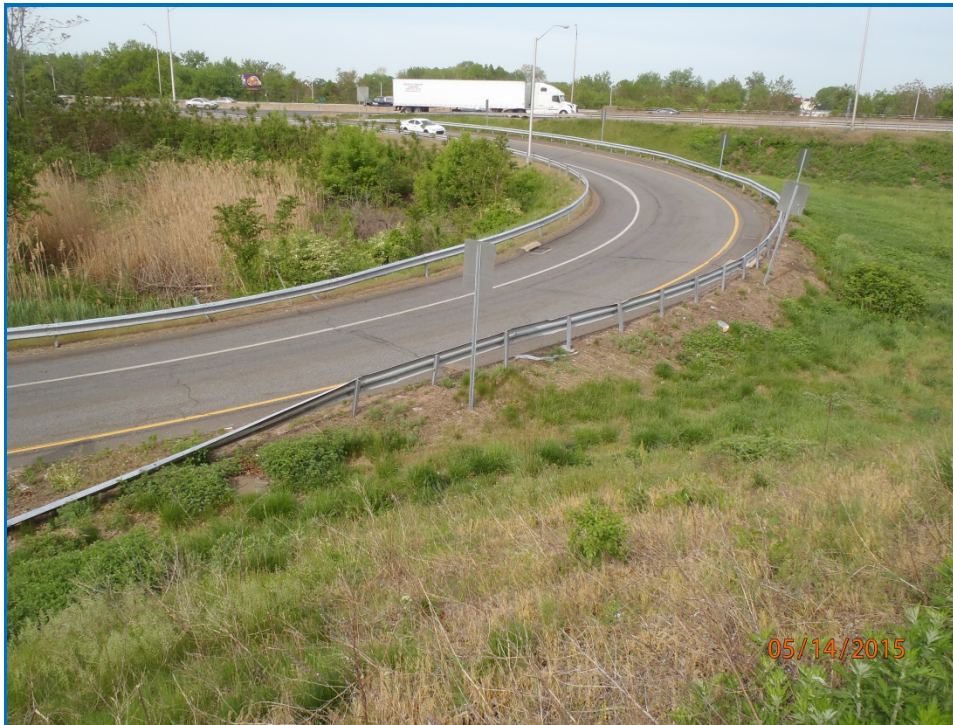
**4: TR-828, Looking westerly towards I-91**

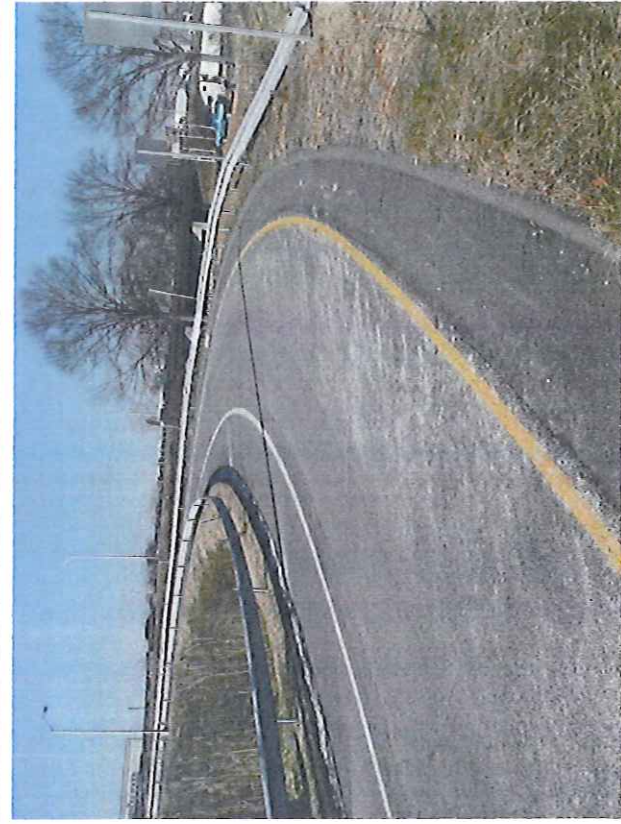
Photo # 3: I-91 TR 828, East Approach Looking West

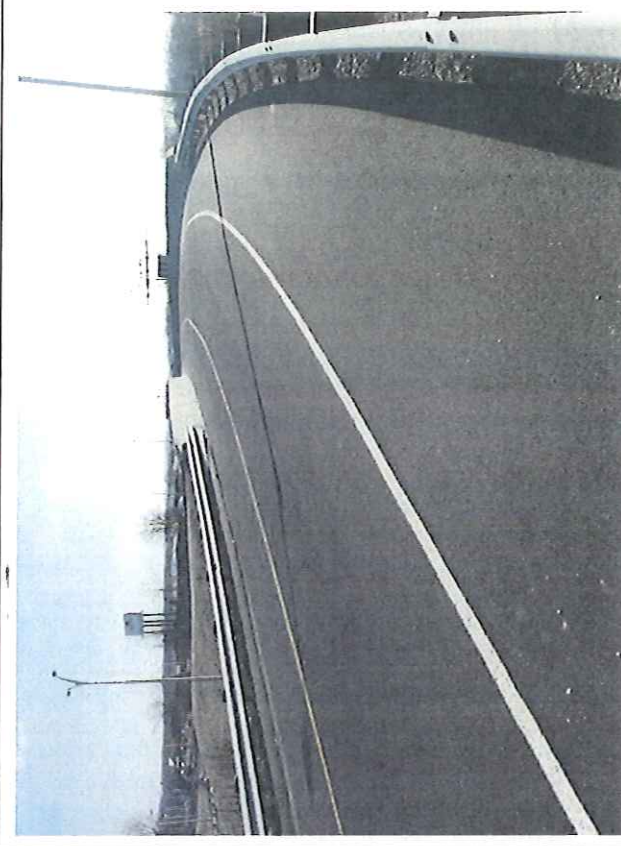
Photo # 4: Rte. 15 Ramp 161, West Approach Looking East

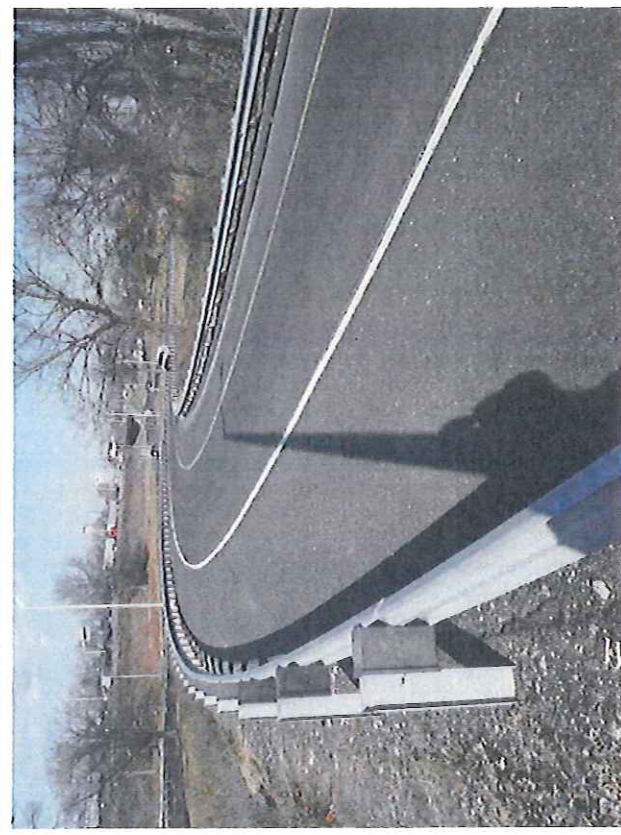
Photo # 5: Rte. 15 Ramp 161, East Approach Looking West
