Eastern Connecticut Corridor Rail and Transit Feasibility Study (ECRTS)

Appendix D: Thames River Corridor Assessment

November 2023

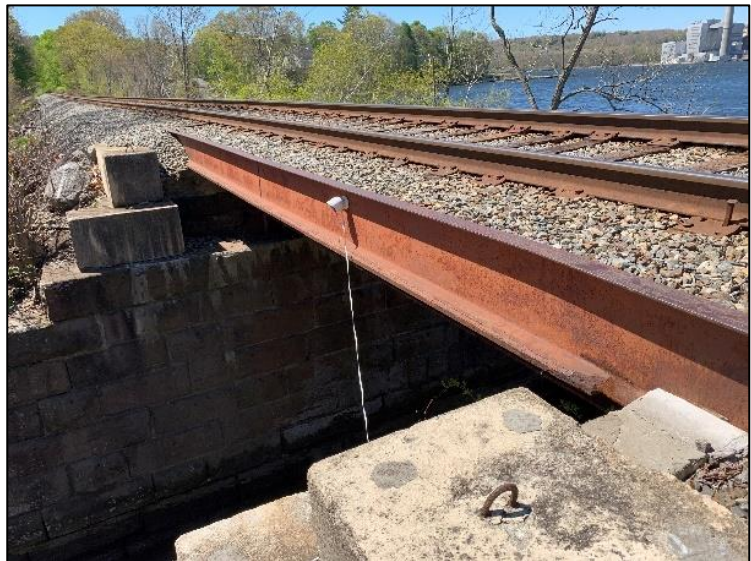
Figure 17: I-Beam Bridge on Gales Ferry Marina (MP 5.11)

Ten (10) UG bridges combined along both corridors were defined as I-beam structures. Of the ten, two (2) received close visual inspections (MP 6.23 West Side and MP 5.11 East Side). Three (3) other structures received a limited visual inspection (MP 6.81 West Side / MP 6.79 and 7.09 East Side). The remaining five (5) were inaccessible due to inability to obtain visual inspection safely. Further inspection would be required that would authorize access to these locations to obtain an in-depth review of condition of these bridges.

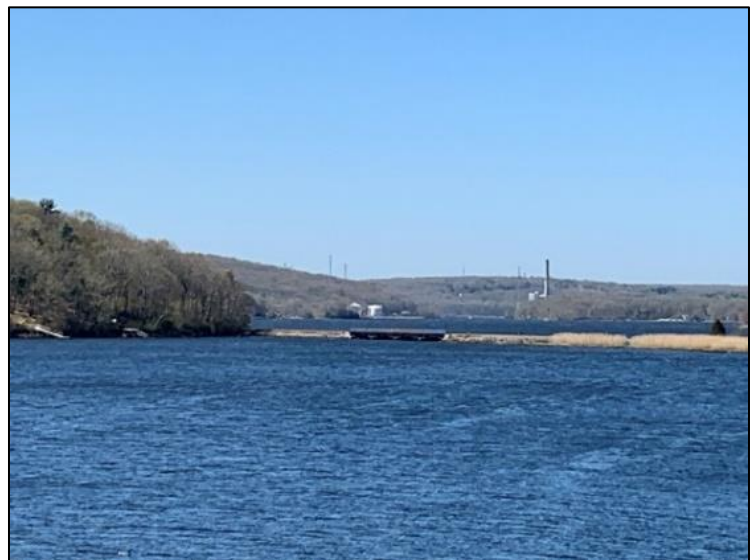
Figure 18: Multi-Span Bridge on Poquetanock Cove (MP 7.83)

The inspection team observed one (1) bridge along the east corridor that was identified as a multi-span bridge. This bridge received a limited visual inspection (MP 7.83) and would require boat access to complete a full in-depth inspection.

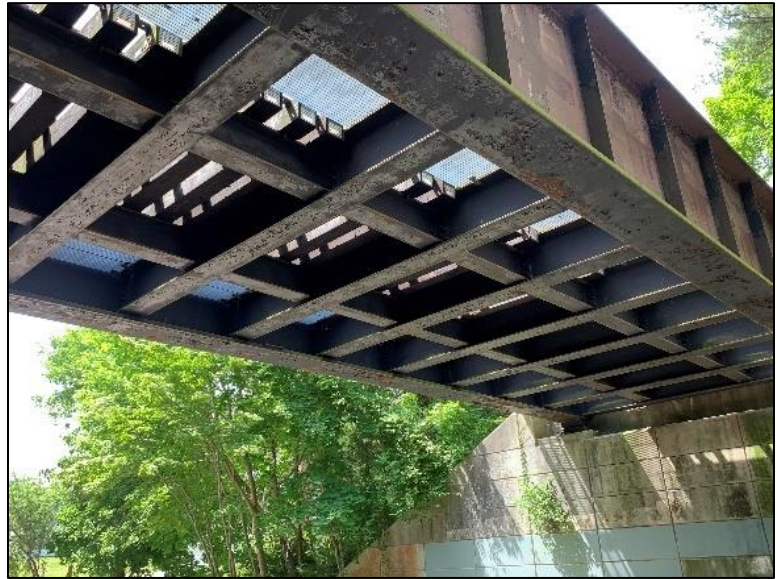
Figure 19: Open Deck Bridge on Shennecossett Road (MP 1.35)

Nine (9) UG bridges were identified as Open Deck structures. Of these nine, only three (3) had visual access and that access was limited for two of them (MP 0.01 and MP 3.80 East Side). Bridge 504358R along the Groton Spur received a visual close-up inspection of the substructure and underside of the superstructure, but there was no access to the top side of the structure (MP 1.35). The remaining six (6) were inaccessible due to the inability to obtain visual inspection safely. Further inspection would require authorized access to these locations to conduct an in-depth review of condition.

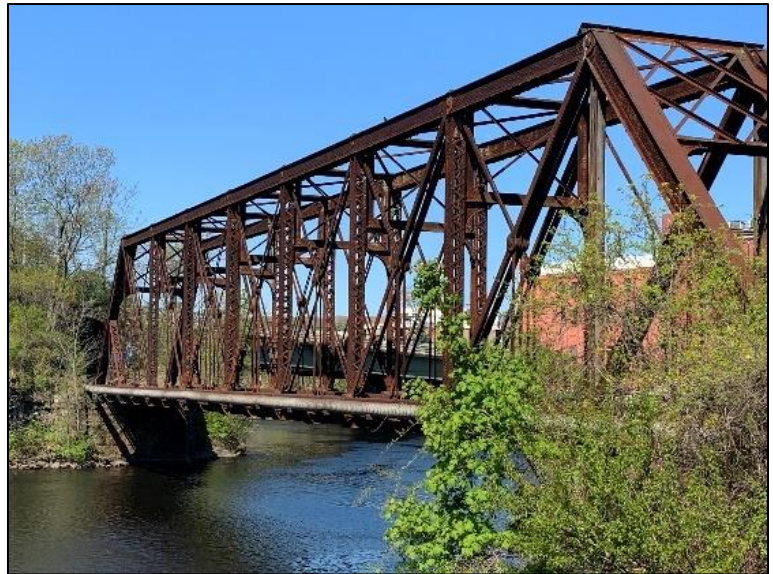
Figure 20: Steel Truss Bridge at MP 12.14

The inspection team observed one (1) Steel Truss bridge along the east corridor that was adjacent to the old Norwich Train Station. The team was able to get close to the deck and superstructure from the northbound side but was not able to obtain a visual on the substructure. Therefore, this bridge received a limited visual inspection (MP 12.14) and would require boat access to complete a full in-depth inspection.

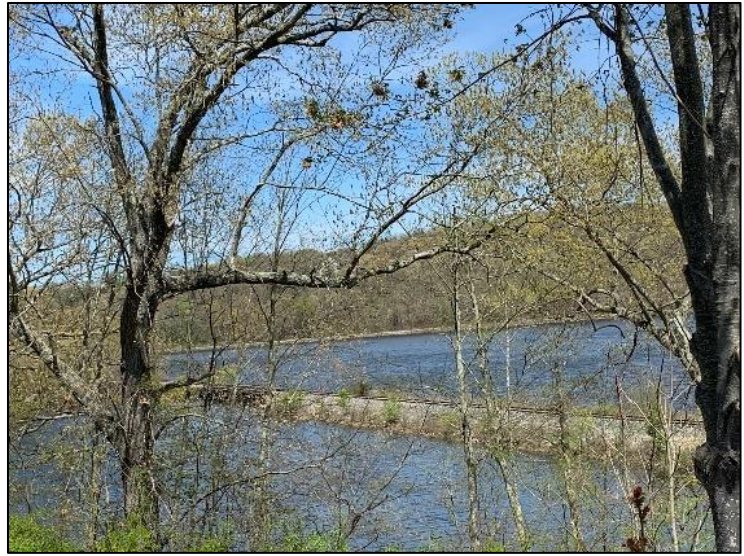
Figure 21: Thru-Girder Bridge at Trading Cove (MP 10.90)

The inspection team observed two (2) Thru-Girders along the west corridor. One bridge was able to receive a limited visual inspection (MP 10.90) while one bridge was inaccessible due to the inability to obtain visual inspection safely (MP 7.47). Further inspection would require authorized access to these locations to obtain an in-depth review of condition of these bridges.

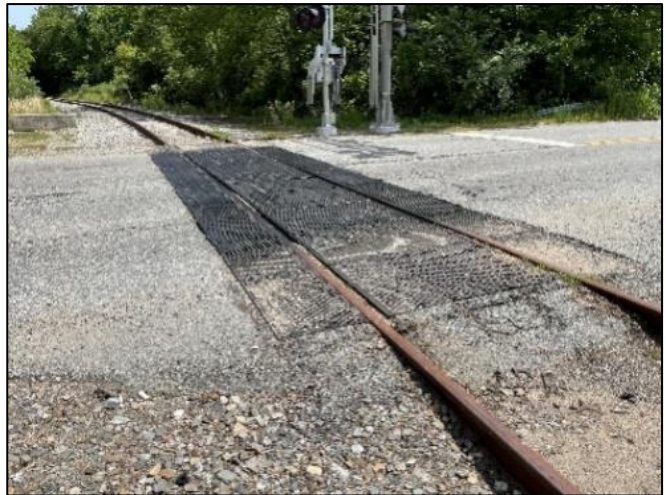
Figure 28: Benham Avenue Grade Crossing (MP 2.37)

Rubber panels imbedded in the road were generally in good condition as they appeared to be installed recently and did not show any visual issues.

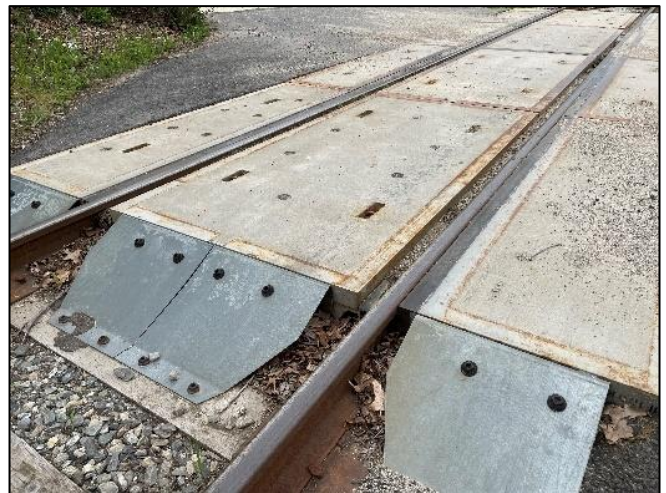
Figure 29: Point Breeze Grade Crossing (MP 6.50)

Pre-cast concrete panels were generally in excellent condition as they appeared to be installed recently and did not show any visual issues.

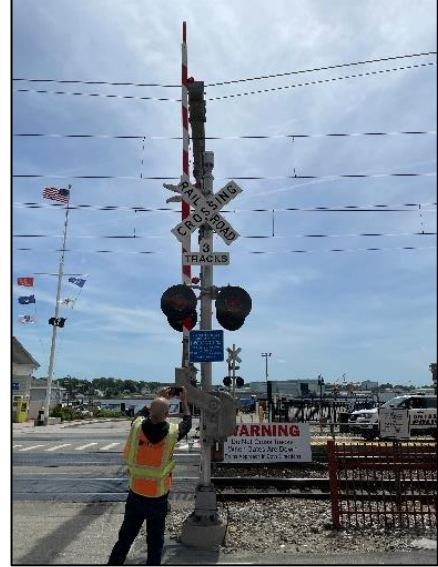
Figure 38: New London Train Station Grade Crossing (MP 122.76)

Few active grade crossings were identified to have a complete combination of bells, flashers, and gates. In general, it was presumed these control devices were in working condition, but further inspection will need to test these devices to ensure they are in proper order.

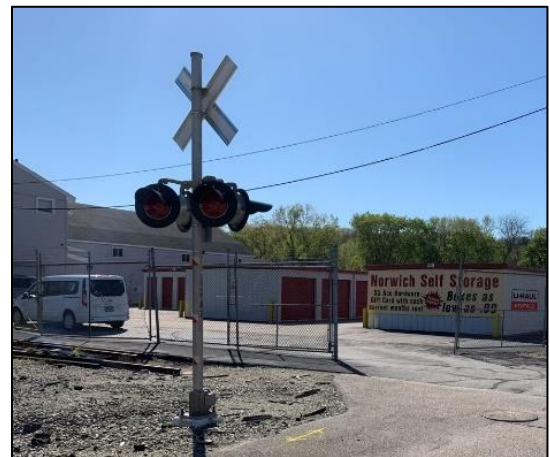
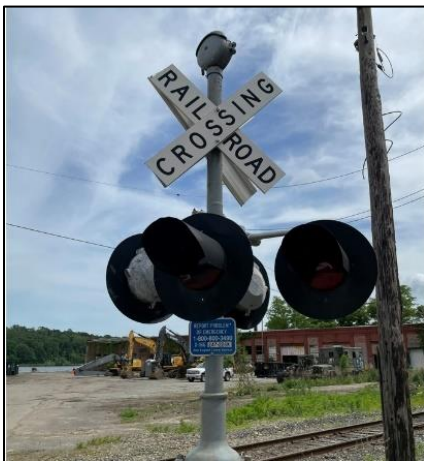
Most active grade crossings observed tended to show flashers only adhered to a crossbuck signpost. In general, it was presumed these were in working condition, but would likely need to be updated to include bells and gates to support passenger rail service.

Figure 39: South Golden Street (MP 12.83)

Figure 40: Terminal Way (MP 11.90)

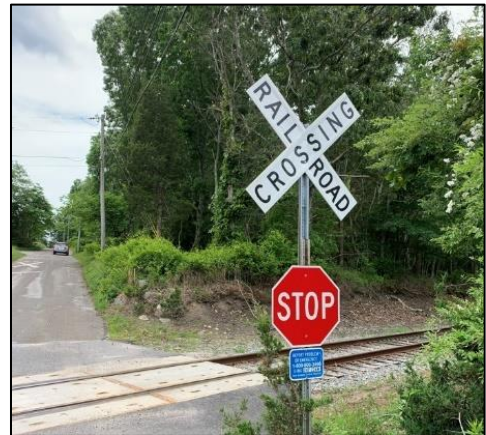
Figure 41: Point Breeze Road (MP 6.50)

Passive grade crossings that crossed over public roads generally had a crossbuck only sign. Only a few grade crossings identified in the field fit this category. Proposed passenger rail service would likely justify classifying these crossings as active and require a full upgrade of communication equipment to support bells, gates, and flashers.

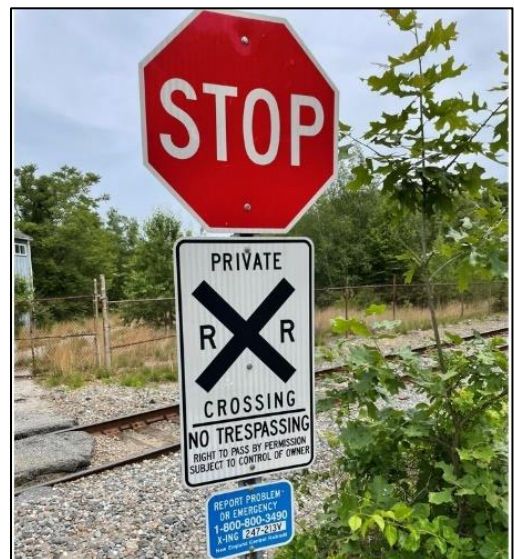
The most common occurrence observed in the field were private grade crossings that were either fenced or unfenced with a stop sign and private crossing sign.

Figure 42: Unfenced Private Grade Crossing - Lower Bartlett Road (MP 5.05)

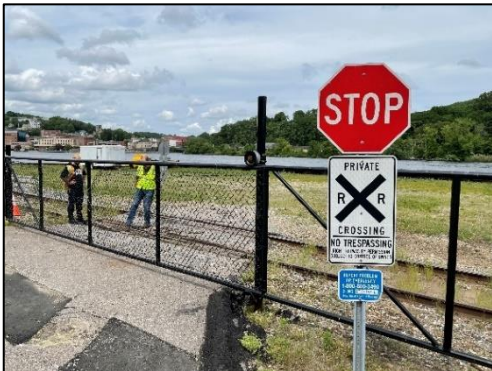
Figure 43: Fenced Grade Crossing - South Thames Street (MP 13.00)

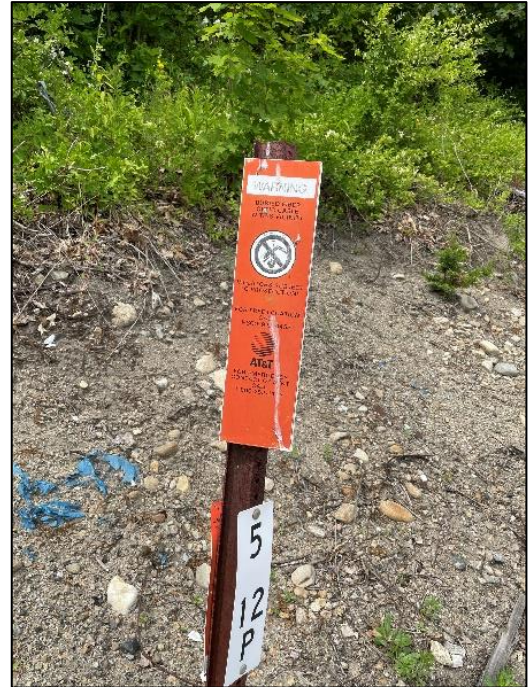
Figure 44: Existing Fiber Optic Cable Warning Post (AT&T)

While out in the field, the team identified fiber optic cable warning posts along numerous grade crossings along the western corridor. This indicates that a portion of the corridor already has fiber, which potentially could be utilized for upgrading the communications infrastructure along the western side of the corridor. Further coordination would need to be scheduled with AT&T to determine what the existing fiber is used for, what utility conflicts could arise if the corridor needed to be rehabbed, and whether the rail corridor could tap into the existing fiber network to support its communication equipment.

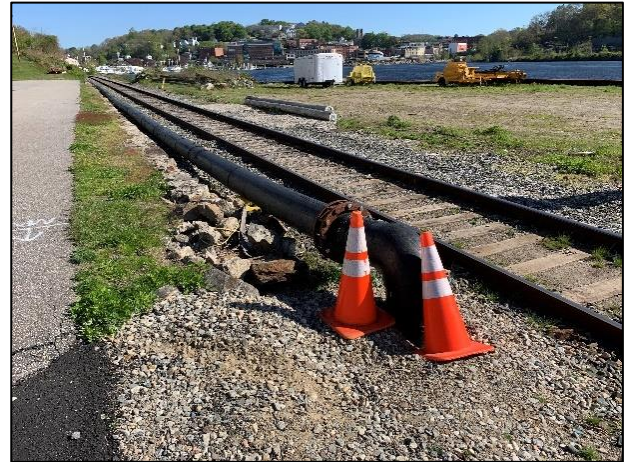
On various segments, the inspection team identified both underground and/or exposed sewage piping. In New London, the team noticed a sign for pipe-sewage with a depth of about 6 feet. In Norwich, the team identified an exposed pipe of approximately 12” in diameter, that is believed to be a temporary outlet for treated water from the Norwich Wastewater Plant. Further inspection will need to confirm where these utilities exist throughout each corridor, where the inlets and outlets officially go, and whether exposed pipes are temporary/permanent and what impacts they would have on ROW construction.

Figure 46: Exposed Outlet Sewage Pipe (Norwich)

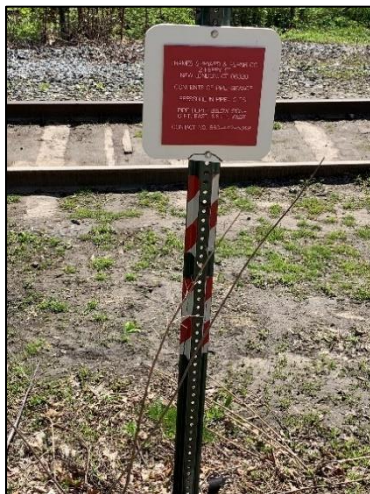
Figure 47: Signage for Buried Sewage Pipe (New London)

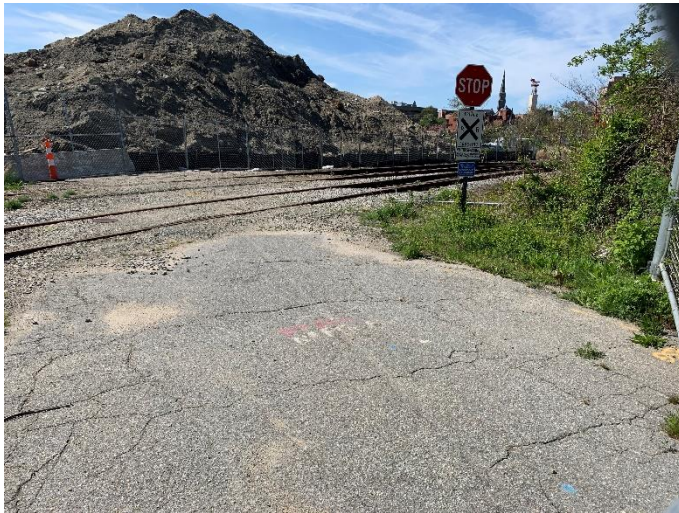
Figure 11: MP 0.40 – Grade Crossing - Thomas Griffin Road - Private Grade Crossing

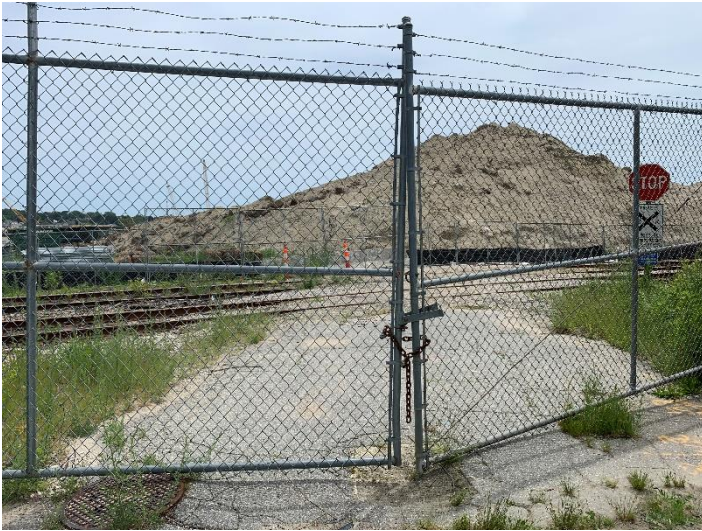
Grade crossing on Thomas Griffin Road, just north of Timber Trestle bridge. Single track splits into double tracks right after crossing the timber trestle bridge. The crossing is gated off and not signaled. Site of Connecticut Port Authority is across the tracks.

Figure 12: MP 0.40 – Grade Crossing – Thomas Griffin Road - Gated Private Crossing

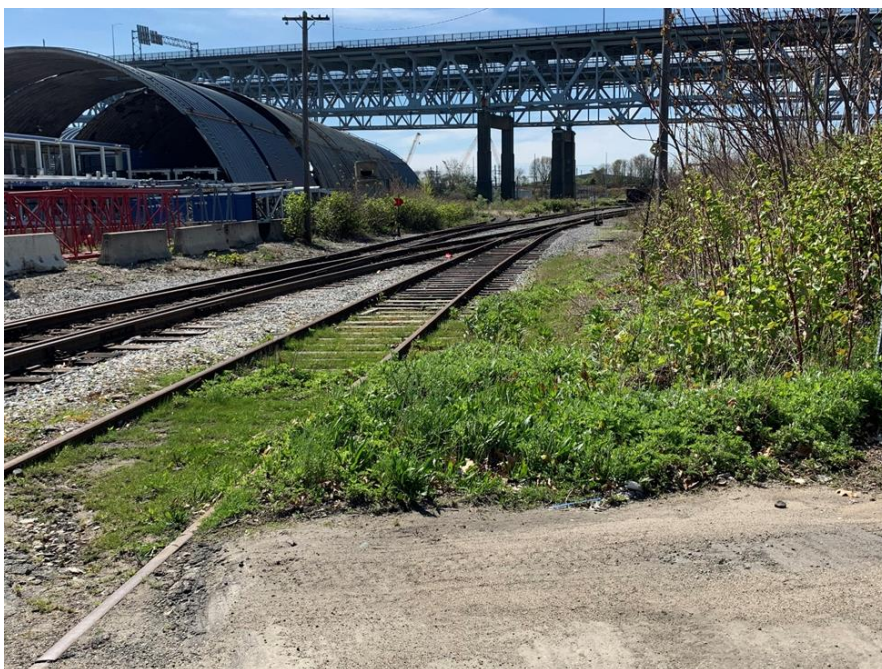
Crossing is in poor condition and is not signaled. Vegetation growing in the gauge – sign of very poor drainage. Most likely, only one track is in active use.

Figure 17: MP 0.91 - Grade Crossing - Eastern Avenue (Looking South)

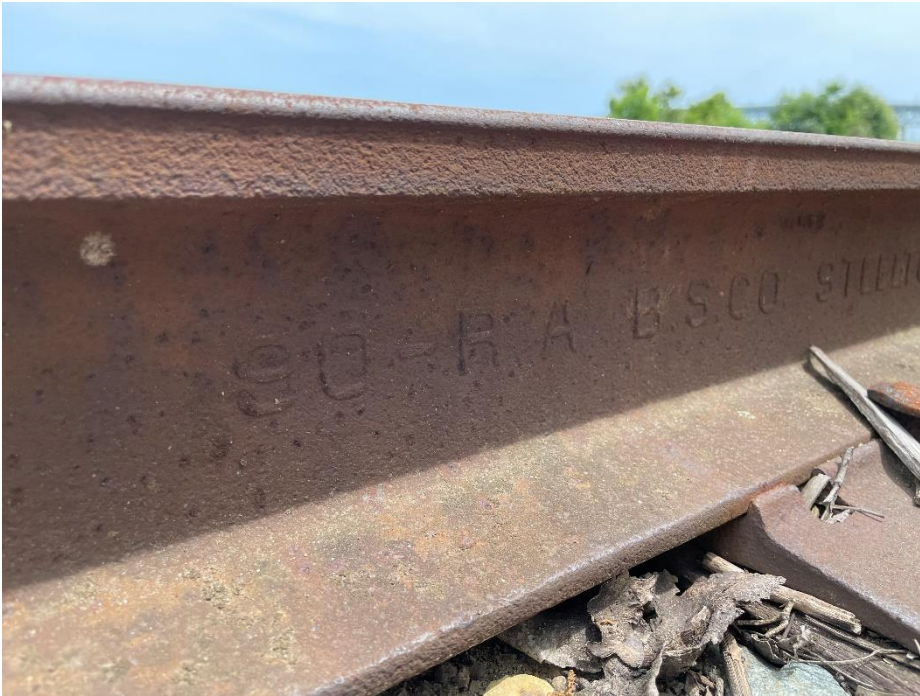
Figure 22: MP 1.07 – Track - Running Rail Weight Stamp - 90RA

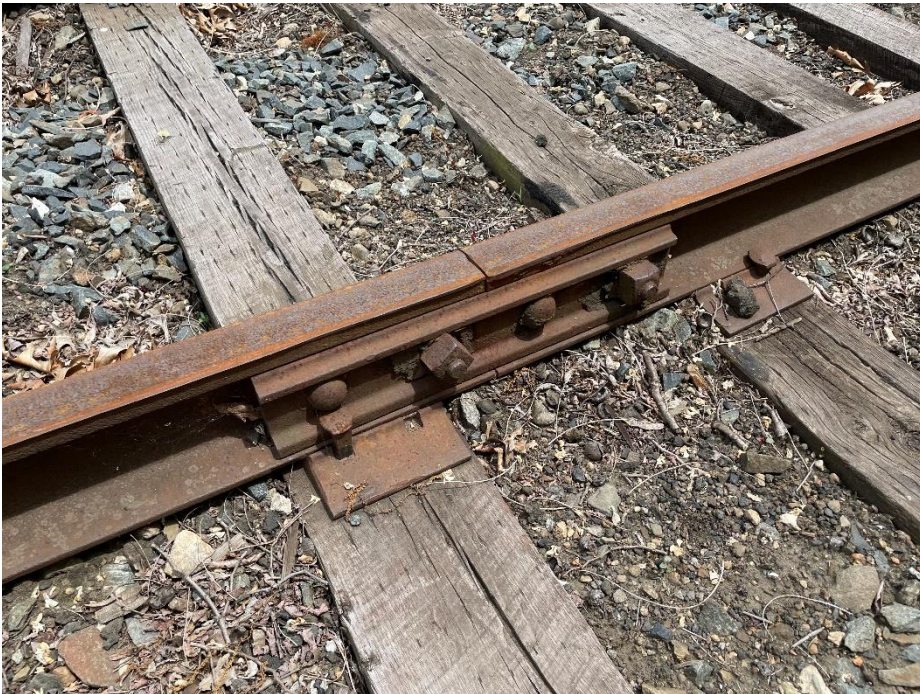
Figure 23: MP 1.07 – Track - Typical Rail Joint and Tie Condition

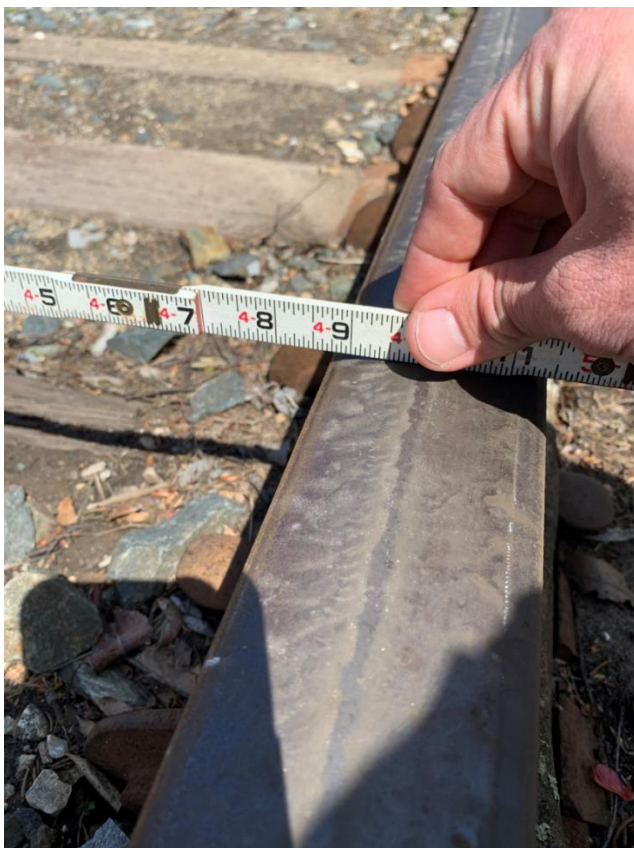
Figure 38: MP 2.37 – Track - Bentham Avenue – Measure of Track Gauge

Gauge dimension 4' - 8³/₄" (1/4" off from the standard 4' - 8¹/₂" gauge)

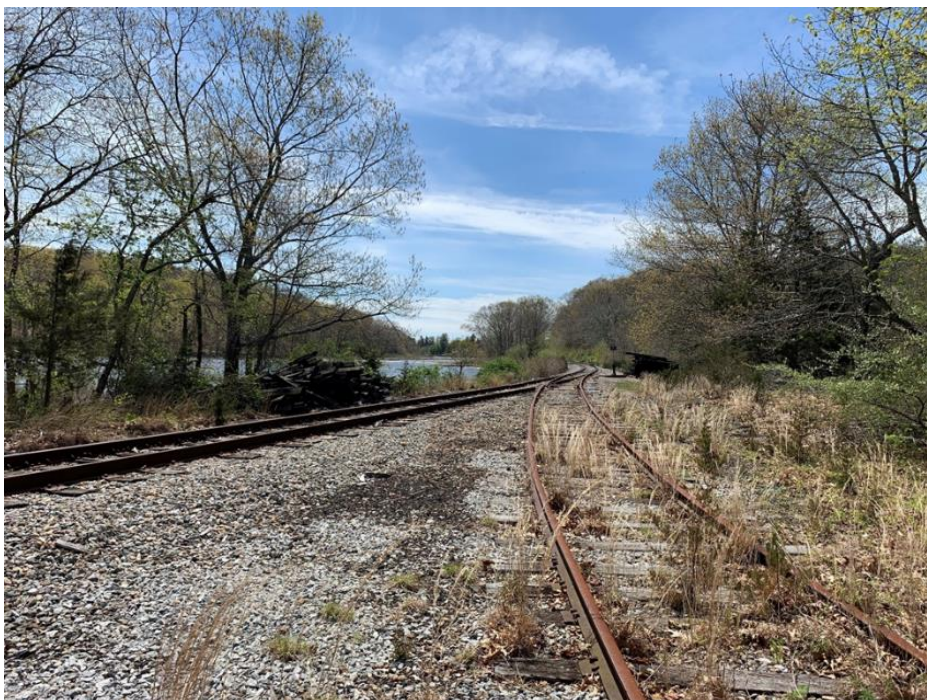
Figure 44: MP 3.00 – Track - Riverhead Building Supply – Looking South

Siding Track on the Right and Mainline track on the left (Looking South)

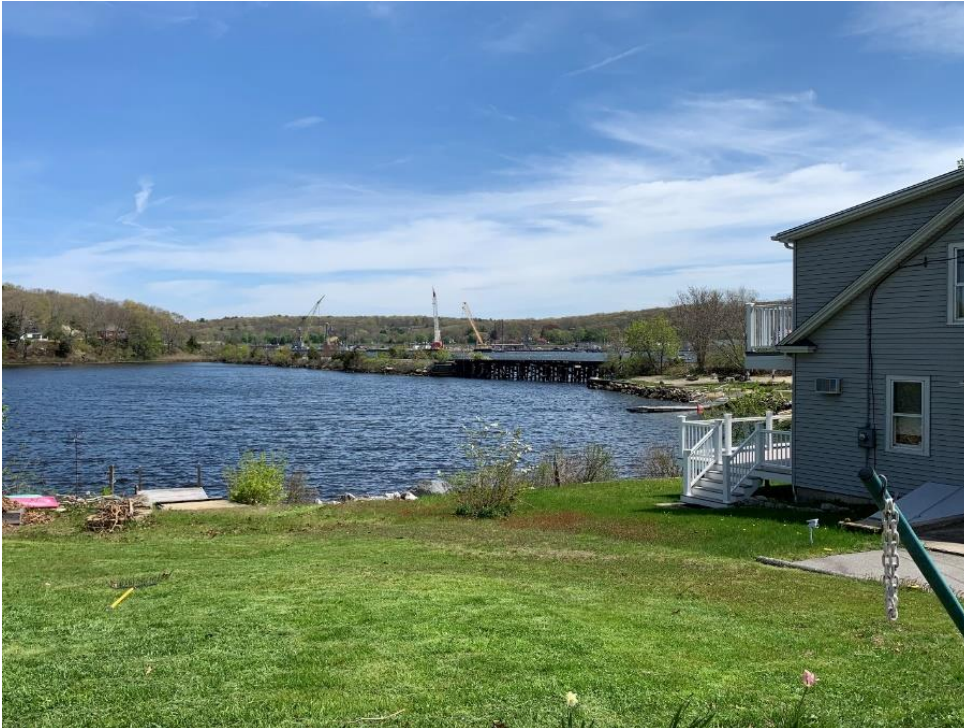
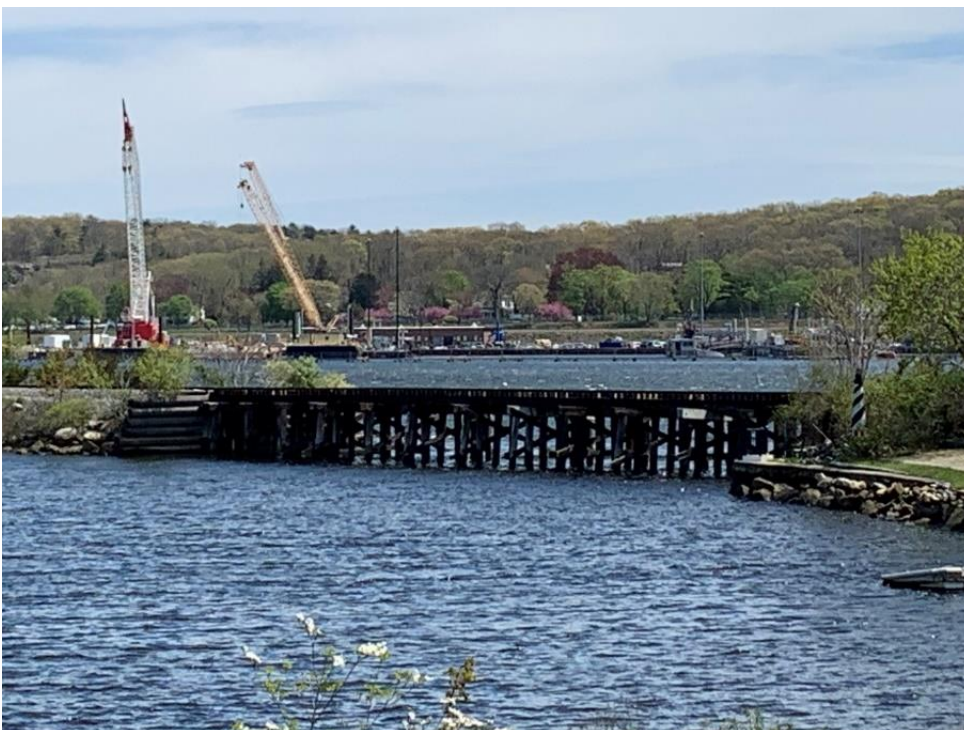
Figure 45: MP 3.25 – UG Bridge - Richards Grove Road - Timber Bridge - (Looking North)

Walking the right of way would be necessary to perform a closer inspection.

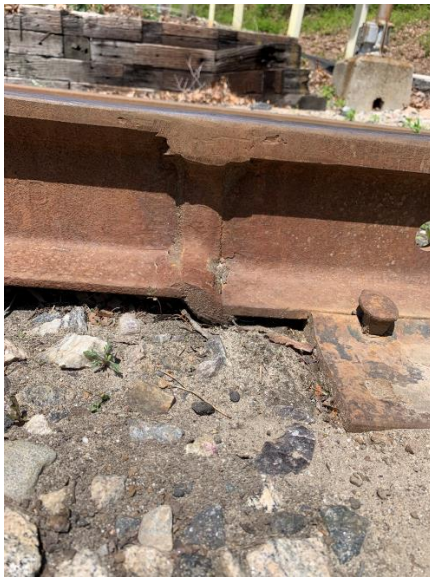
Figure 54: MP 5.76 - Track - Dock Road - CWR

Typical connection between 100 lb/yd rail and 115 lb/yd rail

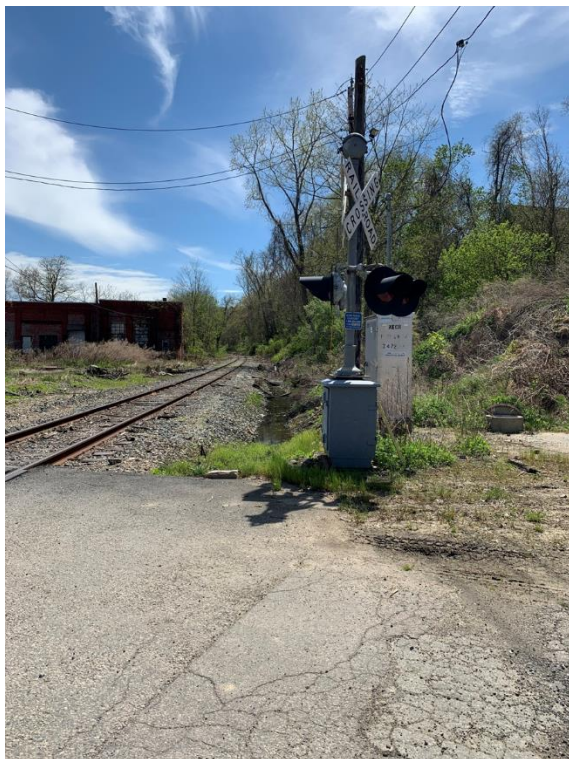
Figure 76: MP 11.90 – Grade Crossing - Terminal Way (Looking South)

Standing water and vegetation near the track – poor drainage.

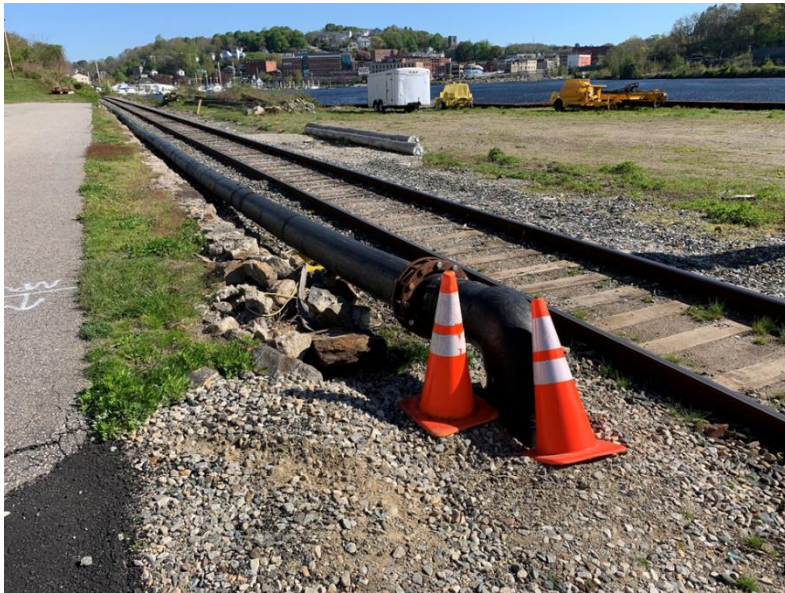
Figure 88: MP 13.00 – Utility - S Thames Street - Exposed Pipe running Alongside the Tracks (Looking North)

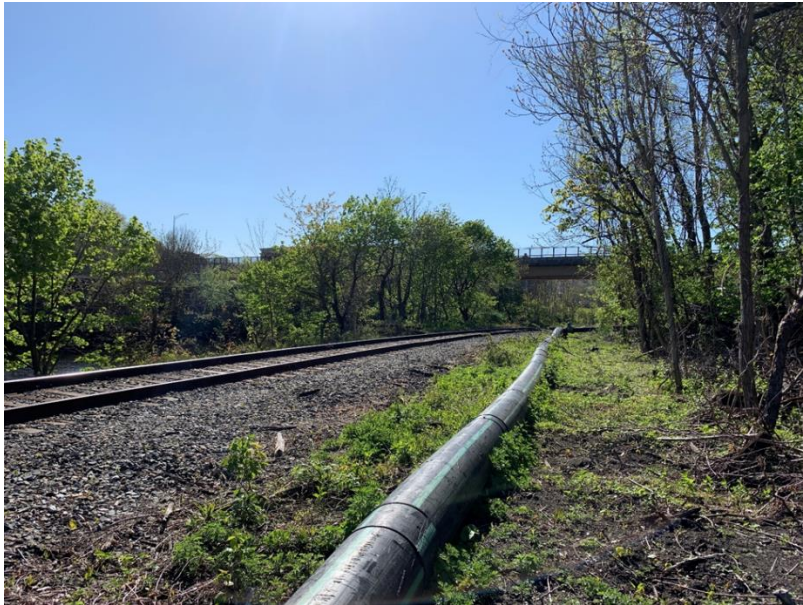
Figure 94: MP 13.50 – Track - North Thames Street (Looking North) - Exposed Piping

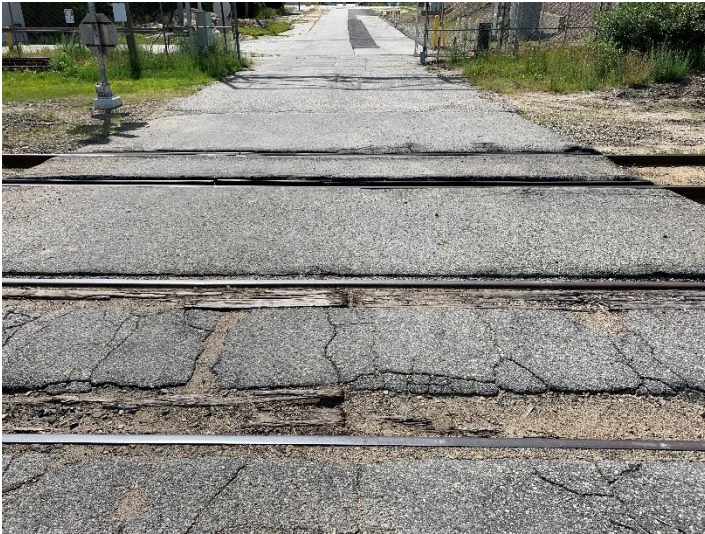
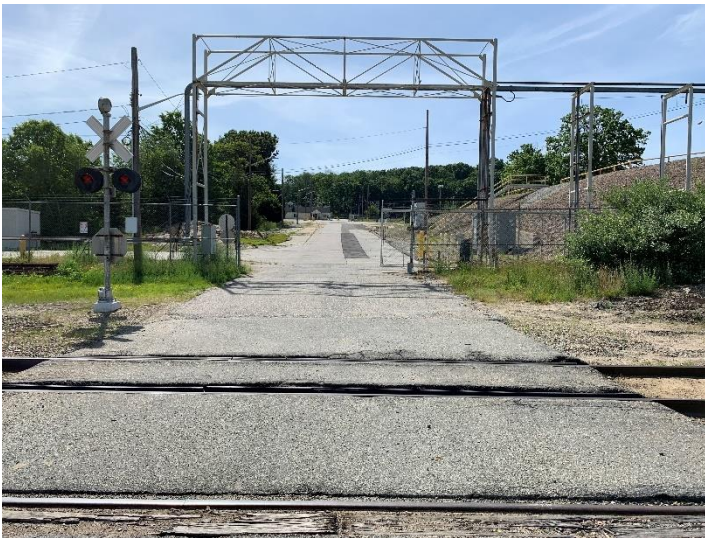
Figure 110: MP 6.08 - Grade Crossing - DOW Chemical (Looking East)

On google earth satellite view this area has a few industrial buildings and large storage tanks. Most likely, they were a part of the DOW Chemical plant. Currently the area has no buildings. It is also under an environmental clean-up operation according to the sign next to the gate. This area could be a potential location for a train station with a parking lot. However, a meeting with DOW Chemical would be necessary to see if they plan to construct a new set of buildings after the environmental clean-up is completed.

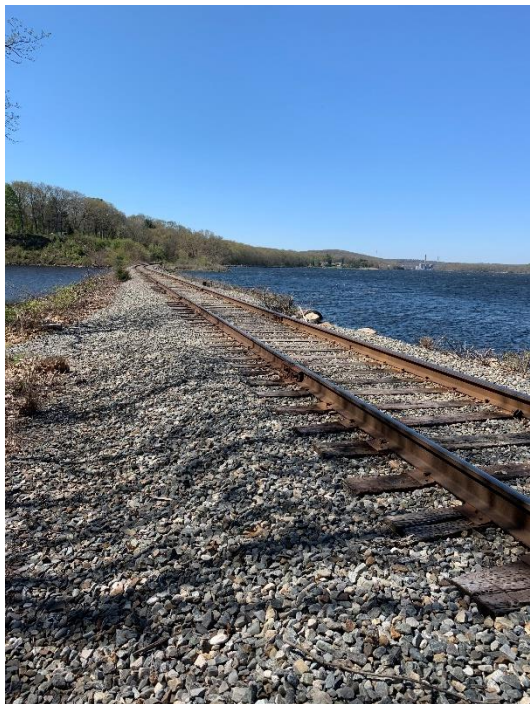
Figure 120: MP 7.09 - UG Bridge - Stoddard Cove (Looking South)

Track outage and/or flagmen are needed to walk on the right of way and perform an inspection.

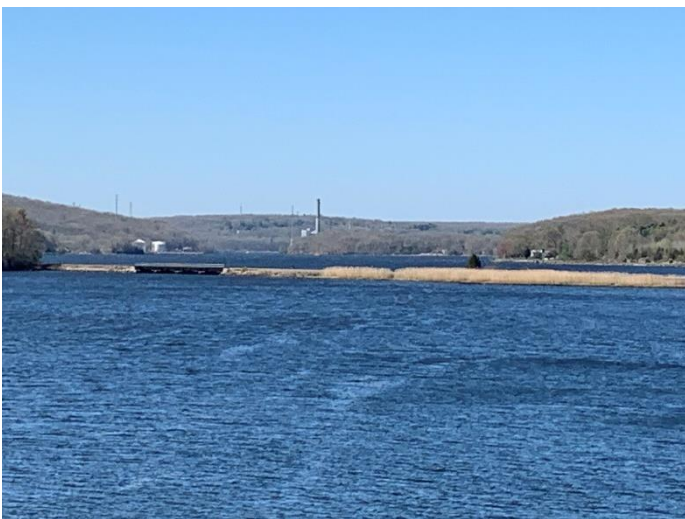
Figure 123: MP 7.83 - UG Bridge - Poquetanock Cove (No Access)

Track outage and/or flagmen are needed to walk on the right of way and perform an inspection.
