BEACON FALLS TRAIN STATION

VISUAL INSPECTION REPORT

January 2007

Prepared by the Bureau of Public Transportation
Connecticut Department of Transportation

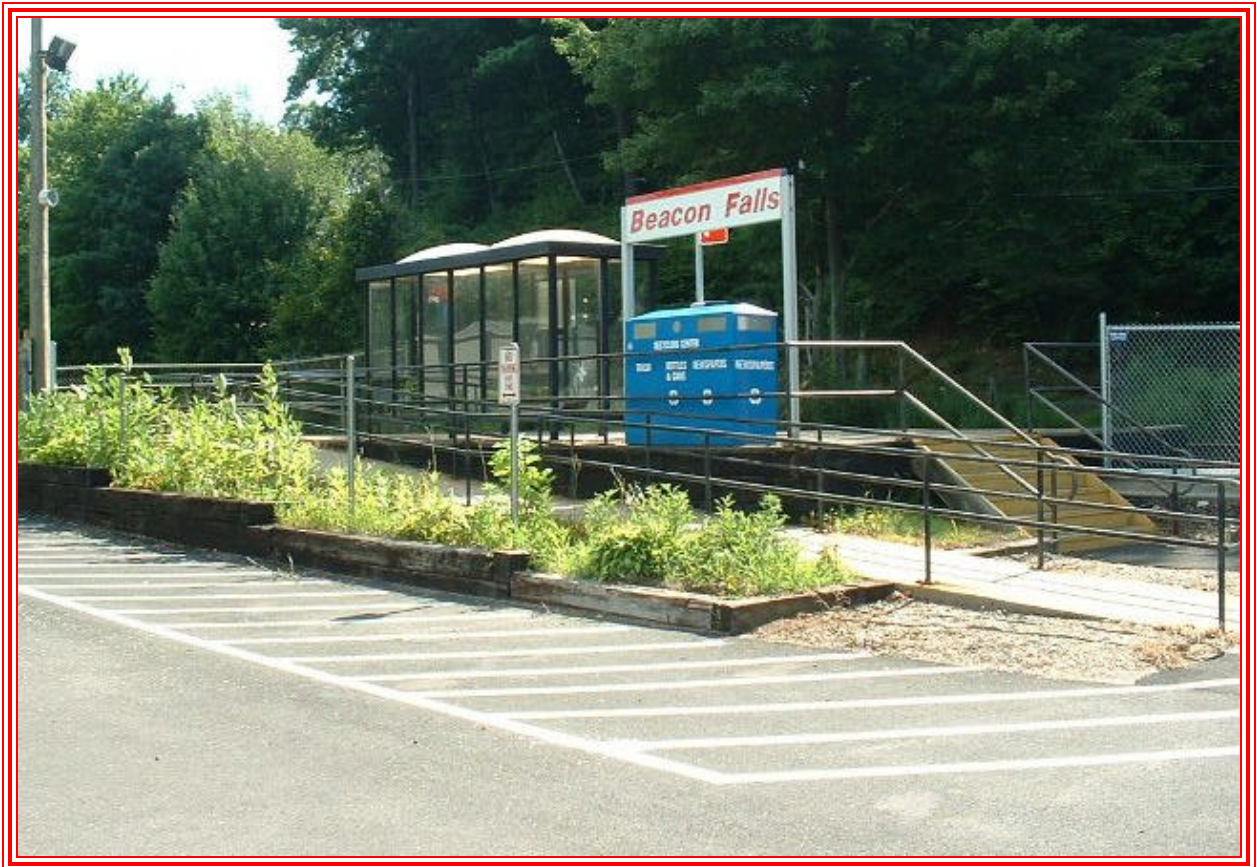
The Beacon Falls Train Station is located across the Naugatuck River from downtown Beacon Falls. This Waterbury Branch train stop consists of a mid-level platform, a ramp, stairs and a shelter. The platform and amenities are relatively new, but some deterioration has been observed. The Plexiglas shelter is functional, but its glazing is scratched from graffiti and numerous attempts to remove it.
