Flexural Capacity of Fire-Damaged Prestressed Concrete Box Beams

PUBLICATION NO. FHWA-HRT-07-024

FEBRUARY 2007

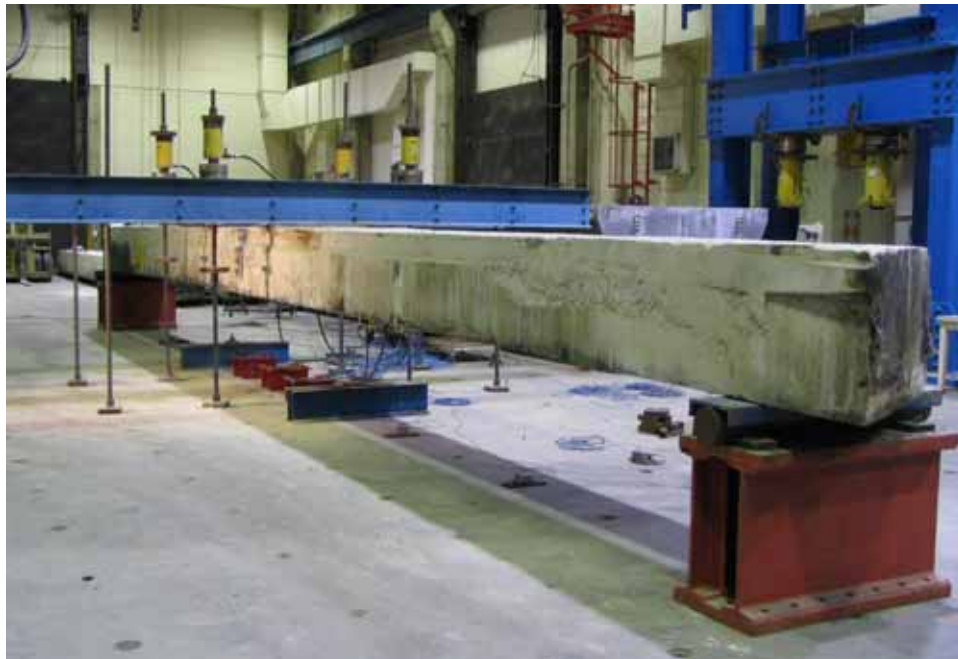
Figure 3. Photo. Flexural loading of a box beam.

The setup for the flexure tests was designed to create a constant moment region at midspan of the beam. The beams were tested on a 14.1 m (46 ft 4 inches) span with two point loads applied 0.91 m (3 ft) on either side of midspan. The beams were supported at both ends by a 200-mm- (8-inch-) wide steel plate that rested on a roller bearing. The loads were applied to each beam through a 300-mm- (12-inch-) wide steel plate that spanned the width of the beam and was grouted to the top flange. Figure 3 is a photograph showing the test setup for the flexural loading of these box beams.

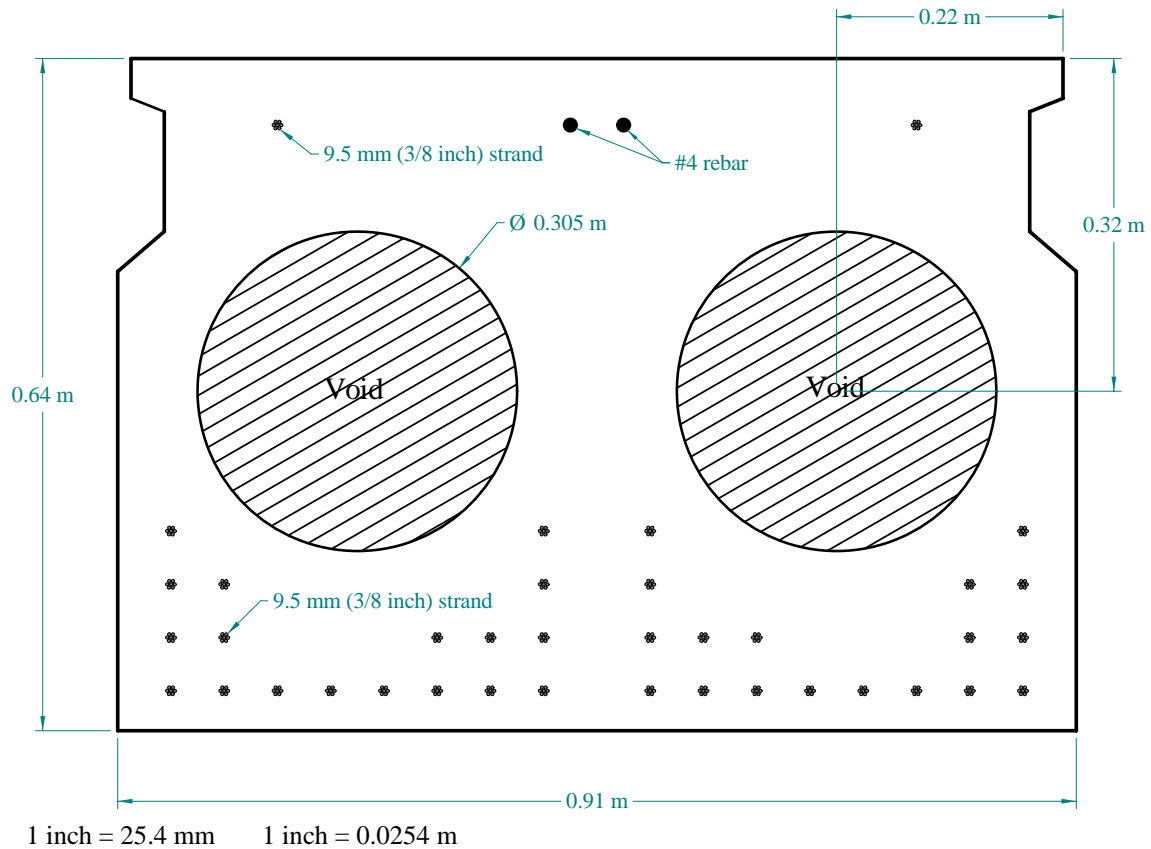
Figure 4. Illustration. Standard cross section of voided box beam.

The four beams had the same nominal midspan cross section as shown in Figure 4. The 0.64-m- (25-inch-) deep, 0.91-m- (36-inch-) wide box beams each contained two 0.305-m-(12-inch-) diameter circular voids located 0.32 m (12.5 inches) down from the top of the beam. The voids were formed with cardboard tubes that were capped at the quarter points and at midspan to allow for a continuous diaphragm across the bridge. Each beam was prestressed with thirty-six 9.5-mm- (0.375-inch-) diameter prestressing strands in the bottom flange, and two of these same strands in the top flange. Two number 4 rebars were also located in the top flange, serving to aid in installation of the mild steel reinforcement shear stirrups.

After failure of each beam at the midspan cross section, this cross section was examined to determine as-built dimensions. It must be noted that the likely intended cross-sectional dimensions are shown in Figure 4, but that the actual as-built dimensions varied. For instance, the total minimum web thickness at middepth of the voids is 0.305 m (12 inches). At this location, the distance from a particular void to the outside face of the beam varied amongst the beams from a low of 51 mm (2 inches) in one beam to a high of 152 mm (6 inches) in another beam. Additionally, note that the distance from the bottom flange to the center of the bottom row of prestressing strands ranged from 38 to 51 mm (1.5 to 2.0 inches) throughout the beams.

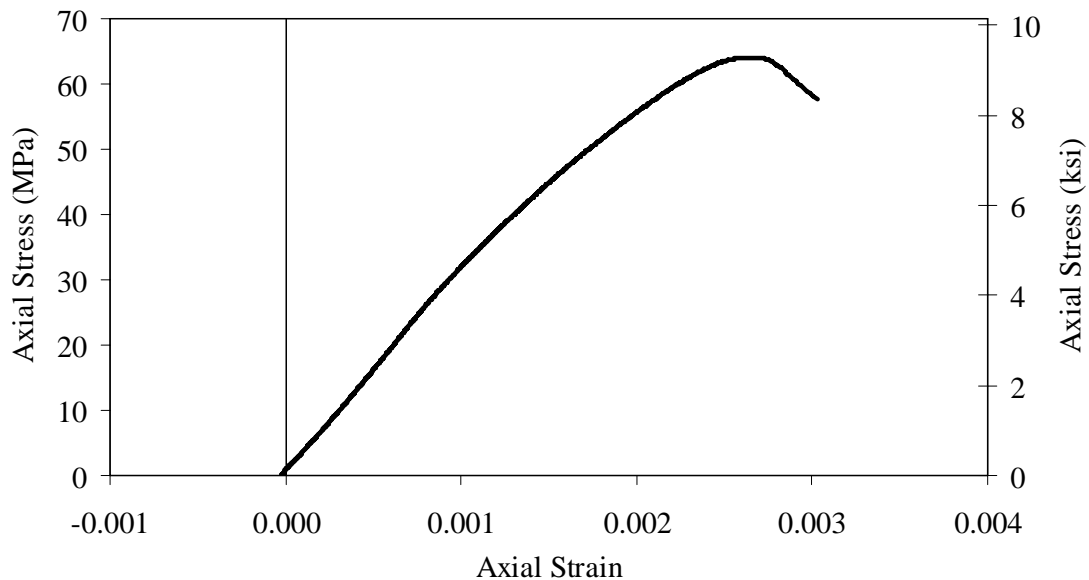
Figure 5. Graph. Compressive stress-strain behavior of core from Beam 3.

Subsequent to the completion of the ASTM C469 testing on one core from each end of each beam, the same cores were tested to failure. In these tests, the ASTM C469 measurements were again captured, but the loading was not halted at 40 percent of the anticipated peak compressive load. These tests provided an indication of the full compressive stress-strain response of the concrete in the beams and specifically the strain levels exhibited by the concrete as it approached compressive failure. Figure 5 shows a representative response from one of the cores. Of the eight cores tested, the average compressive strain observed at the peak compressive stress was 0.00275 with a standard deviation of 0.00018.

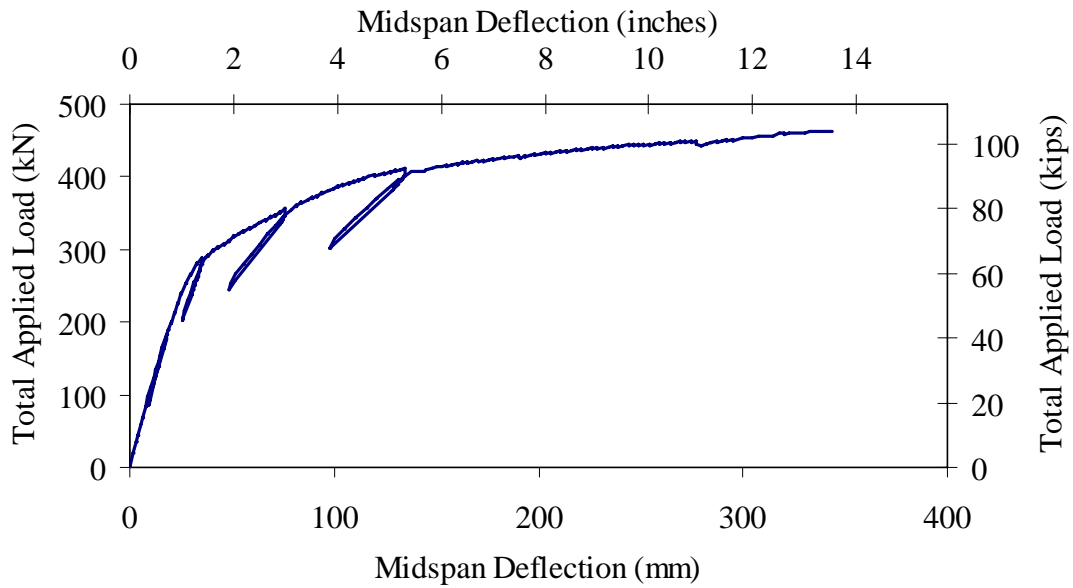
Figure 8. Graph. Applied load versus midspan vertical deflection for Beam 3.

The flexural behavior of Beam 3 was captured through the implementation of the test procedure described above. Figure 8 shows the total applied load versus midspan vertical deflection plot. As is shown on this figure, the beam behaved in an elastic manner until approximately 245 kN (55 kips) of load was applied. This corresponds to an applied moment of 751 kN-m (554 kip-ft). The beam then exhibited decreasing flexural stiffness as the load increased up to 463 kN (104 kips). Flexural failure of the beam occurred at this load when the midspan deflection was 343 mm (13.5 inches). This applied load corresponds to an applied moment of 1,421 kN-m (1,048 kip-ft). Figure 9 shows the deflected shape of the beam at incrementally higher load levels throughout the test.

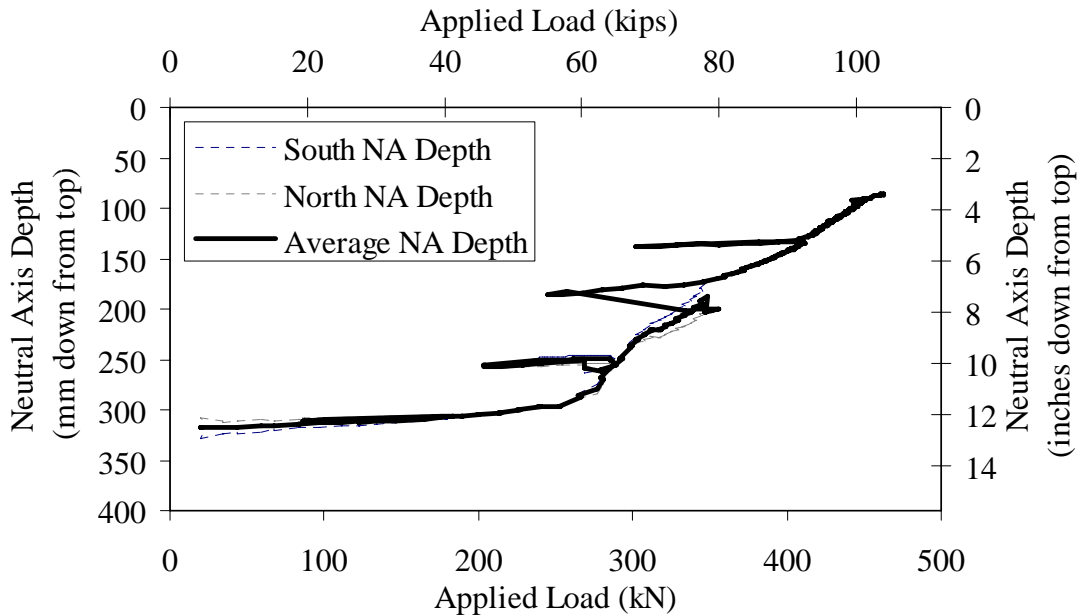
Figure 10. Graph. Midspan neutral axis depth from top of Beam 3.

Figure 10 plots the midspan neutral axis depth from the top of the beam versus the load applied to the beam. The neutral axis depth is calculated for each face of the beam based on the operational strain gages providing reliable readings at a given load level. The neutral axis depths from each face were then averaged to determine the depth plotted in the figure. As would be expected, after the beam began exhibiting inelastic behaviors (i.e., concrete cracking), the neutral axis began to rise.

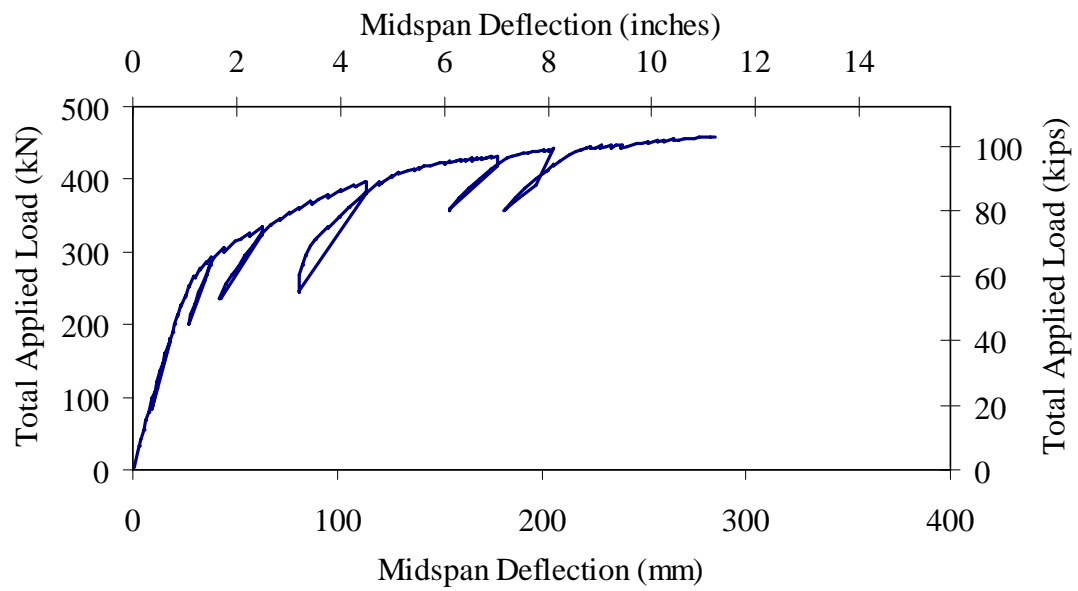
Figure 12. Graph. Applied load versus midspan vertical deflection for Beam 4.

Beam 4 was tested in a similar fashion to Beam 3, described above. Figure 12 shows the total applied load versus midspan vertical deflection plot. As is shown on this figure, the beam behaved in an elastic manner until approximately 245 kN (55 kips) of load was applied. This corresponds to an applied moment of 751 kN-m (554 kip-ft). The beam then exhibited decreasing flexural stiffness as the load increased up to 458 kN (103 kips). Flexural failure of the beam occurred at this load when the midspan deflection was 284 mm (11.2 inches). This applied load corresponds to an applied moment of 1,407 kN-m (1,038 kip-ft). Figure 13 shows the deflected shape of the beam at incrementally higher load levels throughout the test.

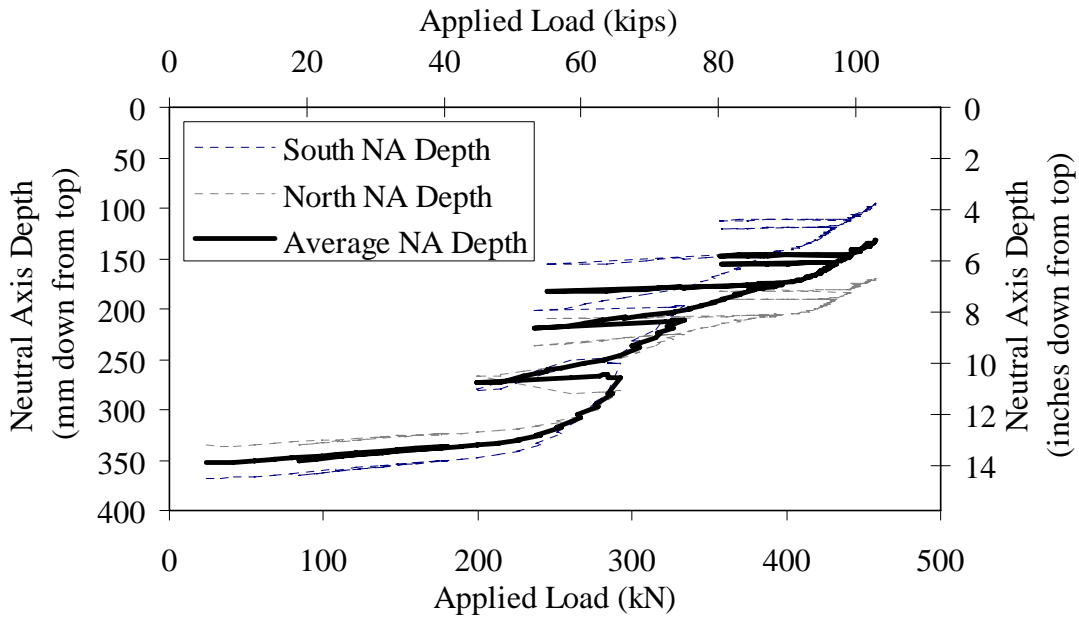
Figure 14. Graph. Midspan neutral axis depth from top of Beam 4.

Figure 14 plots the midspan neutral axis depth from the top of the beam versus the load applied to the beam. As with Beam 3, after the beam began exhibiting inelastic behaviors (i.e., concrete cracking), the neutral axis began to rise.

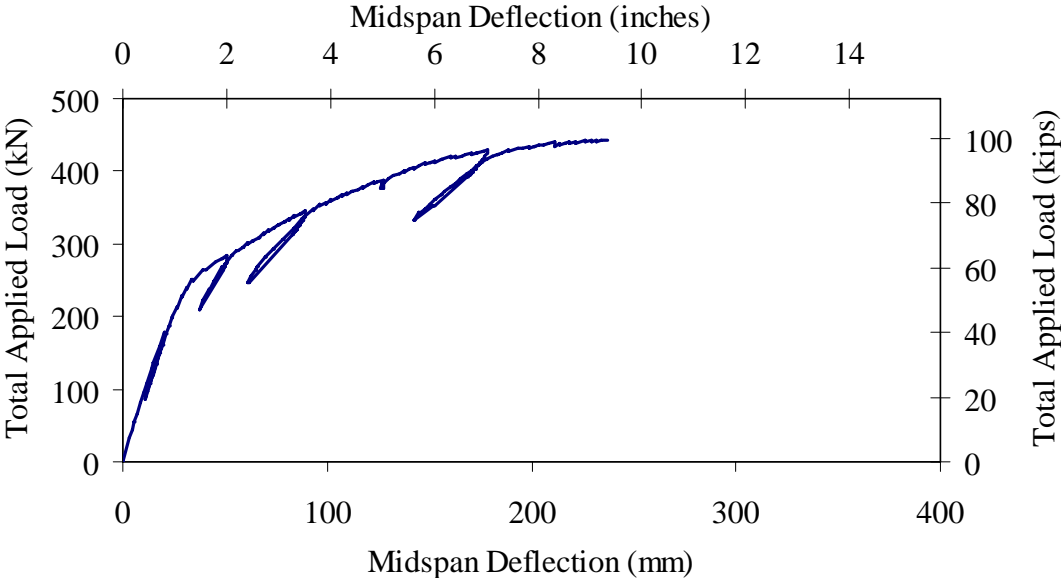
Figure 17. Graph. Applied load versus midspan vertical deflection for Beam 7.

Beam 7 was tested in a similar fashion to Beams 3 and 4, described above. Figure 17 shows the total applied load versus midspan vertical deflection plot. As is shown on this figure, the beam behaved in an elastic manner until approximately 223 kN (50 kips) of load was applied. This corresponds to an applied moment of 681 kN-m (503 kip-ft). The beam then exhibited decreasing flexural stiffness as the load increased up to 445 kN (100 kips). Flexural failure of the beam occurred at this load when the midspan deflection was 236 mm (9.3 inches). This applied load corresponds to an applied moment of 1,362 kN-m (1,005 kip-ft). Figure 18 shows the deflected shape of the beam at incrementally higher load levels throughout the test.

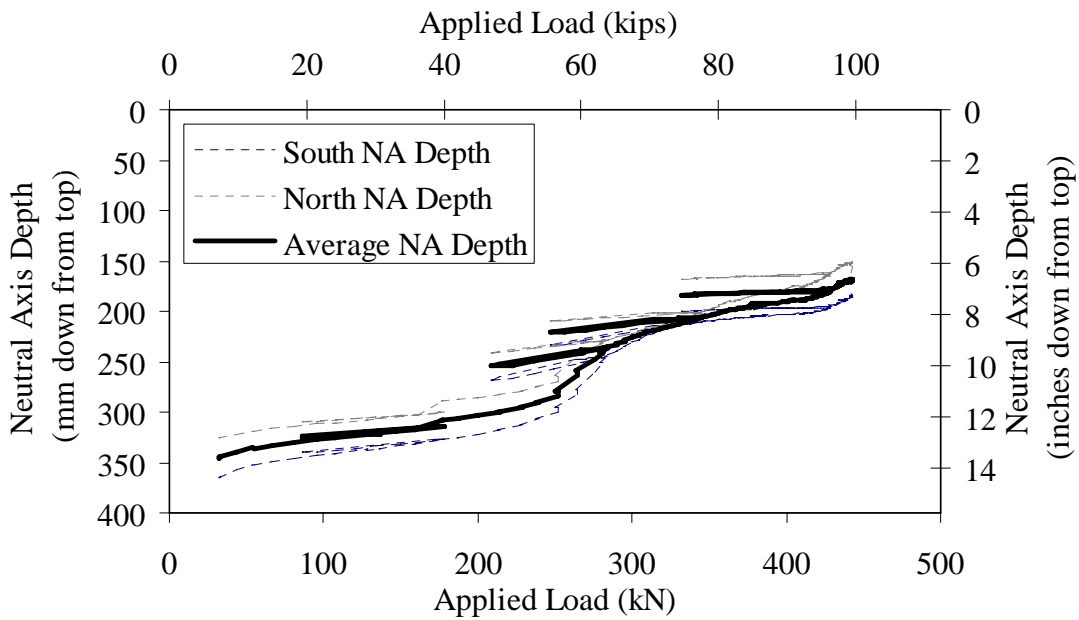
Figure 19. Graph. Midspan neutral axis depth from top of Beam 7.

Figure 19 plots the midspan neutral axis depth from the top of the beam versus the load applied to the beam. As with Beams 3 and 4, after the beam began exhibiting inelastic behaviors (i.e., concrete cracking), the neutral axis exhibited a marked decrease in depth from the top flange.

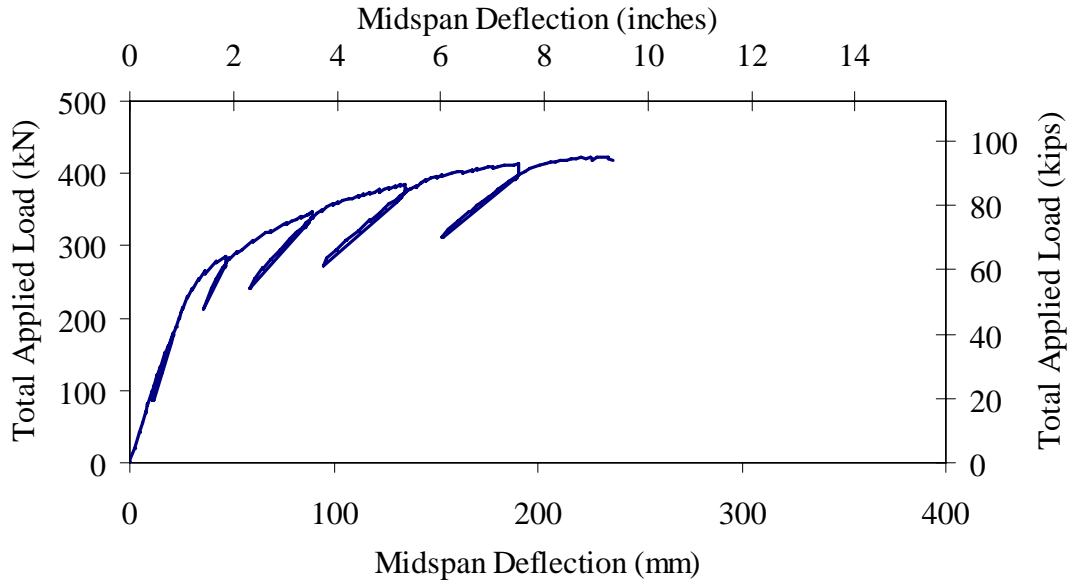
Figure 21. Graph. Applied load versus midspan vertical deflection for Beam 14.

Beam 14 was tested in a similar fashion to the previously discussed beams. Figure 21 shows the total applied load versus midspan vertical deflection plot. As is shown on this figure, the beam behaved in an elastic manner until approximately 223 kN (50 kips) of load was applied. This corresponds to an applied moment of 681 kN-m (503 kip-ft). The beam then exhibited decreasing flexural stiffness as the load increased up to 423 kN (95 kips). Flexural failure of the beam occurred at this load when the midspan deflection was 236 mm (9.3 inches). This applied load corresponds to an applied moment of 1,301 kN-m (960 kip-ft). Figure 22 shows the deflected shape of the beam at incrementally higher load levels throughout the test.

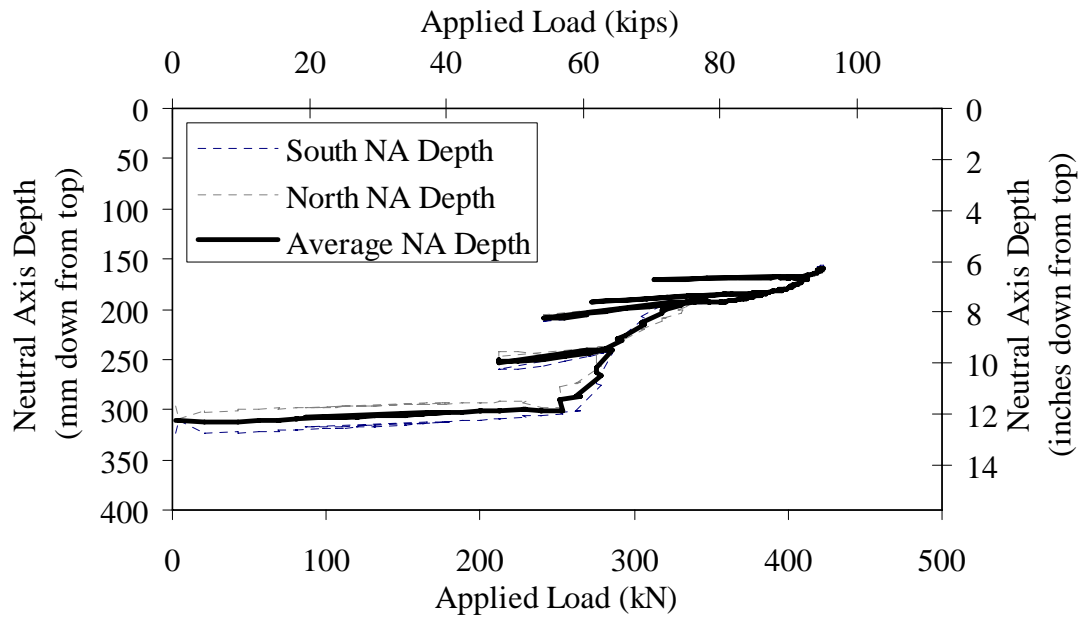
Figure 23. Graph. Midspan neutral axis depth from top of Beam 14.

Figure 23 plots the midspan neutral axis depth from the top of the beam versus the load applied to the beam. As with the previously discussed beam tests, after the beam began exhibiting inelastic behaviors (i.e., concrete cracking), the neutral axis exhibited a marked decrease in depth from the top flange.

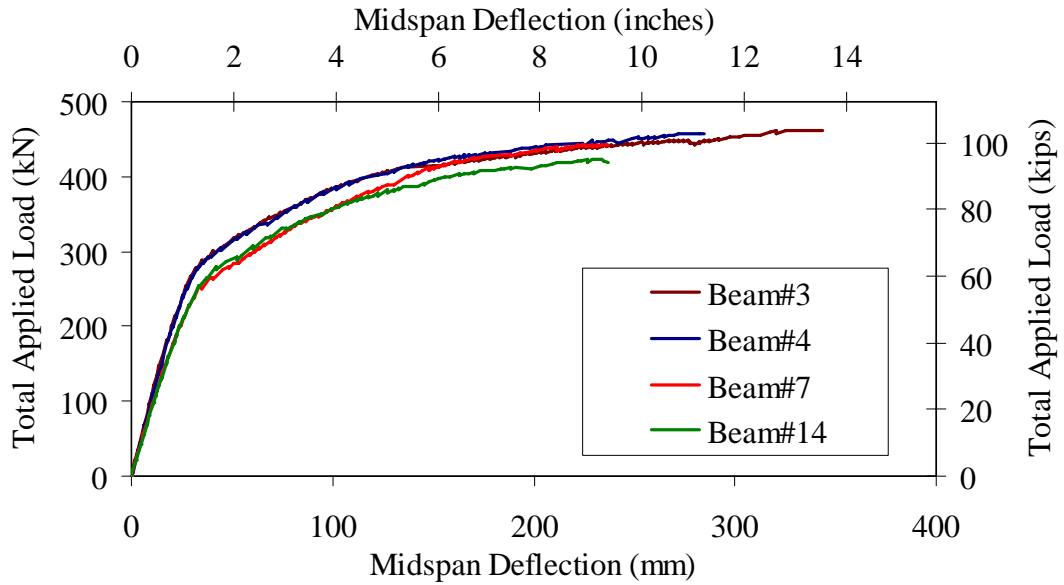
Figure 25. Graph. Applied load versus midspan vertical deflection backbone curves.

The experimentally observed midspan deflection at flexural failure was also similar, with all four beams failing after at least 230 mm (9 inches) of deflection had occurred. Figure 25 shows the backbone curves for the applied load versus midspan deflection behavior of the four beams. The figure clearly shows that all four beams exhibited ductile behavior with significant deflection occurring prior to flexural failure.

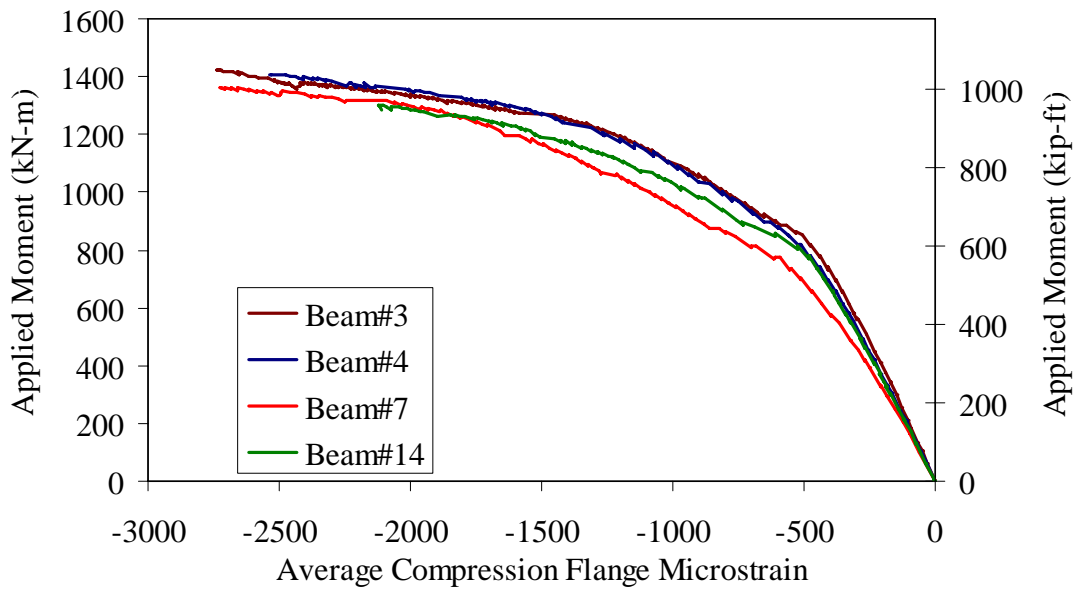
Figure 26. Graph. Applied moment versus average compression flange strain backbone curve.

The midspan compression flange strain throughout the loading of the beam is also instructive with regard to the flexural behavior. The prestress and dead load moments resisted by the beam at midspan combine to create a compressive strain of approximately 0.0001 in the top flange. Figure 26 plots the average strain observed in the three gages on the top flange versus the moment that was applied to the midspan cross section. As in Figure 25, this figure only presents the backbone of the response with the unloading-reloading sequences having been eliminated from the data set. Adding the initial strain in the top flange of the beam to the applied strain values shown in Figure 26 results in the determination that the flexural failures of the beams occurred when the compressive strain in the top flange was between 0.0021 and 0.0028. Recall that the flexural failures of two of these beams were observed to be caused by compression failure of the top flange concrete, and the failure of the other two may have been caused by the same mechanism. Given the widely used concrete flexural design assumption wherein concrete is assumed to fail in compression at a strain of 0.003, the failure of these beams at compression flange strains below 0.0028 is notable.
