ENVIRONMENTAL IMPACT EVALUATION

State Office Building Redevelopment Project

Hartford, Connecticut DCS Project No. BI-2B-381

APRIL 18, 2017

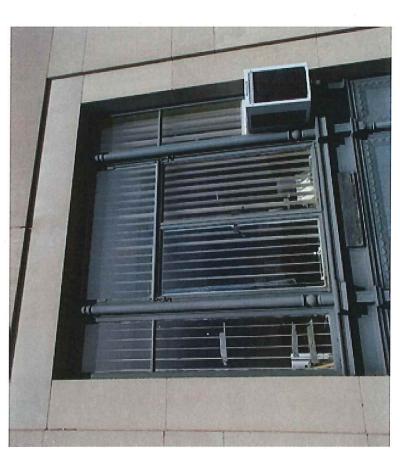
APPENDIX B.0 (WINDOW ELEVATION)
SIMPSON GUMPERTZ & HEGER 02/08/2017

WINDOW ELEVATION - WITH THERM MODEL CALL OUTS

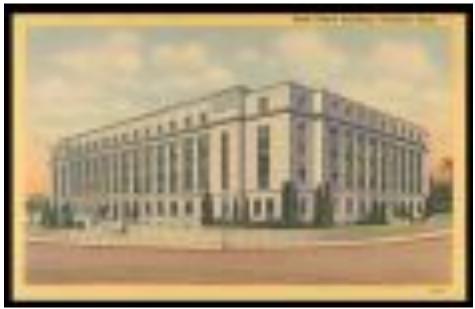
Figure A1. Historic view of exterior of State Office Building - note "golden" appearance of vertical grills in this colorized view. Note also the green at the spandrel panels. *Image courtesy of Simpson, Gumpertz & Heger, Inc.*

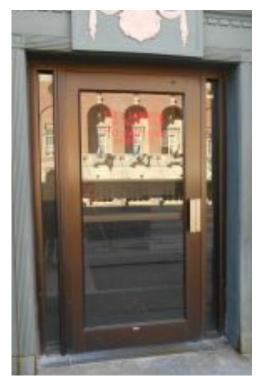
Figure A2. Contemporary view of north elevation door, showing replaced door element.

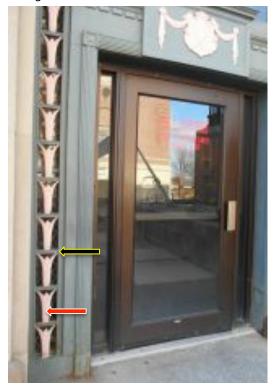
Figure A4. Contemporary view of north elevation doorway showing doorframe grill (see black arrow) with palmette ornaments (see red arrow).

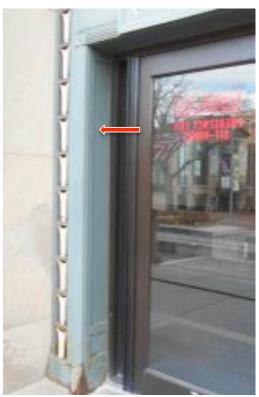
Figure A5. Contemporary view of door jamb element.

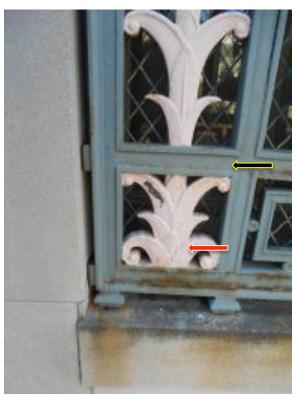
Figure A7. Contemporary view of north elevation vertical grill frame (see black arrow) and anthemion ornament elements (see red arrow).

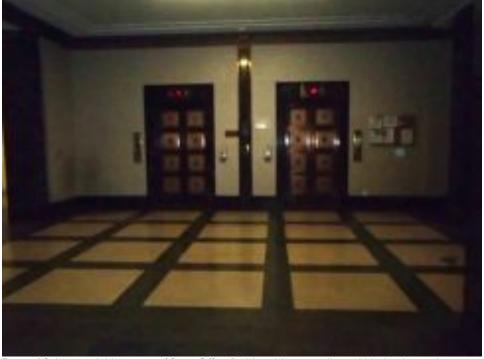
Figure A8. Interior lobby image of State Office Building. Note metallic and black scheme. *Image courtesy of SGH*.

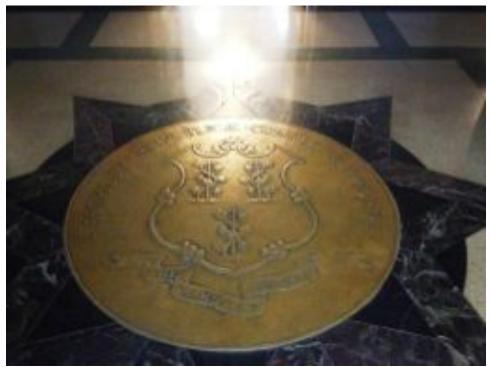
Figure A9. Interior lobby image of State Office Building. Note metallic and black scheme. *Image courtesy of SGH*.

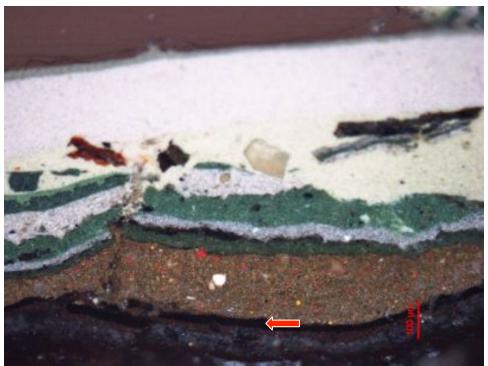
Figure B2a: Cross Section, Sample E, door grill frame, brightfield, 100x magnification. Red arrow indicates the location of the original, deep black finish.

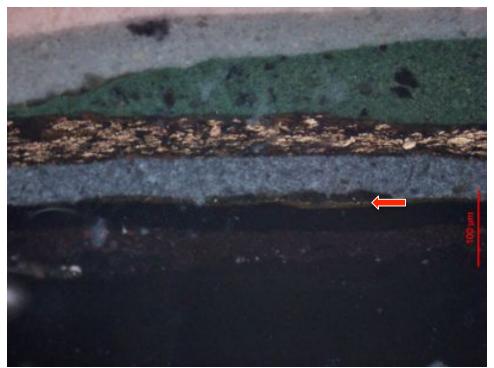
Figure B4c: Cross Section, Sample B, door grill palmette, brightfield, 200x magnification. Red arrow indicates location of original metal leaf finish.

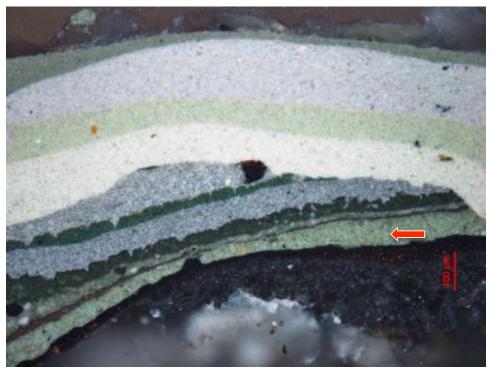
Figure B8a: Cross Section, Sample L, spandrel panel, brightfield, 100x magnification. Red arrow indicates the location of the original, medium green finish.

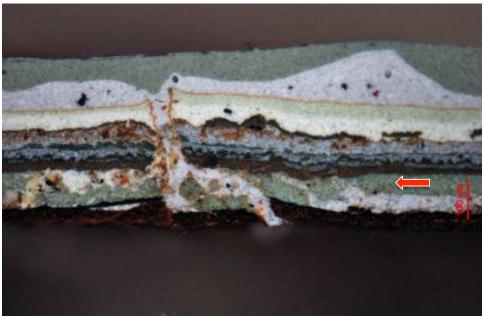
Figure B9a: Cross Section, Sample G, spandrel column, brightfield, 100x magnification. Red arrow indicates the location of the original, medium green finish.

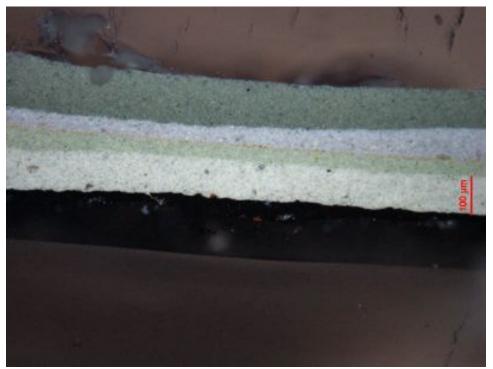
Figure B10a: Cross Section, Sample J, spandrel molding, brightfield, 100x magnification.
