GREEN'S FARMS TRAIN STATION

VISUAL INSPECTION REPORT

January 2007

Prepared by the Bureau of Public Transportation
Connecticut Department of Transportation

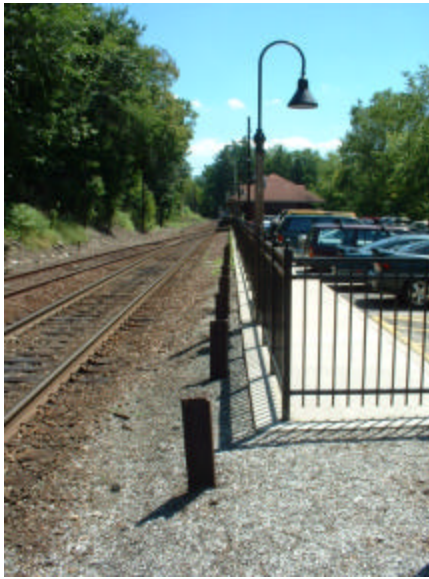
Fence, Walk and Post Mounted Light Next to Track

- **Fence** – Nearly every station uses metal fencing beyond the platform ends to restrict unauthorized access to the tracks. Fencing has also been installed to secure parking areas, demarcate private property or cordon off potentially hazardous areas. Most locations employ a chain link fence, although occasional ornamental steel, cast iron or wood fences can be found. The condition of station fencing has been noted in this report.

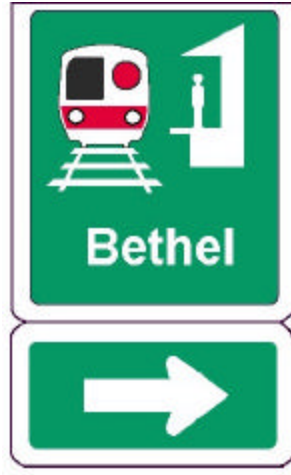
Typical Trailblazing Sign

- **Highway Access** – While traveling to each station, inspectors observed the placement of trailblazing signage. In addition, they assessed the ease of locating appropriate station parking and drop-off areas. Typically, a green highway sign has been placed in advance of the proper exit for a particular train station. This sign notes the name of the station and commuter service operator. However, trailblazing signage at ramp termini or on secondary routes is typically missing or indistinguishable amid the clutter of other signs. Primary routes from the major roadways to each station need to be established and prominently identified. Conversely, trailblazing the return route is also required.

Highway Access – Highway exit signs appropriately note the proper exit for the Green's Farms Station. A missing trailblazing sign at the end of the Exit 18 northbound ramp may cause temporary confusion, but station signs continue at the next intersection.
