STRATFORD TRAIN STATION
VISUAL INSPECTION REPORT

January 2007

Prepared by the Bureau of Public Transportation
Connecticut Department of Transportation

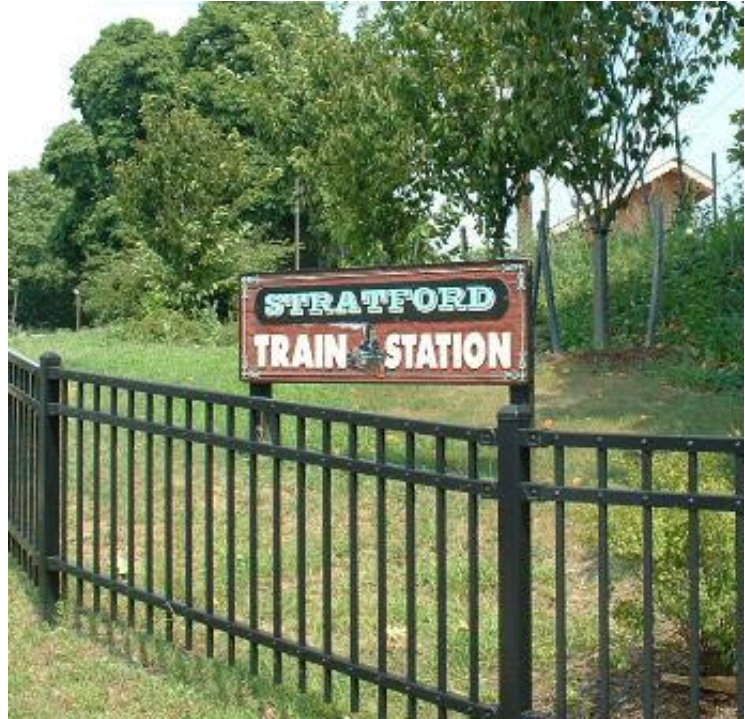
This station has short platforms with no canopies. The Town and CDOT have plans to extend the platforms, construct a parking garage and possibly add a canopy to the westbound platform

Platforms – The platforms at Stratford Station are only four cars in length. Structurally, the platforms are in fair to good condition. Nearly all the joints between platforms are failing. Some of the stairs are cracked and spalling. The aluminum platform, stair and ramp railings are weathered with an occasional bent panel. The trackside edge of the platform has a painted yellow stripe. Platform illumination appears to be sufficient. With support from CDOT, the Town plans to extend the platforms over the next few years.

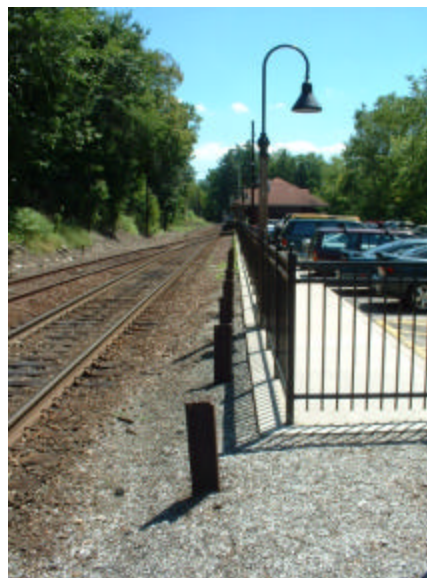
Fence, Walk and Post Mounted Light Next to Track
