**Housatonic River Basin Natural Resources Restoration Plan
Project Proposal**

**Heminway Pond Dam Removal
Steele Brook
Aquatic Natural Resources Restoration/Enhancement**

**Town of Watertown
August, 2011**

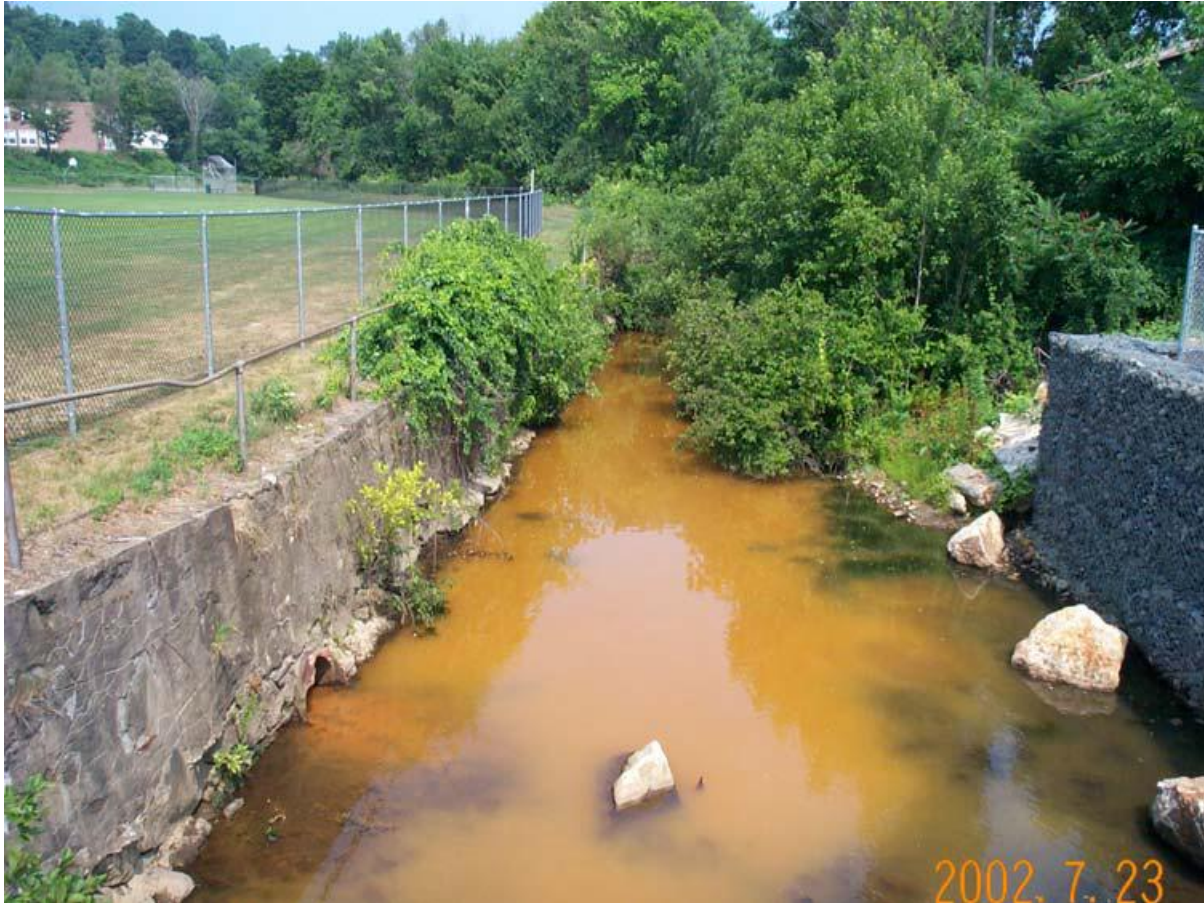
Figure 1 (Photograph courtesy of CT DEEP).

Steele Brook is a high gradient stream originating in the forested area north of Watertown and flows southeasterly to its confluence with the Naugatuck River in Waterbury. The brook is designated as a Class A surface water from the headwaters to the former outfall of the Watertown Fire District sewage treatment plant upstream of Pin Shop Pond. Below this point, the brook is designated as a Class B surface water stream. Portions of Steele Brook have been on the Connecticut Department of Energy and Environmental Protection's list of impaired water bodies since 2002 for not meeting Aquatic Life Goals. These Aquatic Life Goals are measures of the benthic macroinvertebrate community in the water body. Steele Brook, in this area, had poor benthic macroinvertebrate populations. In the area directly downstream of Heminway Pond the water quality does not meet water quality standards. Between the dam and Echo Lake Road there is a major local impact to water quality through iron precipitate settlement during low flow periods. There has been a concern in this area due to orange discoloration of the water, turbidity, and loss of habitat caused by flocculation. There is a shift in macroinvertebrate communities which occurs below Heminway Pond in the vicinity of Echo Lake Road and extends to the mouth of Steele Brook. Sites upstream of Heminway Pond have good benthic macroinvertebrate communities and meet CT DEEP Water Quality Standards. The orange discoloration of the water exists during low flow periods in the area between the dam and Echo Lake Road. It was first observed at the outlet area of a pipe which drains from the baseball field adjacent to the pond area. Orange discoloration has also been witnessed in the bank area across from the ball field (east side of the channel) and in the rock lined channel to the west of the pond area. Figure 1 is a photograph portraying the orange discoloration in the channel downstream of the dam.

During the summer of 2001, CT DEEP collected 8 rounds of ambient water chemistry from 6 sites from Route 6 to the mouth of the brook. Preliminary sediment grab samples and water chemistry were taken from 3 locations in Heminway Pond. The orange discoloration ends approximately at the end of the broken wall on the west bank of the brook. CT DEEP has anecdotal evidence that the area occupied by the baseball field was once a landfill. There is also evidence that the area was at one time a wetland. Other water quality concerns, particularly elevated bacteria levels, exist within the basin. A TMDL (Total Maximum Daily Load) was developed for Steele Brook, with copper identified as the critical pollutant; however, the primary sources of copper have been addressed.

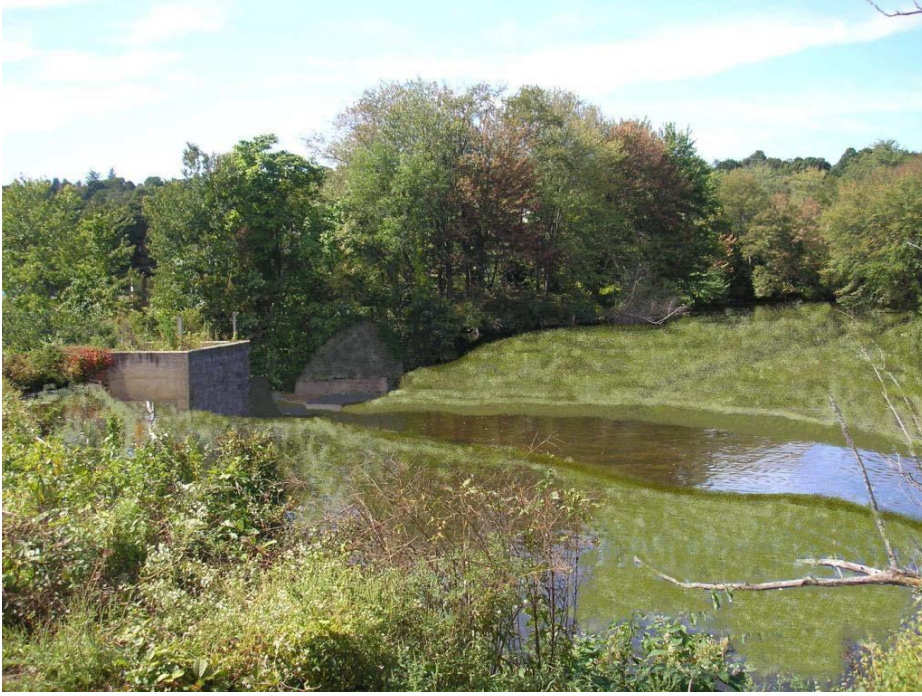
Conceptual of full removal

Full Removal of Spillway would result in major beneficial impacts and no adverse impacts to fisheries in Steele Brook and the Heminway Pond area. The beneficial impacts would result from complete removal of a major fish barrier, Heminway Pond Dam, elimination of the pond, and the creation of a new channel/floodplain system in the pond area. Fish passage would be accomplished due to the removal of the spillway, and

the construction of a more suitable stream channel above and below the dam. The proposed channel would facilitate the unimpeded migration of the full range of fish species through the entire project reach. Subsequently, implementation of this option allows the maximum amount of fish passage possible at this site. The removal of the spillway would eliminate the thermal impacts associated with the pond and the channel between the dam and Echo Lake Road. There are no adverse impacts to fisheries associated with implementation of this alternative as it would open this stretch of stream to passage which has not been passable since construction of the dam.
