# REHABILITATION STUDY REPORT

State Project No. 063-703  
Bridge No. 03614 in Hartford, CT  
I-91 TR 828, 15-161 over Drainage

State of Connecticut  
Department of Transportation  
Newington, Connecticut

*Submitted:* February, 2016

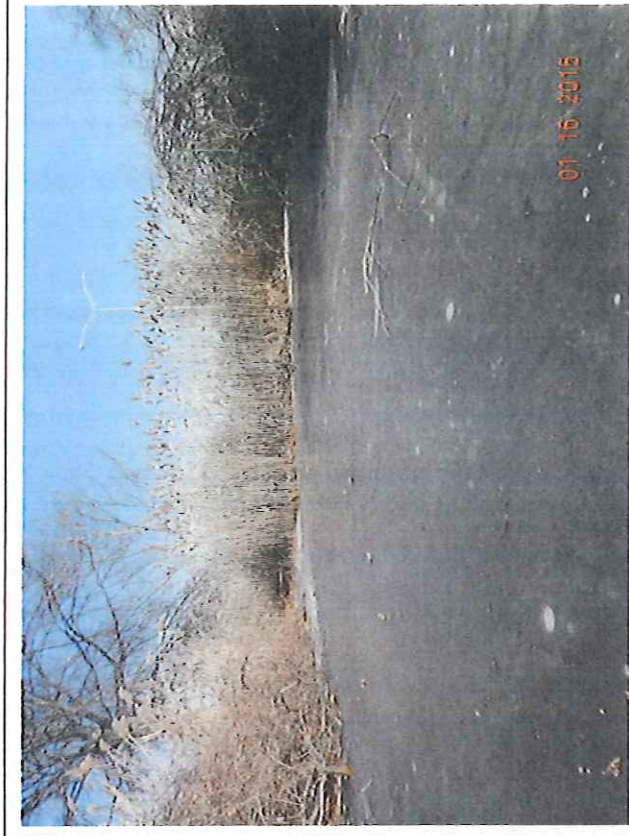
Photo # 8: Channel Looking Upstream (North)
